Grinding noises from area of front axle - wheel bearing defective

Topic number	LI33.20-P-047117
Version	3
Design group	33.20 Wheel location, wheel hub
Date	05-21-2010
Validity	Model 204 except 4MATIC; except 204.9## (GLK), 207
Reason for change	New repair method / damage code
Reason for block

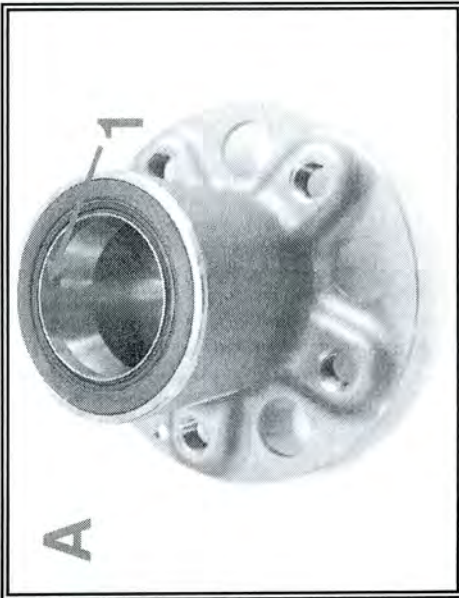
The most important new feature of the repair method is the use of a repair hub (Figure A) with inserted stainless steel race (1).

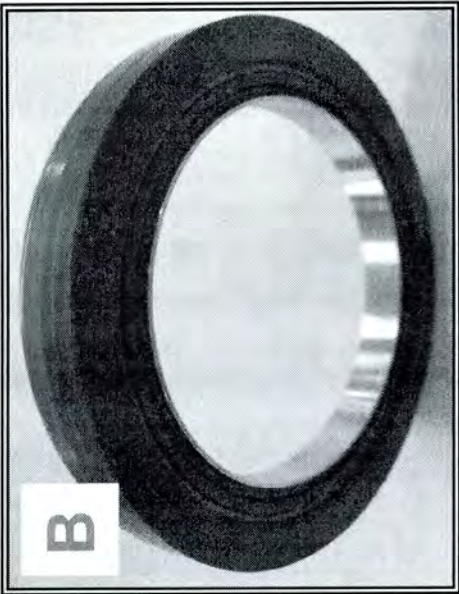
For this case there is a repair kit (Figure B), consisting of a wheel hub sealing ring with preinstalled stainless steel race.

This repair kit must be pulled into the wheel hub which is to be reinstalled.

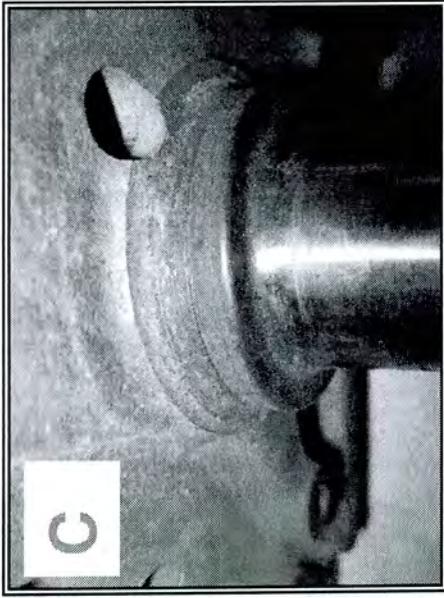
- 1.) Detach wheel hub, bearing and brake cover plate.
- 2.) Use a wire brush to remove loose corrosion from the contact surface of the wheel hub sealing ring (Figure C).
- 3.) Clean steering knuckle spindle thoroughly.
- 4.) Install new brake cover plate (Figure E) with optimized sponge rubber (picture 2).
- 5.) Push on repair hub (Figure A) without tilting it and pull as far as the stop with the clamp nut (Figures G,H,I)
- 6.) Adjust wheel bearing play (Figure J).
- 7.) Install sponge rubber ring (Figure F) on rpm sensor.
- 8.) Reassemble the vehicle.

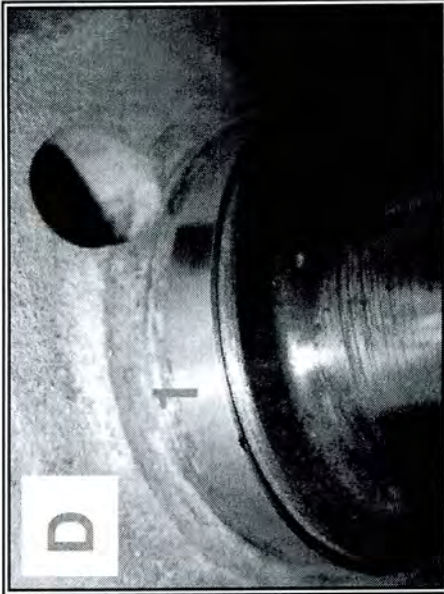
The stainless steel race (1) is pressed onto the corroded steering knuckle (Figure D) during assembly of the wheel hub and guarantees the new seal with the wheel hub sealing ring. This means that it is no longer necessary to replace the steering knuckle!

When the repair hub with stainless steel race is installed, the stainless steel race is positively pressed onto the steering knuckle (Figure D).
