# SERVICE CAMPAIGN BULLETIN

NTB11-073

## VOLUNTARY SERVICE CAMPAIGN CALL WAITING FUNCTION NAVIGATION UPDATE

**CAMPAIGN ID #:** P1234

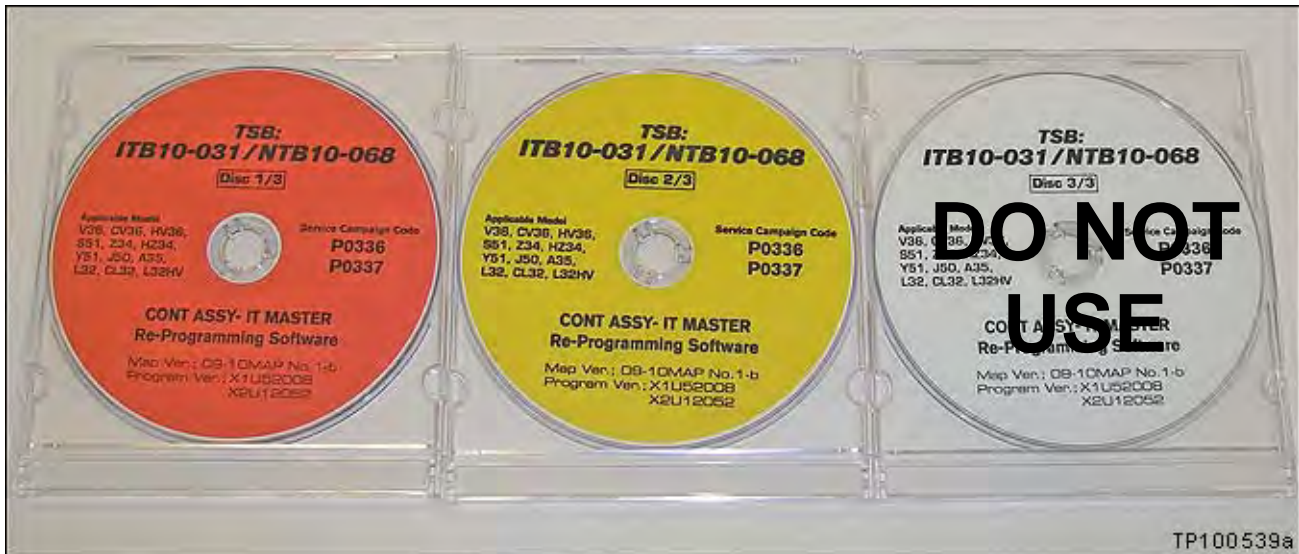
- Discs 1/3 and 2/3 of the set shown in Figure A are used for 2010 models in this campaign.
- Do not use disc 3/3.

**NOTE:** Numbers on the disc do not match this bulletins reference number or the campaign ID #.

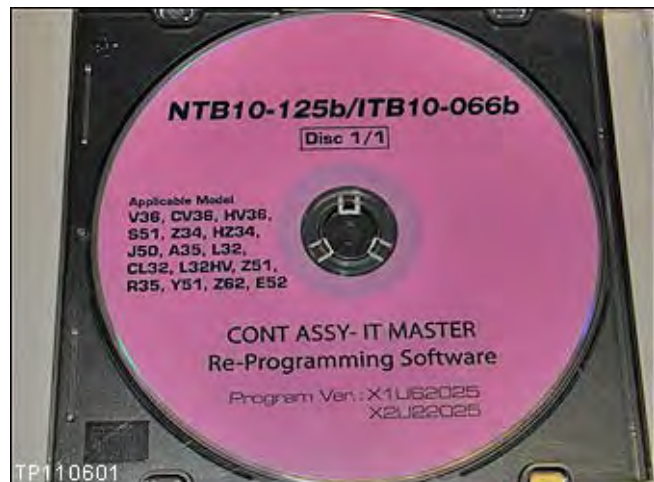
Figure B

- This disc (Figure B) is required for all applied models in this campaign.
- This disc replaces disc 3/3 above.
- This disc also replaces disc NTB10-068 (disc1/1) for GT-R.

**NOTE:** Numbers on the disc do not match this bulletins reference number or the campaign ID #.

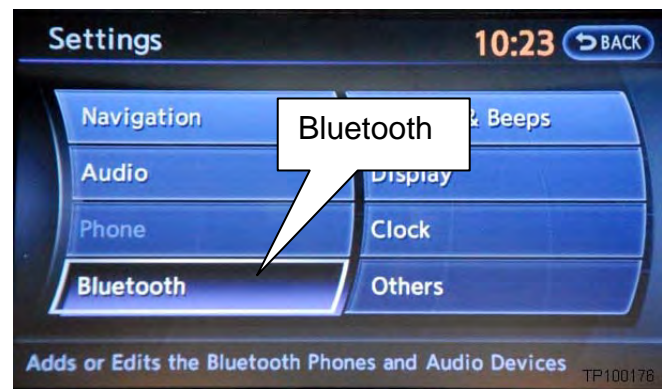
Figure 1

5. Touch "Bluetooth".

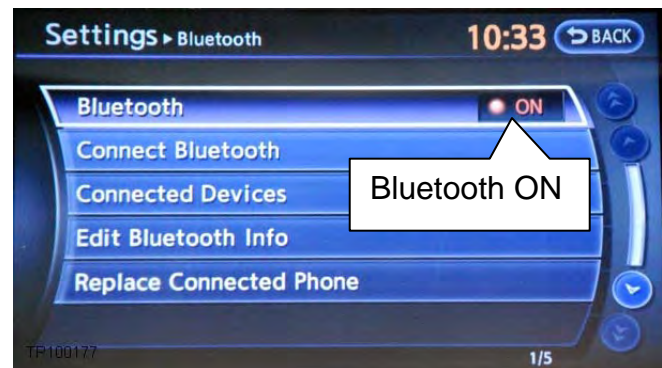
Figure 2

6. Make sure Bluetooth is OFF.

- Touching Bluetooth will change the setting ON > OFF or OFF > ON.

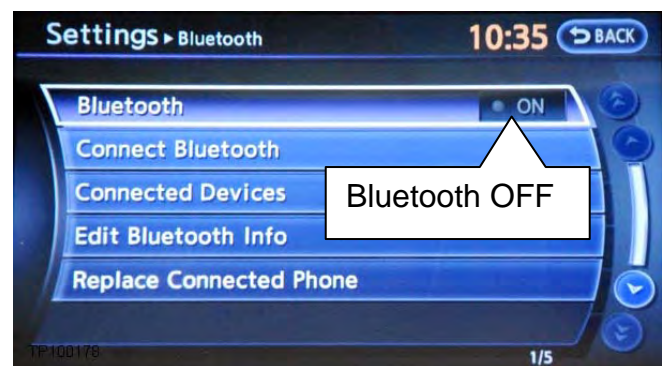
Figure 3

- Bluetooth is OFF when the ON indicator is "grayed-out".

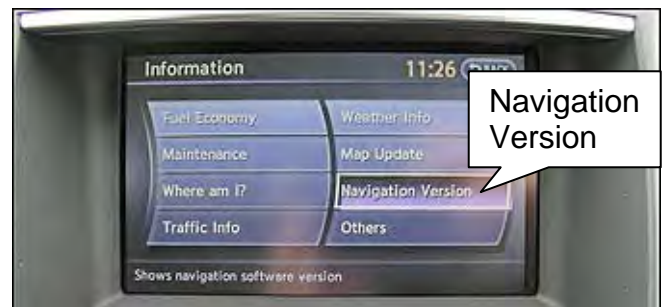
Figure 4

4. Select Navigation Version on the display screen.

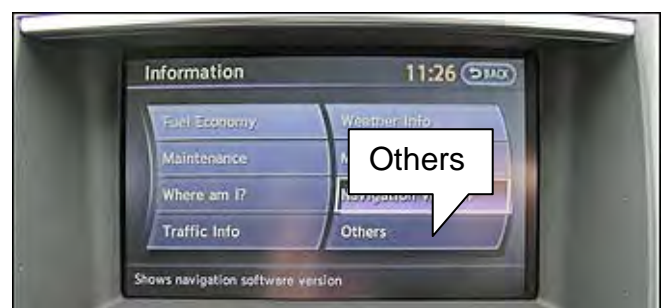
Figure 5

**NOTE:** On some vehicles you will need to select “Others” to find “Navigation Version”.

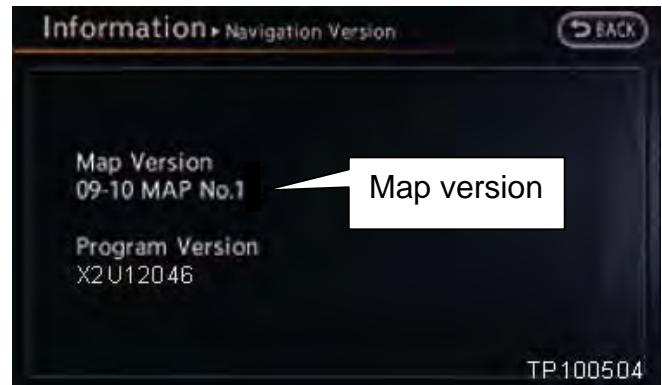
Figure 6

5. Check "Map Version".

- If the Map Version is **09-10 MAP No.1**  
or  
**09-10 MAP No.1a**

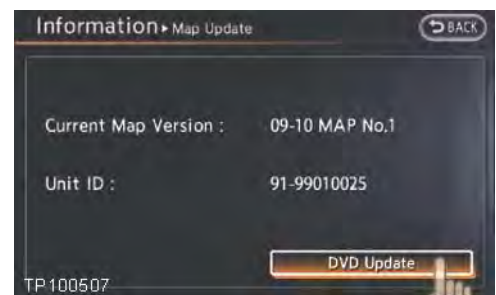
Figure 9

13. Touch "DVD update".

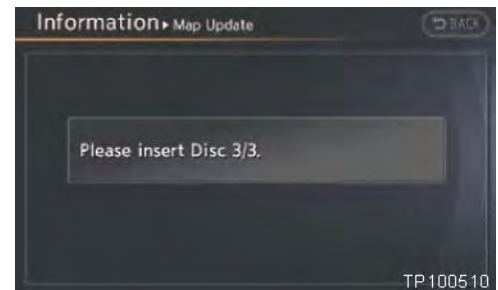
Figure 12

17. When the message "Please insert Disc 3/3" displays, insert disc  
**NTB10-125b / ITB10-066b (Disc 1/1).**

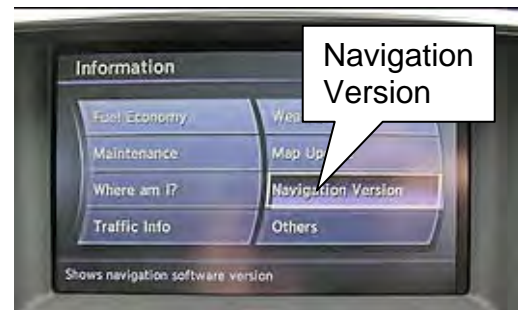
Figure 14

b. Select Navigation Version on the display screen.

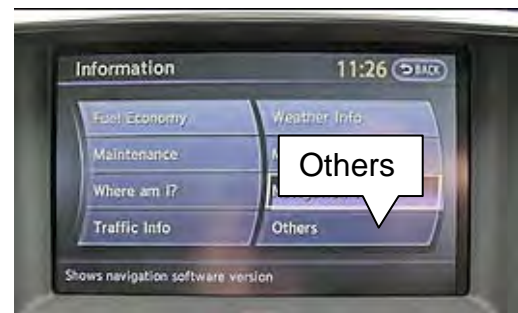
Figure 15

**NOTE:** On some vehicles you will need to select “Others” to find “Navigation Version”.

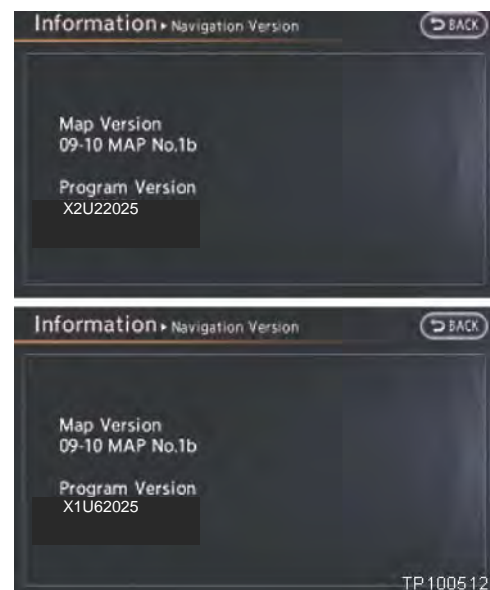
Figure 16

d. Map Version should be **09-10 MAP No.1b**.

e. Program Version should be:  
**X2U22025 or X1U62025**

**NOTE:** If the Map Version or the Program version is different than above, go back to step 5 on page 6.

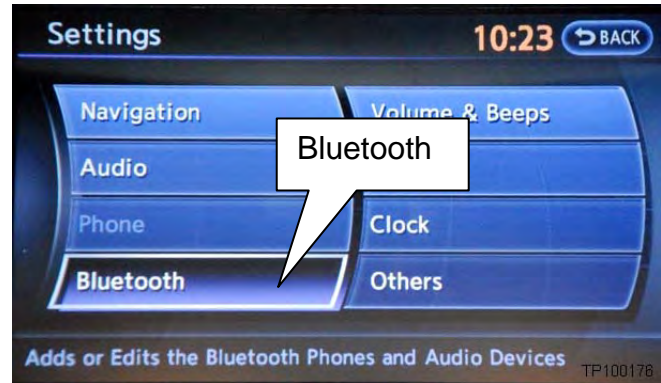
Figure 17

2. Touch “Bluetooth”.

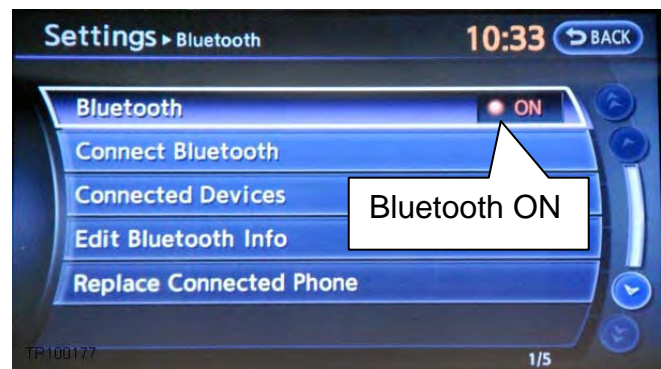
Figure 18

3. Make sure Bluetooth is set to the customers setting (as it was before starting the procedure).

- Touching Bluetooth will change the setting ON > OFF or OFF > ON.
- Bluetooth is ON when the ON indicator displays in orange.

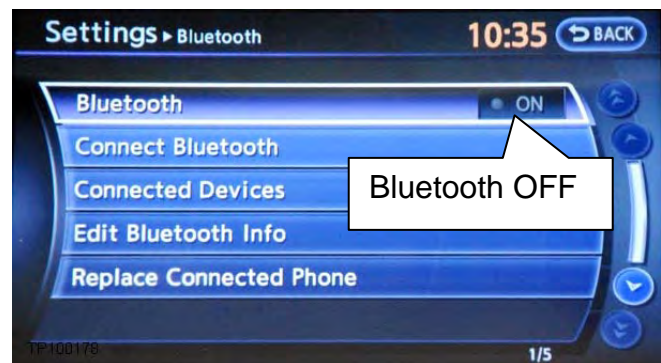
Figure 19

- Bluetooth is OFF when the ON indicator is “grayed-out”.

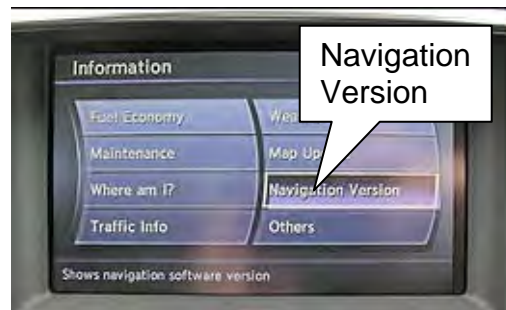
Figure 21

b. Select Navigation Version on the display screen.

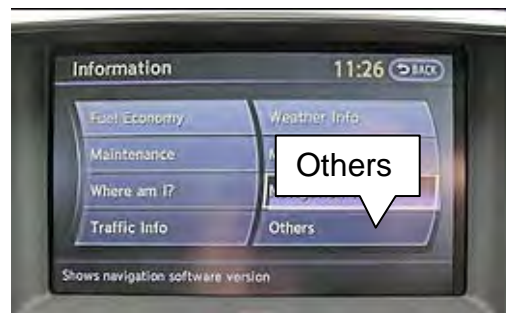
Figure 22

**NOTE:** On some vehicles you will need to select “Others” to find “Navigation Version”.

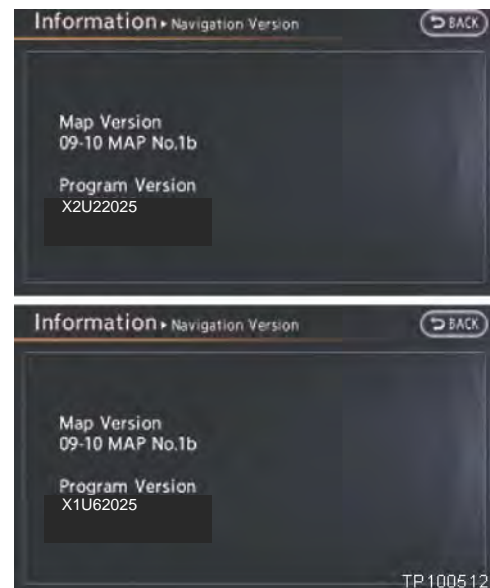
Figure 23

d. Program Version should be:

**X2U22025 or X1U62025**

**NOTE:** If the Program version is different than above, turn the ignition off, go back to step 5 on page 11 and load the disc again.
