ITB11-046a

## **VOLUNTARY SERVICE CAMPAIGN CALL WAITING FUNCTION NAVIGATION UPDATE**

**CAMPAIGN ID #:** P1235

**APPLIED VEHICLES:** 2010 G37 Convertible (HV36)  
2010 G37 Coupe (CV36)  
2010 G37 Sedan (V36)  
2011 – QX56 (Z62)  
2010 – 2011 FX35/50 (S51)  
2010 – 2011 EX35 (J50)  
2011 – 2012 M37/56 (Y51)  
2012 M35h Hybrid (Y51HV)

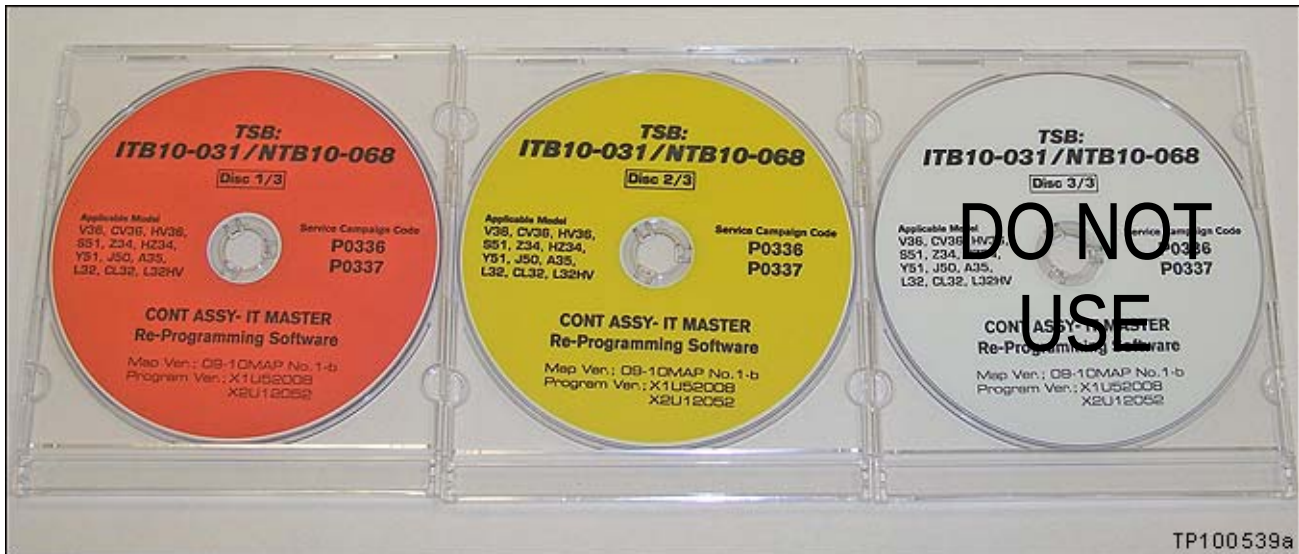
- Discs 1/3 and 2/3 of the set shown in Figure A are used for 2010 models in this campaign.
- Do not use disc 3/3.

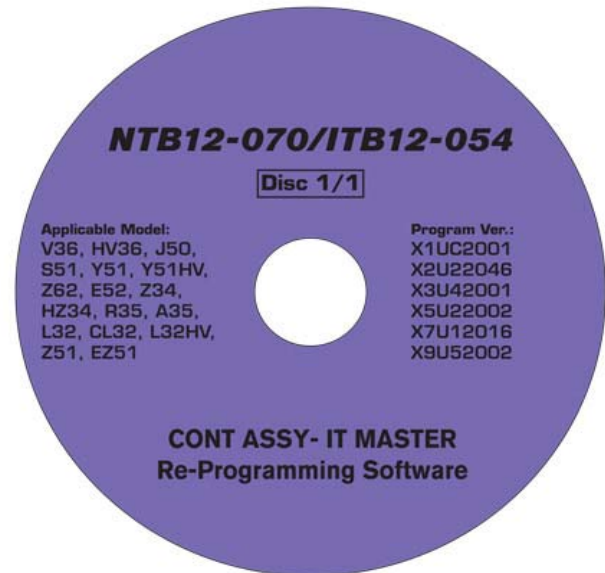
Figure B

- This NEW disc (Figure B) is required for all applied models in this campaign.
- This disc replaces disc 3/3 above.
- This disc also replaces disc NTB10-125b/ITB10-066b (disc 1/1).

NOTE: Numbers on these discs do not match this bulletin's reference number or the campaign ID #.

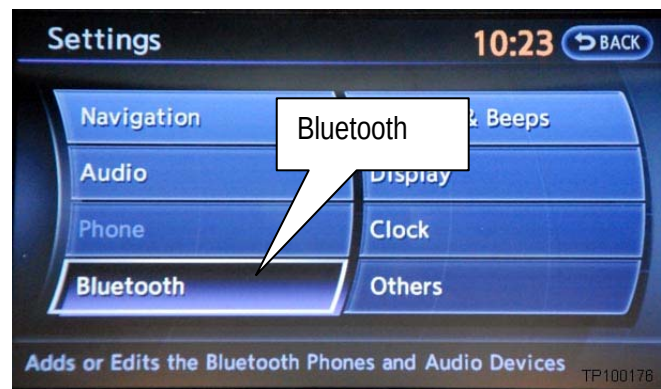
Figure 1

5. Touch "Bluetooth".

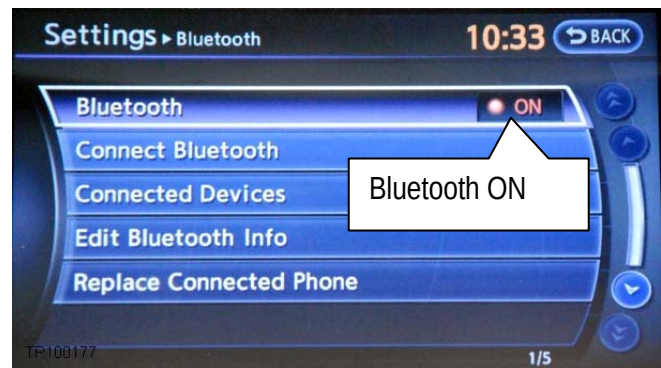
Figure 2

6. Make sure Bluetooth is OFF.

- Touching Bluetooth will change the setting ON > OFF or OFF > ON.

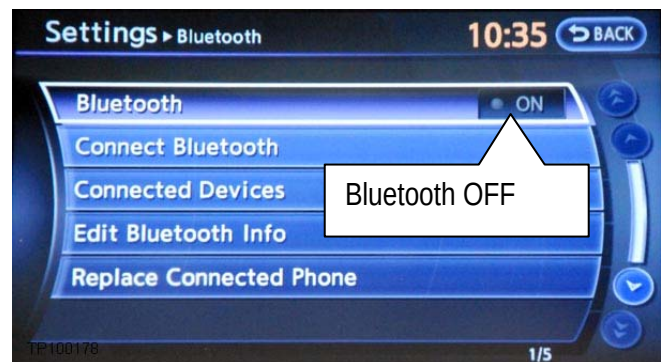
Figure 3

- Bluetooth is OFF when the ON indicator is "grayed" out.

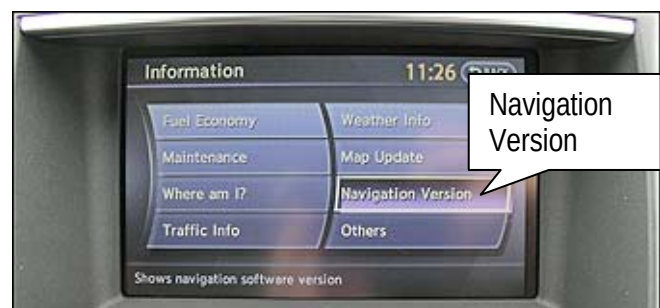
Figure 4

4. Select “Navigation Version” on the display screen.

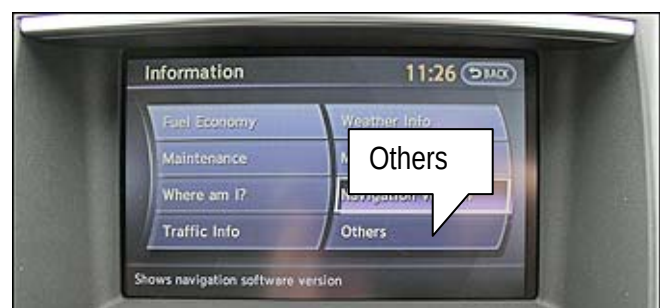
Figure 5

NOTE: On some vehicles you will need to select “Others” to find “Navigation Version”.

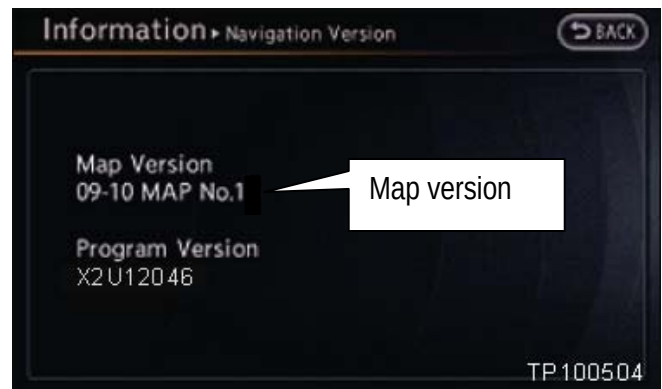
Figure 6

5. Check "Map Version".

- If the Map Version is 09-10 MAP No.1  
or  
09-10 MAP No.1a

- If the Map Version is any other then above:
  - a. Insert the new disc  
NTB12-070 / ITB12-054 (Disc 1/1) into the  
in-dash CD / DVD player.

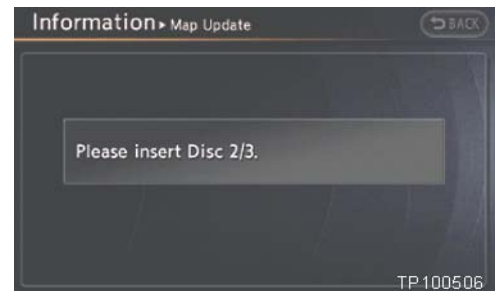
Figure 8

12. When the message “Please insert Disc 2/3” displays, insert disc ITB10-031 / NTB10-068 (Disc 2/3).

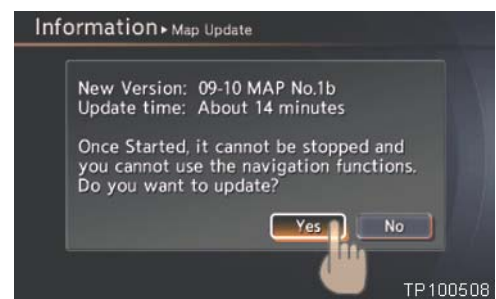
Figure 10

14. Touch “Yes” to begin the map update process.

- Map update will take about 15 minutes.

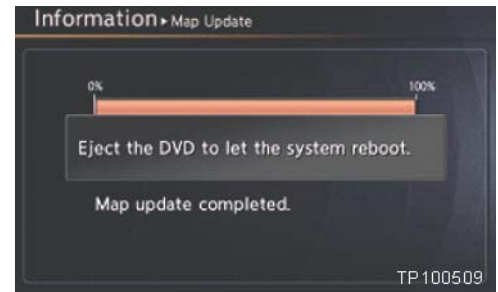
Figure 11

15. When “Eject the DVD to let the system reboot” is displayed, eject Disc 2/3.

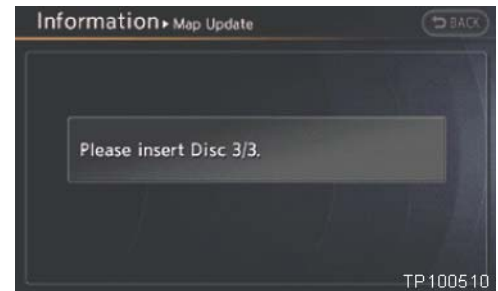
Figure 12

17. When the message “Please insert Disc 3/3” displays, insert the new disc  
NTB12-070 / ITB12-054 (Disc 1/1).

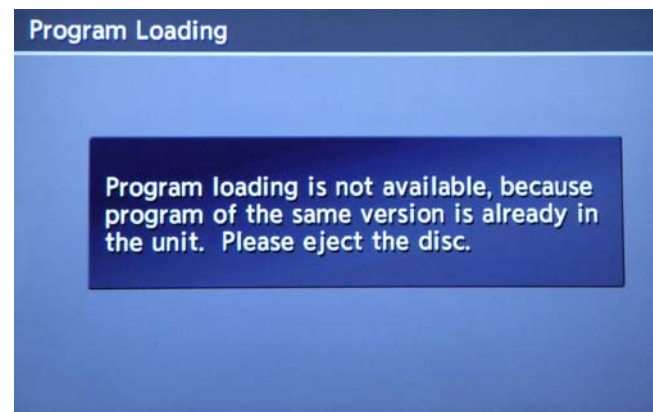
Figure13

- If the screen in Figure 13 is displayed, this disc is not needed.
  - Remove/eject the DVD from the CD slot.
  - Go to C: Check Bluetooth® Setting on page 12.

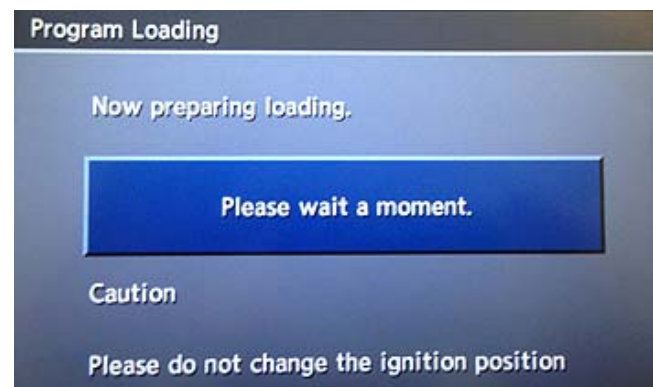
- If “Now preparing loading” shown in Figure 14 is displayed, reprogramming will begin automatically.
  - Follow the on-screen Caution during the reprogram.

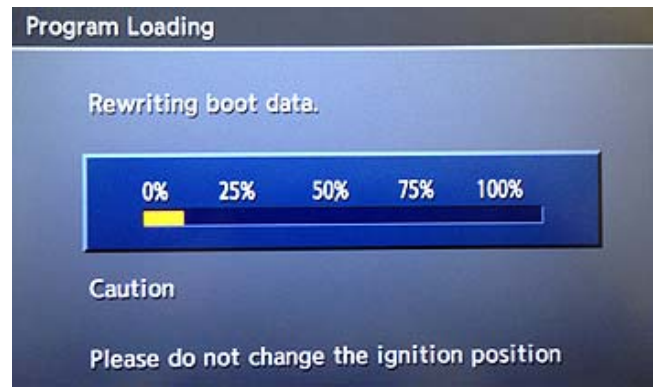
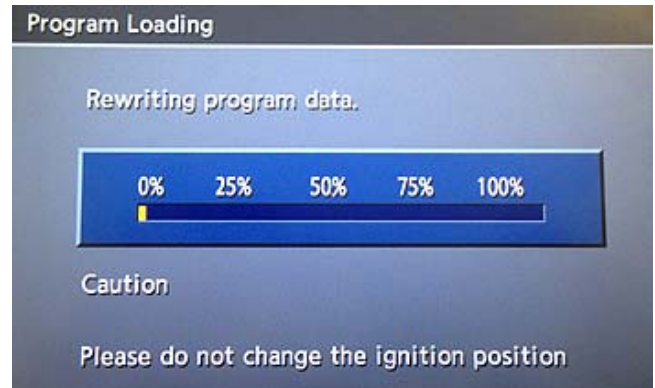
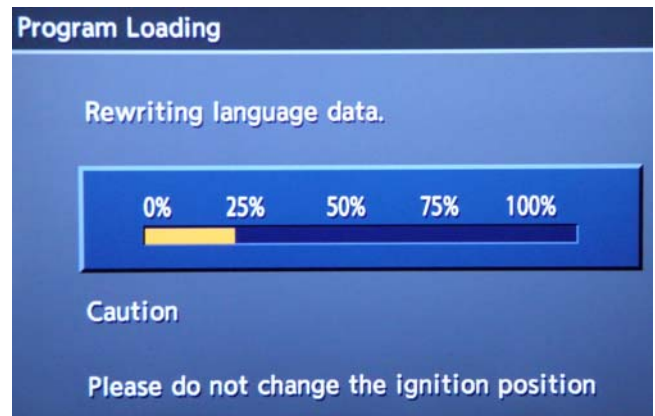
19. During the first part of the update process, 3 more screens will be displayed along with a percentage of completion (progress) bars:

- Rewriting boot data. (Figure 15)
- Rewriting program data (Figure 16)
- Rewriting language data (Figure 17)

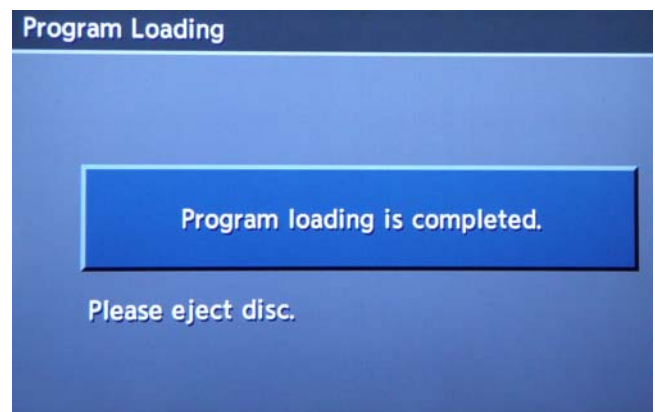
Figure 18

- "Program loading is completed" will be displayed (Figure 18).
- The Re-programming Software DVD will automatically eject.

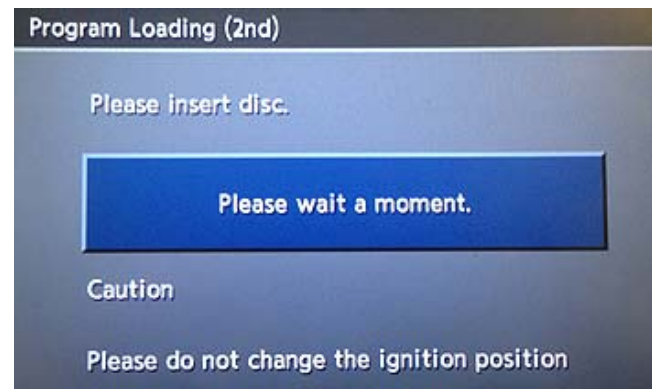
22. After the DVD is removed, the screen in Figure 19 ("Please insert disc") may ask to reinstall the same Re-programming Software DVD for a second time.

- If not (Navigation System restarts), go to step 25 on the next page.
- If so, re-insert DVD disc.
  - At the top of the screen "Program Loading (2nd)" will be displayed.

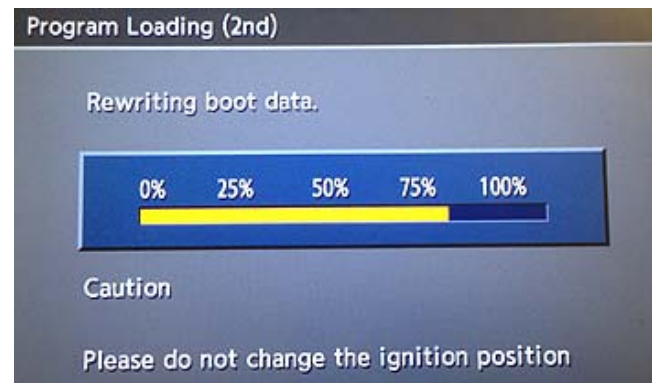
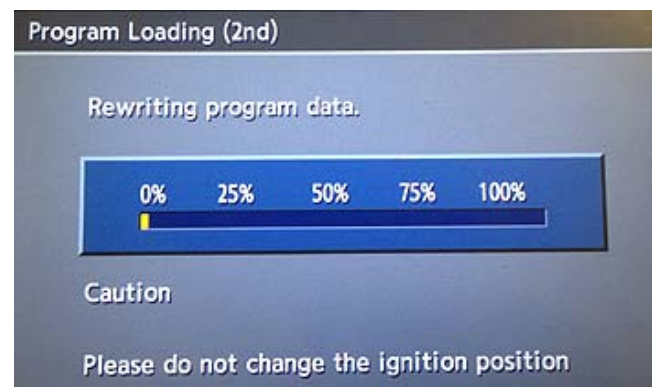
23. "Rewriting boot data" (Figure 20) and "Rewriting program data" (Figure 21) will be displayed.

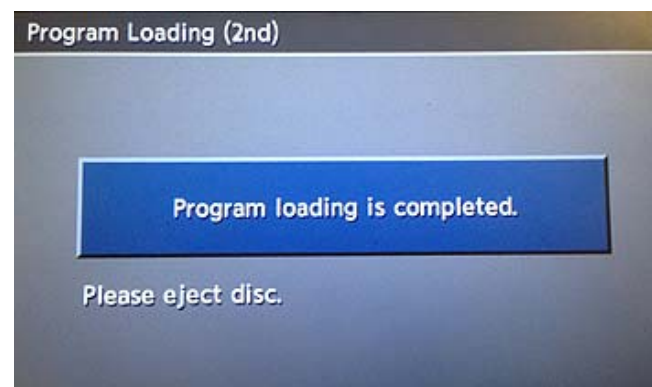
Figure 22

- "Program loading is completed" will be displayed (Figure 22).
- The Re-programming Software DVD will automatically eject.
- The Navigation system will restart.
- Proceed to step 25.

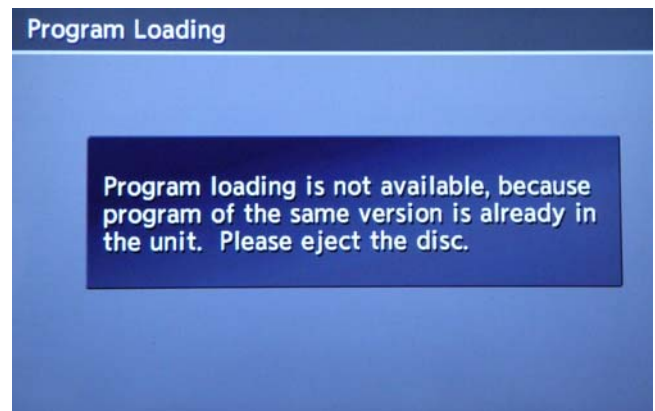
- If Figure 23 is displayed, it indicates that the re-program has been completed.
  - If complete, go to step 26.

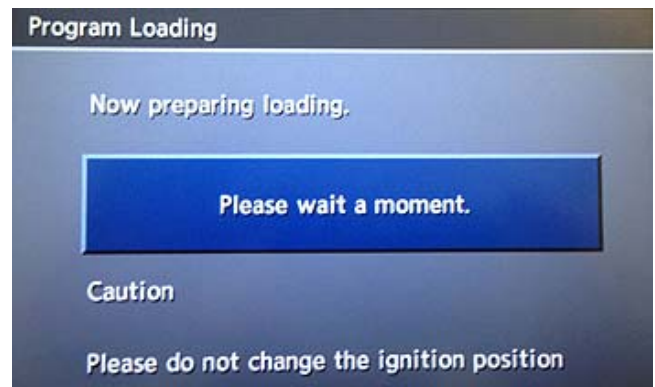
- If Figure 24 is displayed, the update did not complete. Allow the update to complete:
  - Go back to step 18 on page 8.
  - Follow steps 18 through 25 again.

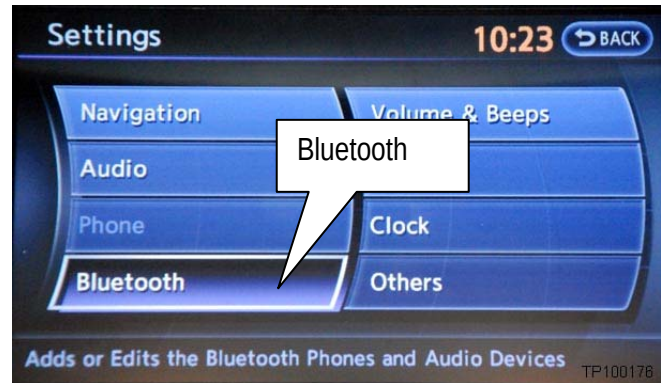
Figure 17

2. Touch “Bluetooth”.

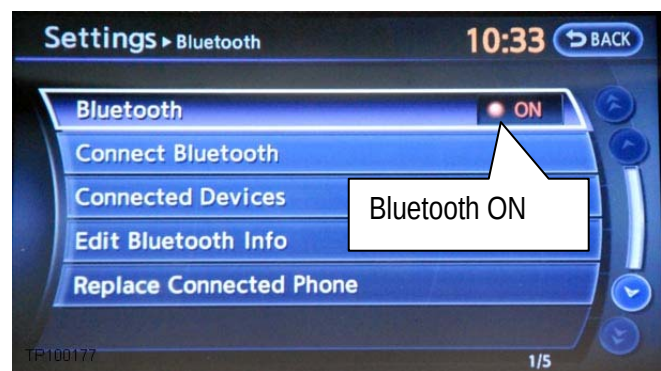
Figure 18

- Touching Bluetooth will change the setting ON > OFF or OFF > ON.
- Bluetooth is ON when the ON indicator displays in orange.

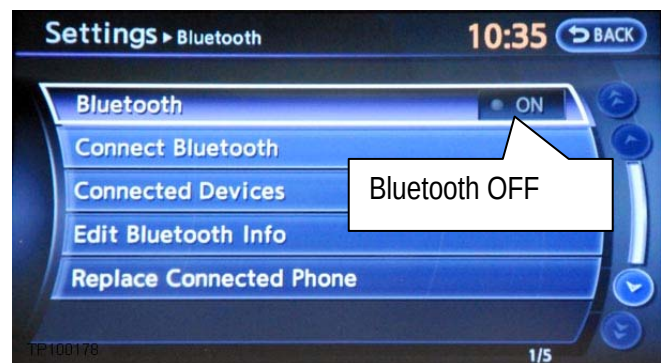
Figure 19

- Bluetooth is OFF when the ON indicator is “grayed out”.

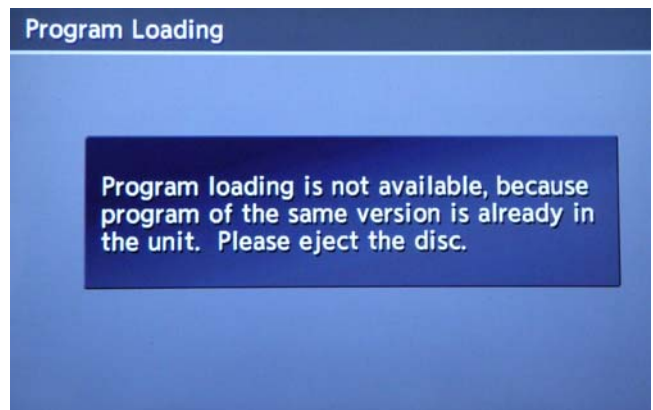
FigureA1

- If the screen in Figure A1 is displayed, this disc is not needed.
  - Remove/eject the DVD from the CD slot
  - Procedure is complete.

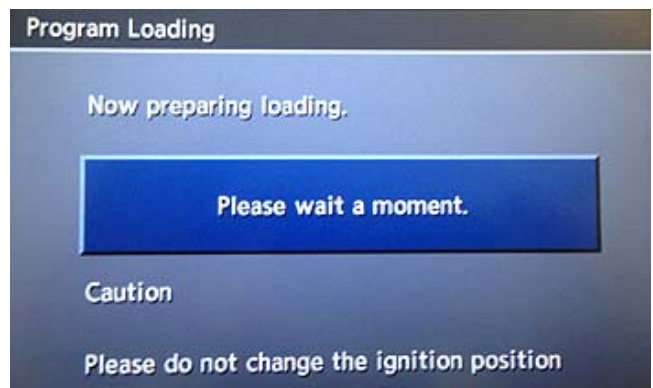
- If “Now preparing loading” shown in Figure A2 is displayed, reprogramming will begin automatically.
  - Follow the on-screen Caution during the reprogram.

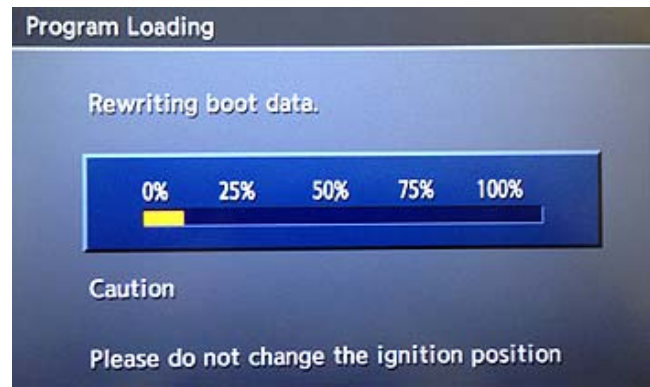
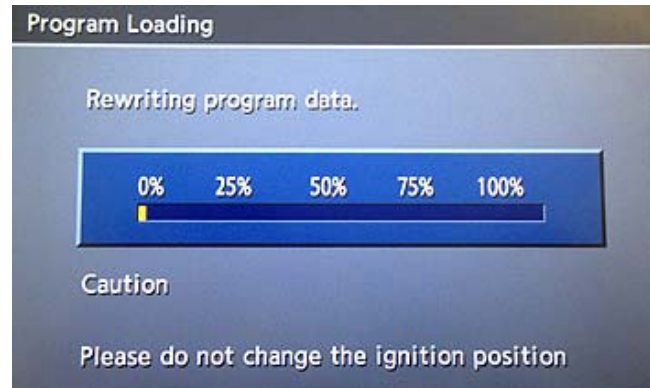
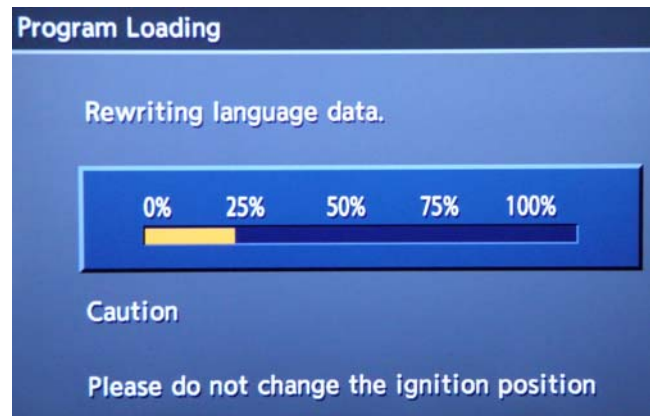
6. During the first part of the update process 3 more screens will be displayed along with a percentage of completion (progress) bars:

- Rewriting boot data. (Figure A3)
- Rewriting program data (Figure A4)
- Rewriting language data (Figure A5)

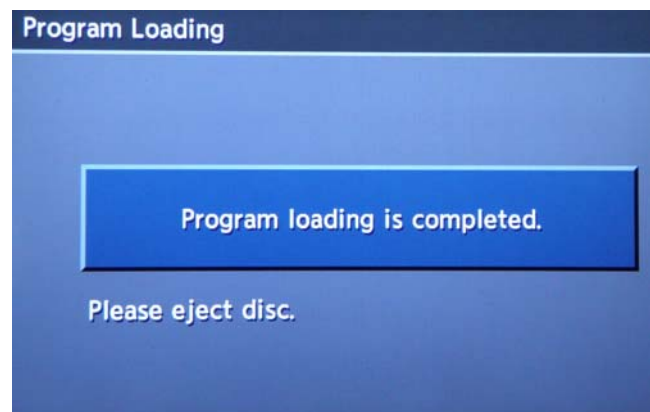
Figure A6

- "Program loading is completed" will be displayed (Figure A6).
- The Re-programming Software DVD will automatically eject.

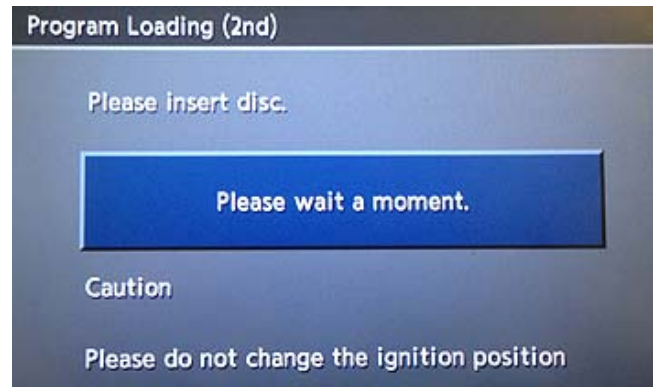
9. After the DVD is removed, the screen in Figure A7 (Please insert disc) may ask to reinstall the same Re-programming Software DVD for a second time.

- If not (Navigation System restarts), go to step 12 on the next page.
- If so, re-insert DVD disc.
  - At the top of the screen “Program Loading (2nd)” will be displayed.

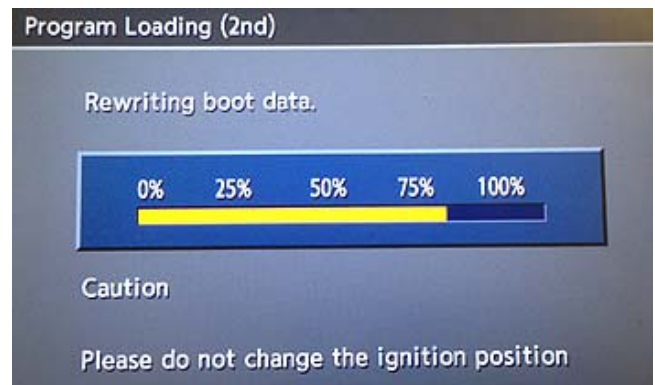
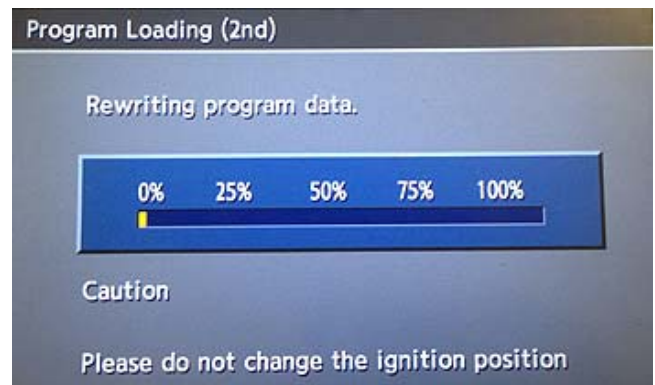
10. “Rewriting boot data” and “Rewriting program data” will be displayed once the DVD is reinstalled.

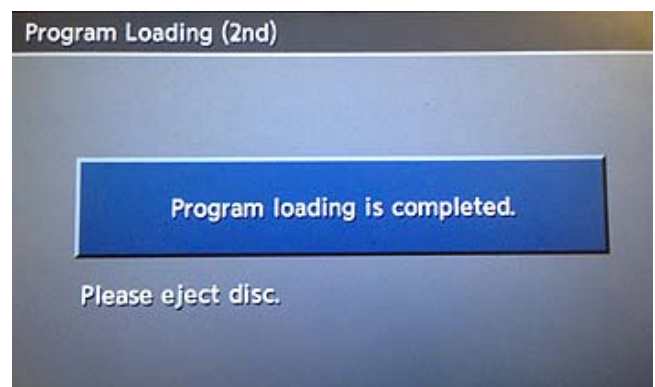
Figure A10

- “Program loading is completed” will be display (Figure A10).
- The Re-programming Software DVD will automatically eject.
- The Navigation system will restart.
- Proceed to step 12.

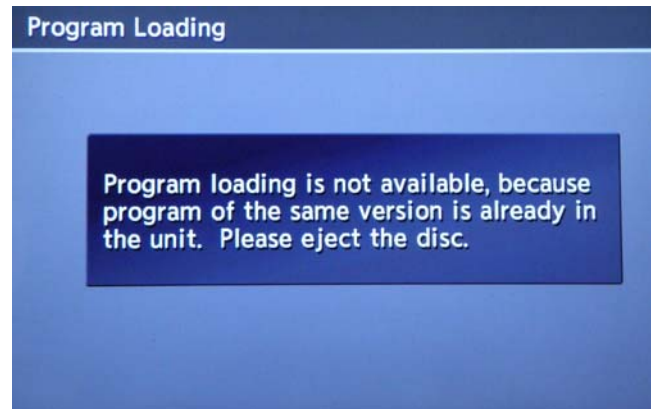
- If Figure A11 is displayed, it indicates that the re-program has been completed.
  - If complete, go to step 13.

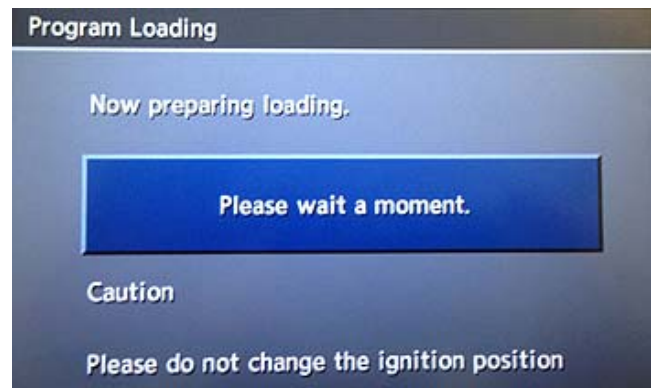
- If Figure A12 is displayed, the update did not complete. Allow the update to complete.
  - Go back to step 5 on page 13.
  - Follow steps 5 through 12 again.
