ITB12-053

## **VOLUNTARY SERVICE CAMPAIGN 2013 JX35 METER BACK LIGHT ILLUMINATION AND DISTANCE TO EMPTY INACCURACY**

**CAMPAIGN ID #:** P2538**APPLIED VEHICLE:** 2013 JX35 (L50)**Check Service COMM to confirm campaign eligibility.**

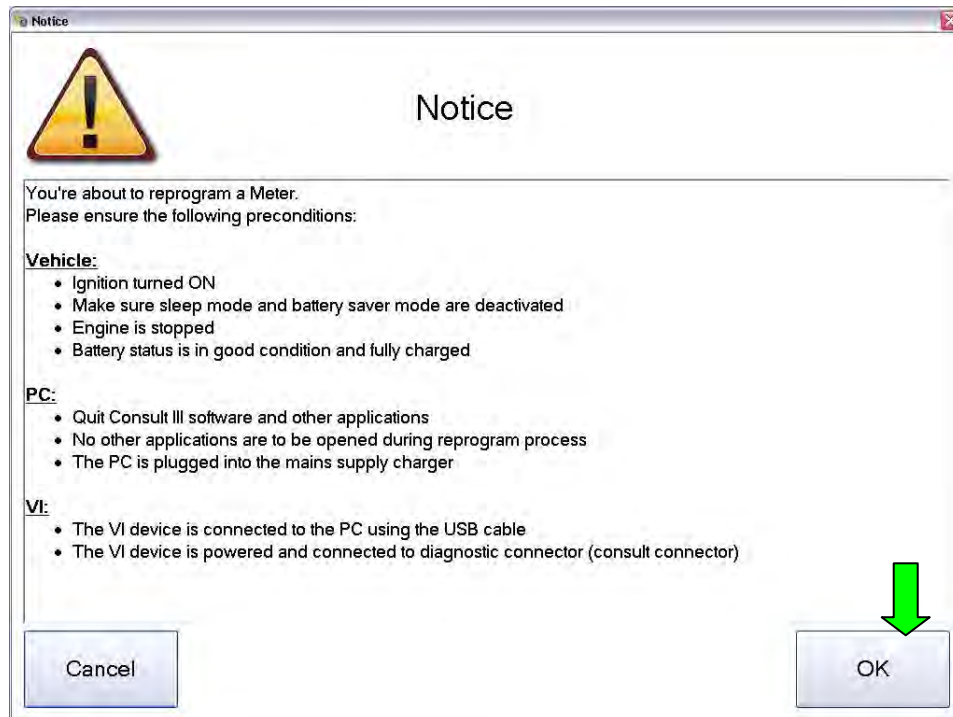
Figure 2

12. Select **OK** – meter reprogramming will start.
