# SERVICE BULLETIN

EC12-034

January 3, 2013

## 2013 SENTRA; ENGINE HAS HESITATION OR STOPS RUNNING AT IDLE OR VERY LOW SPEEDS

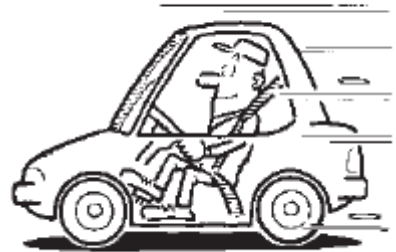
Figure A

- Take the vehicle for a 10 minute drive in order to meet the following Idle Air Volume Learn (IAVL) conditions:
  - Engine coolant temperature: 70 -100°C (158 -212°F)
  - Battery voltage: More than 12.9V (At idle)
  - Transmission: Warmed up

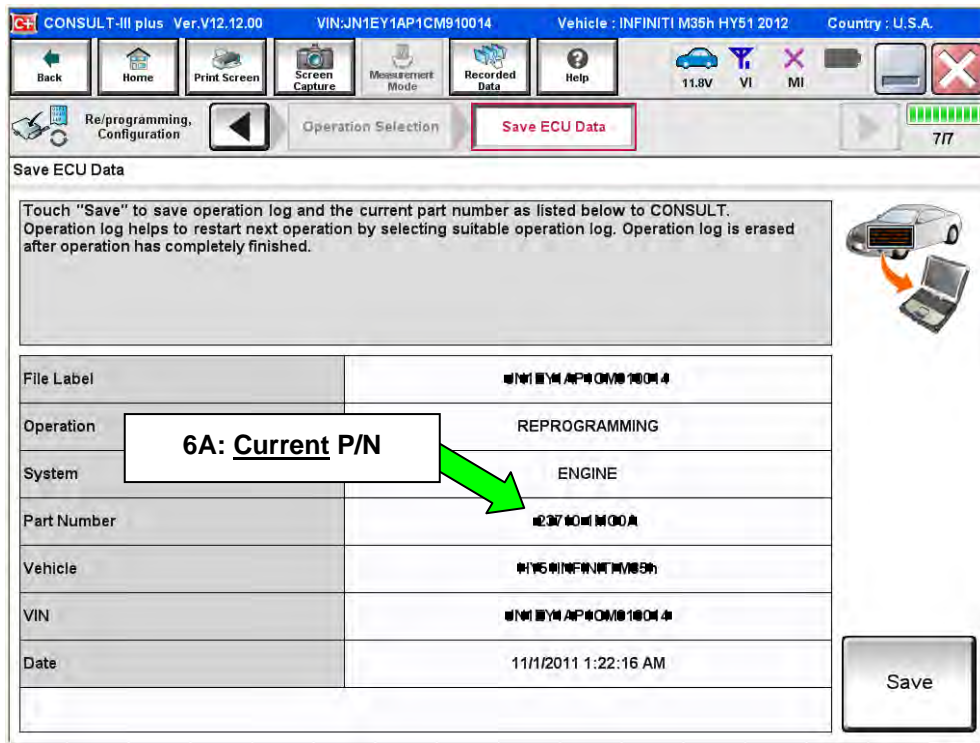
6. When you get to the screen shown in Figure 2, confirm this bulletin applies as follows:

A. Find the ECM or TCM **Part Number** and write it on the repair order.

**NOTE:** This is the current ECM or TCM Part Number (P/N).  
ECM preprogramming must be performed first.

5. Follow the on-screen instructions and navigate the C-III plus to the screen shown in Figure 2 on the next page.

B. Compare the P/N you wrote down to the numbers in the **Current ECM or TCM Part Number** column in **Table A** on next page.

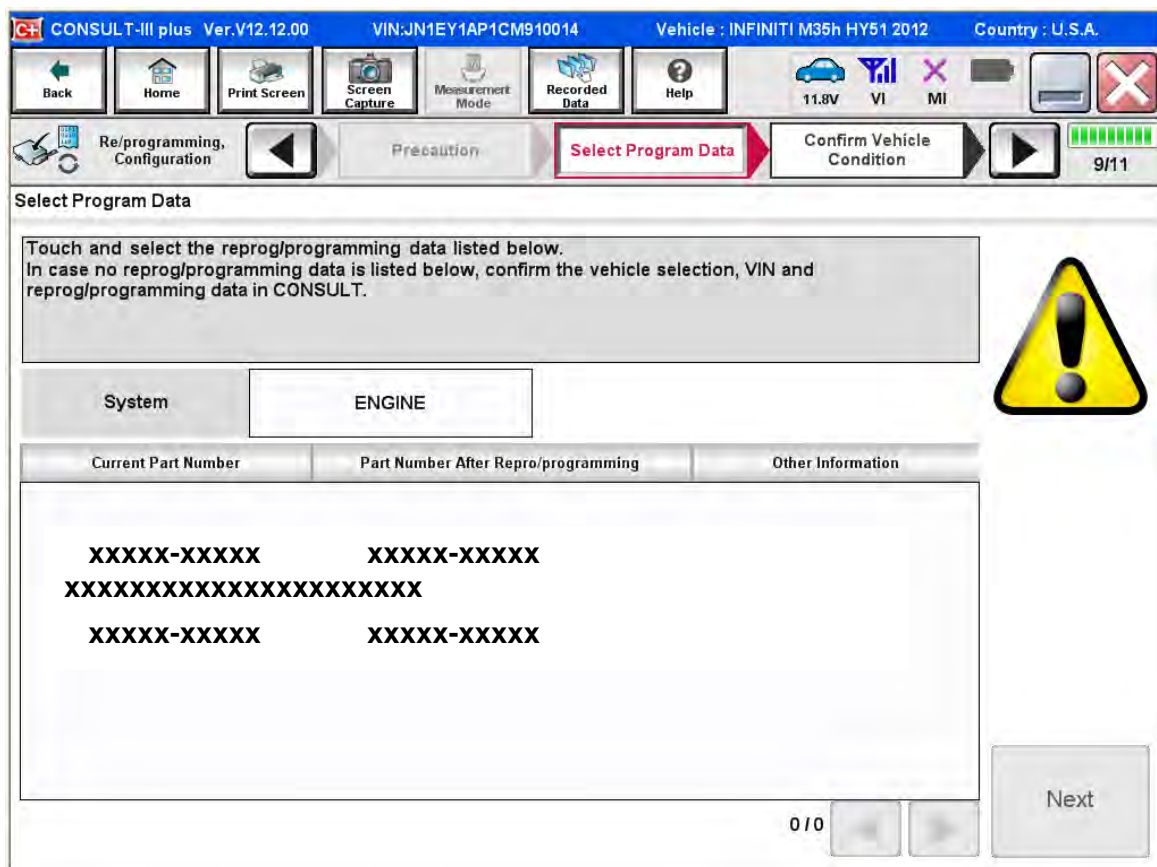
- In some cases, more than one new P/N for reprogramming is available.
  - In this case, the screen in Figure 3 displays.
  - Select and use the reprogramming option that **does not** have the message “Caution! Use ONLY with NTBXX-XXX”.
- If you get this screen and it is blank (no reprogramming listed), it means there is no reprogramming available for this vehicle.

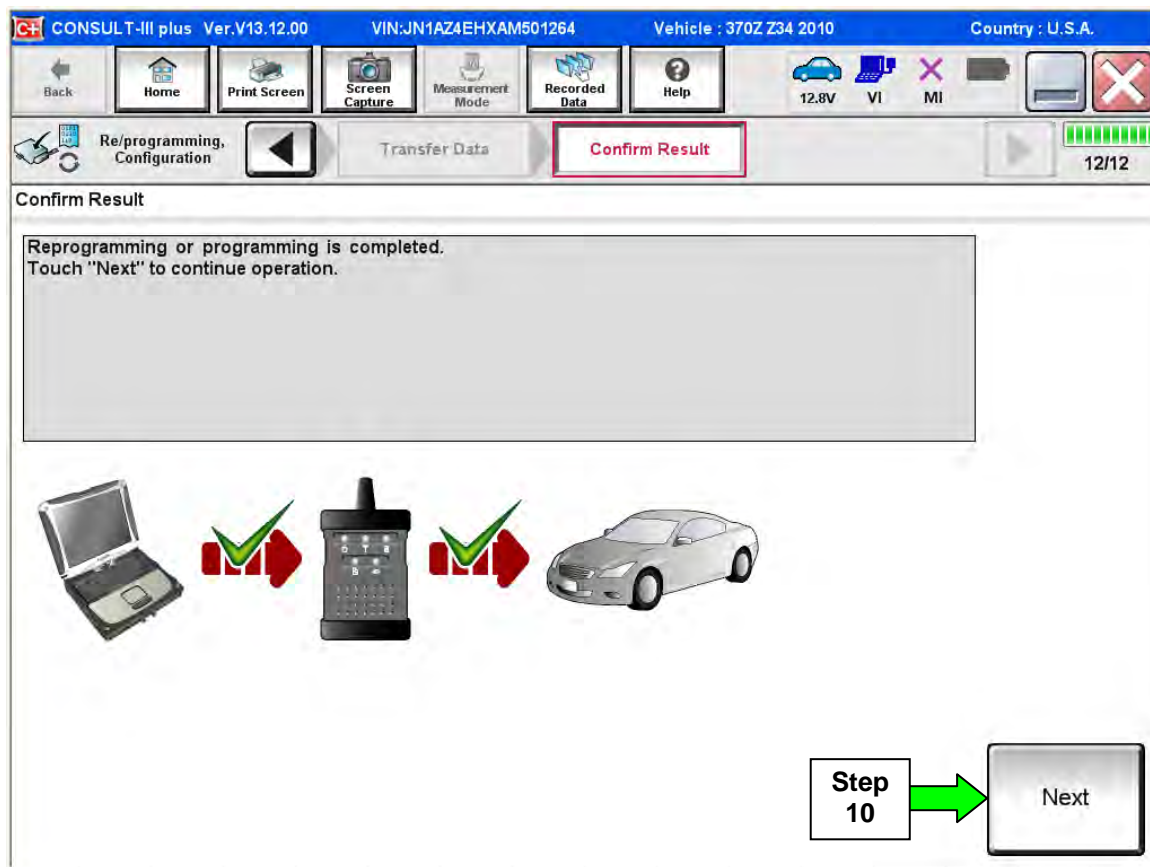
8. When the screen in Figure 4 displays, reprogramming is complete.

**NOTE:** If the screen in Figure 4 does not display (reprogramming does not complete), refer to the information on the next page.

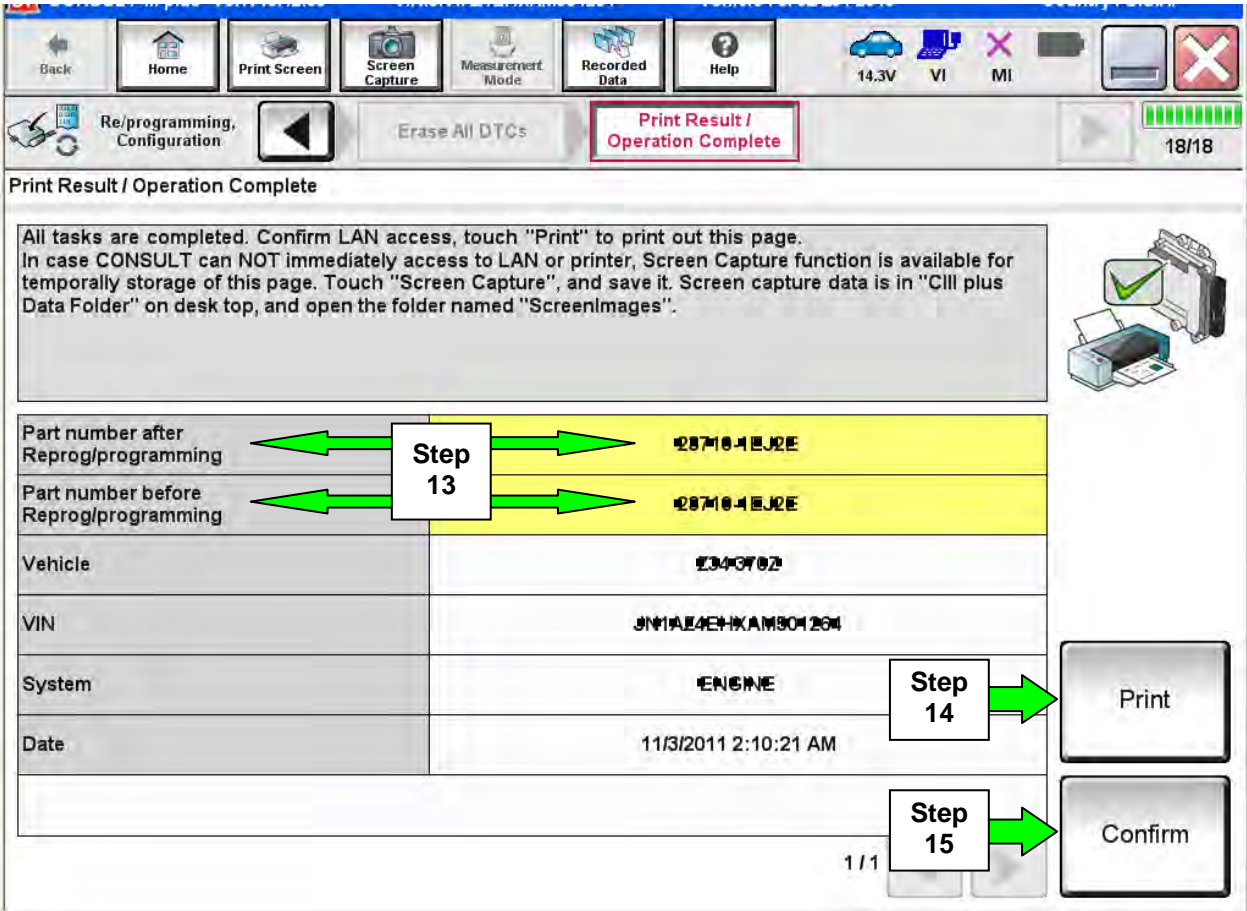
- 12. When the entire reprogramming process is complete, the screen in Figure 7 will display.
- 13. Verify the before and after part numbers are different.
- 14. Print a copy of this screen (Figure 7) and attach it to the repair order for warranty documentation.
- 15. Select **Confirm**.
