# Service Action

**Code: 64C9**

**Subject: 2012 – 2013 MY Volkswagen Beetle  
Front Window Motors**

**January 09, 2013**

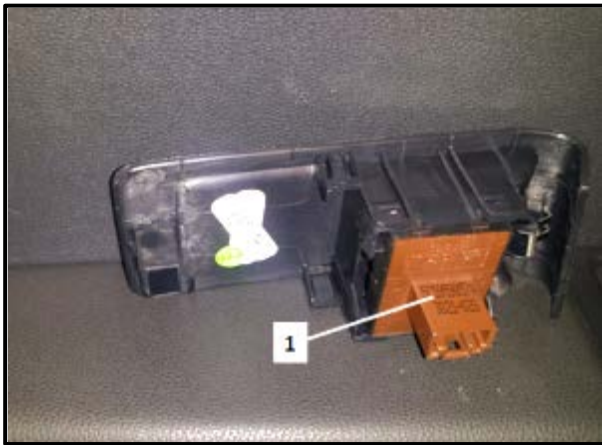
⇐ Disconnect connector <1> and remove the handle trim.

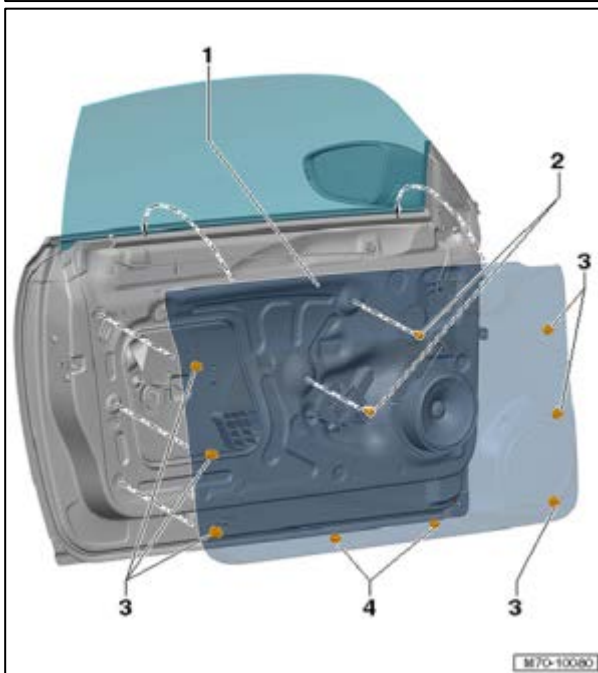
⇐ Turn and release screws <4> 90° to align them with their slot.

⇐ Loosen the clips <3> for the door trim panel out of the mounts <1> with the wedges (T10383).

⇐ Remove the door trim panel <1> vertically from the window shaft seal. If using a trim removal wedge (3409), care must be taken to not damage door panel.

⇐ Disconnect the connectors from the door trim panel <3>.

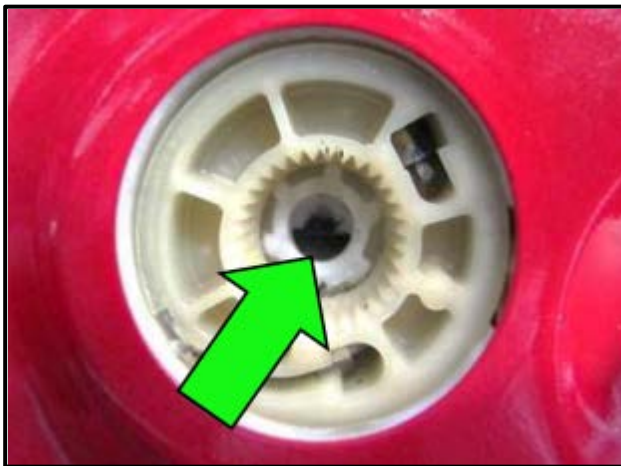
⇐ Place a large drop of adhesive part number (D 195 800 A1) as shown <arrow> into the lower corner of the regulator bore.

**CAUTION:** It is important that the adhesive remains only in the regulator bore and does not leak out onto the gear splines. Do not allow adhesive to come in contact with the regulator gear splines.

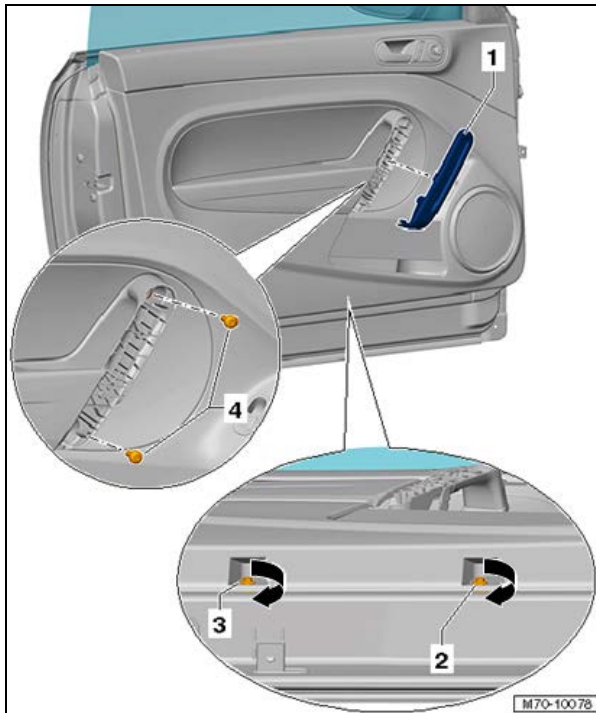
- ⇐ Reinstall the screws <4> (4.5 Nm) with torque wrench (VAG1783).
- ⇐ Turn and secure <2 and 3> 90° in direction of <arrow>.
- ⇐ Reinstall the upper section of the grip recess <1> on the mount in the door trim panel.

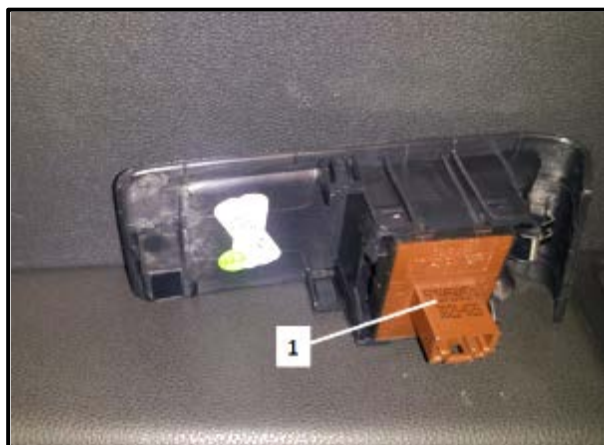
- Reconnect the connector <1> and reinstall handle trim.
- ⇐ Once installation of new motor(s) is complete allow minimum of three (3) hours cure time of adhesive before restoring electrical power to windows. Vehicle may be moved but do not reinstall fuses until cure time is complete.

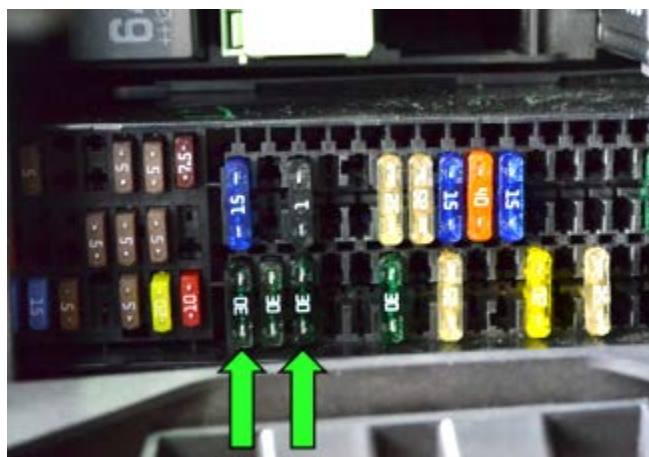
**Section H – Reinstall Fuses**

- ⇐ Once minimum 3 hour cure time is complete, reinstall the two fuses SC43 and SC45 <arrows> for door control units (window motors).
- Using the VAS tester, clear all DTC's from the vehicle.
