Applies To: **2014 Accord Plug-in** – Check the iN VIN status for eligibility

Product Update: Audio and Audio-Navigation Unit Software Update

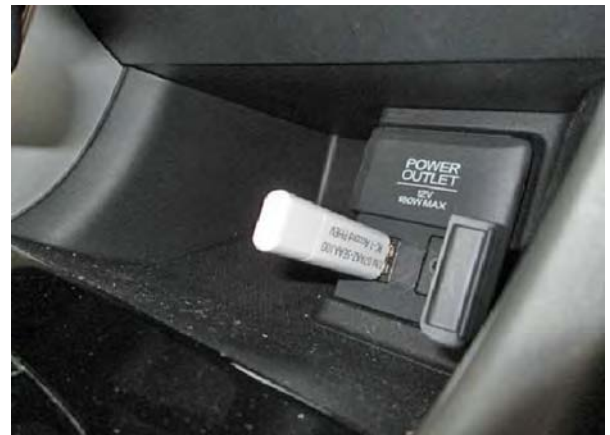
1. Connect a battery charger or a fully charged jumper battery to the vehicle and leave it connected during the entire update procedure to maintain a steady voltage.
2. Press the POWER button twice (without pressing the brake pedal) to select the vehicle ON mode.
NOTE: Do not put the USB stick in before the system boot up. It may lock up the unit.
3. Wait for the navigation system to finish booting up, then insert the USB update device into the USB port in the center console. See TOOL INFORMATION.

NOTE: The vehicle must remain ON during the update procedure. If the vehicle is turned OFF, or the USB update device is removed at any time during the update process, the audio-navigation unit will lock up and you will need to use the RECOVERY PROCEDURE.

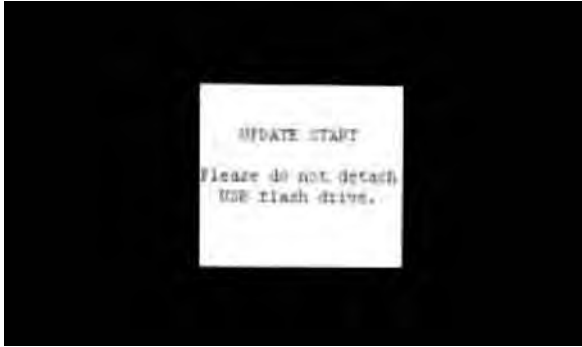
- Both screens will shut off for about 10 seconds and reboot with the notification below flashing on the navigation screen.

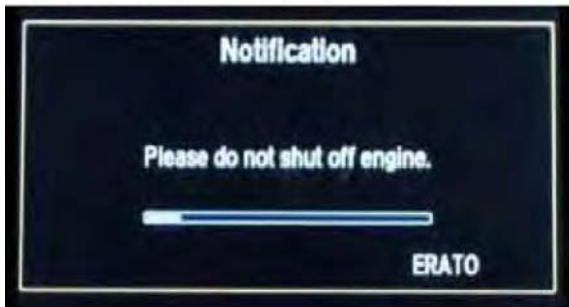
Navigation Screen

- The software update will begin. A Notification screen loading bar will display on both screens. NOTE: The engine does not need to be running to do this update.

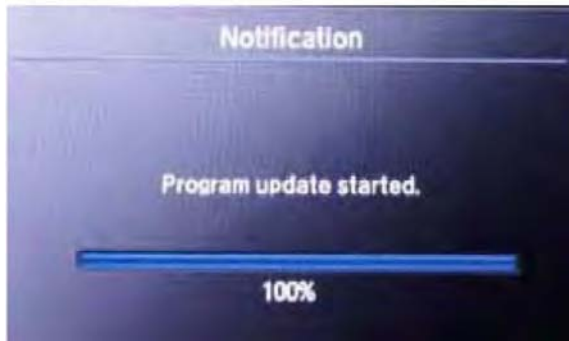
Touch Screen

NOTE: The software update takes about 30 minutes to complete.

On the touch screen, the progress bar will stop at 100% after ERATO is updated and remain at 100% throughout all SH and Utility updates. The progress bar will go back to 0% and resume when the BUuCOM update starts.
