Applies To: **2014 Accord Plug-in** – Check the iN VIN status for eligibility

## Product Update: Audio and Audio-Navigation Unit Software Update (Supersedes 13-024, dated March 19, 2013, to revise the information marked by the black bars)

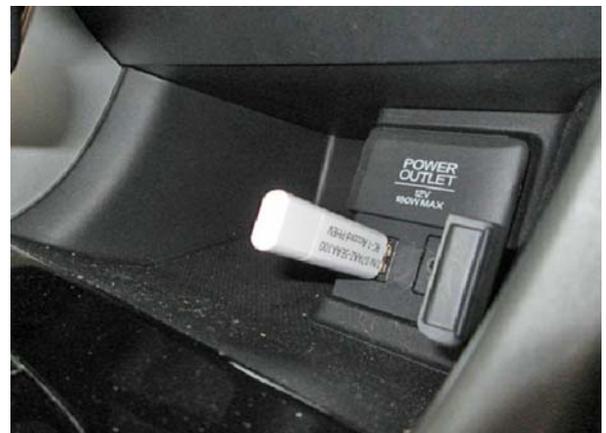
1. Connect a battery charger or a fully charged jumper battery to the vehicle and leave it connected during the entire update procedure to maintain a steady voltage.
2. Press the POWER button twice (without pressing the brake pedal) to select the vehicle ON mode.  
 NOTE: Do not put the USB stick in before the system boot up. It may lock up the unit.
3. Wait for the navigation system to finish booting up, then insert the USB update device into the USB port in the center console. See TOOL INFORMATION.

**NOTE: The vehicle must remain ON during the update procedure. If the vehicle is turned OFF, or the USB update device is removed at any time during the update process, the audio-navigation unit will lock up and you will need to use the RECOVERY PROCEDURE.**

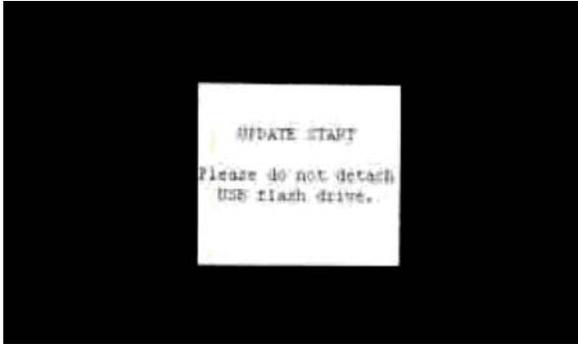
- Both screens will shut off for about 10 seconds and reboot with the notification below flashing on the navigation screen.

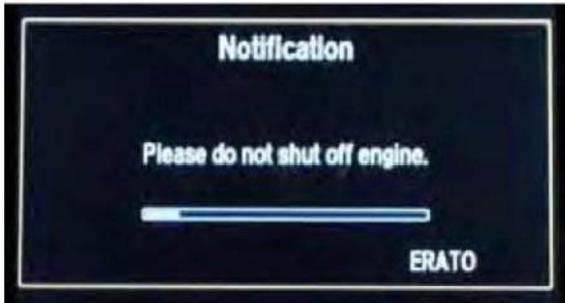
**Navigation Screen**

- The software update will begin. A Notification screen loading bar will display on both screens. NOTE: The engine does not need to be running to do this update.

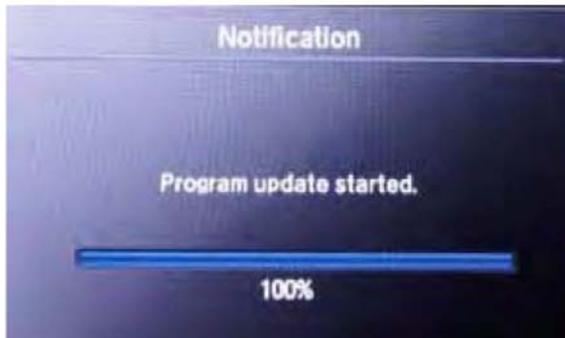
**Touch Screen**

NOTE: The software update takes about 30 minutes to complete.

On the touch screen, the progress bar will stop at 100% after ERATO is updated and remain at 100% throughout all SH and Utility updates. The progress bar will go back to 0% and resume when the BUuCOM update starts.
