ITB10-045b

VOLUNTARY SERVICE CAMPAIGN 2007 – 2008 FX SPEEDOMETER AND ODOMETER PROGRAMMING ERROR

CAMPAIGN ID#: P0303**APPLIED VEHICLES:** 2007 – 2008 FX (S50)

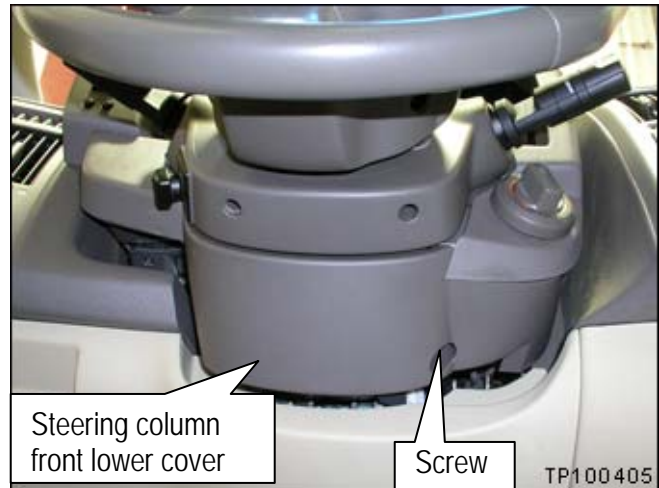
Figure 1

1. Remove the steering column front lower cover.
 - a. Remove screw shown in Figure 1.
 - b. Carefully pull down to snap loose and remove the cover.

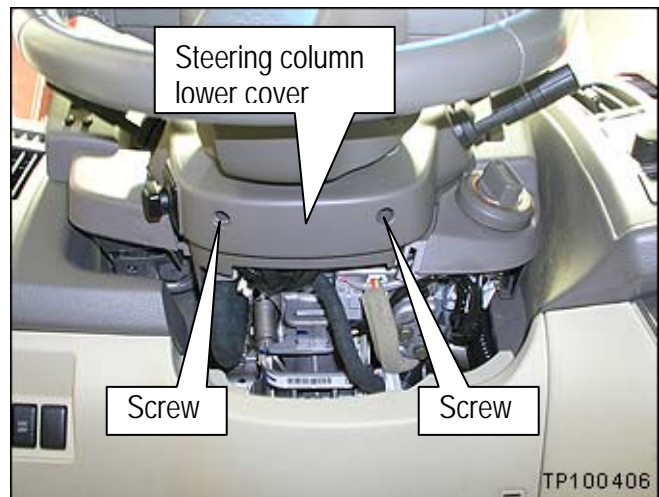
Figure 2

2. Remove the steering column lower cover.
 - a. Remove 2 screws shown in Figure 2.
 - b. Carefully pull down to snap loose and remove the cover.

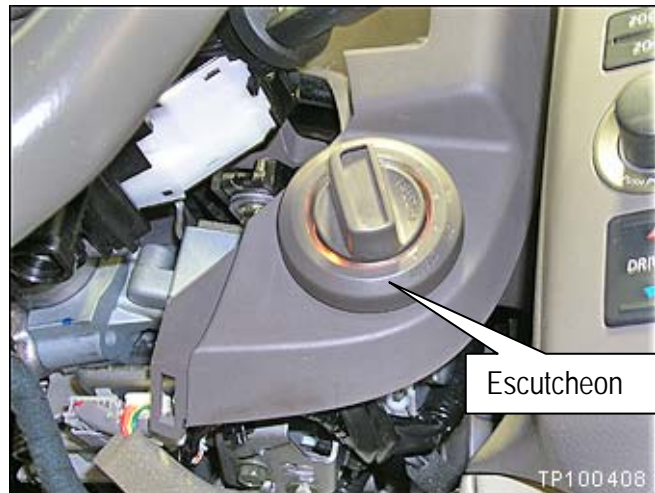
Figure 4

4. Remove the steering lock escutcheon.
 - Use a plastic trim tool if needed.
 - Pull the escutcheon to remove it.

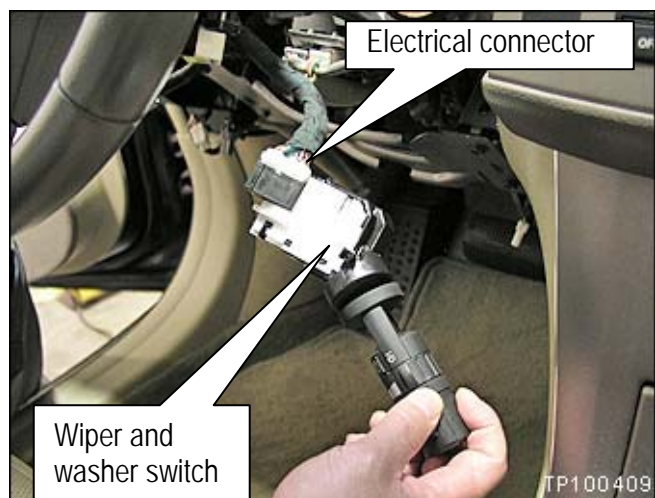
Figure 5

5. Remove / unclip the wiper and washer switch, and then disconnect the electrical connector.

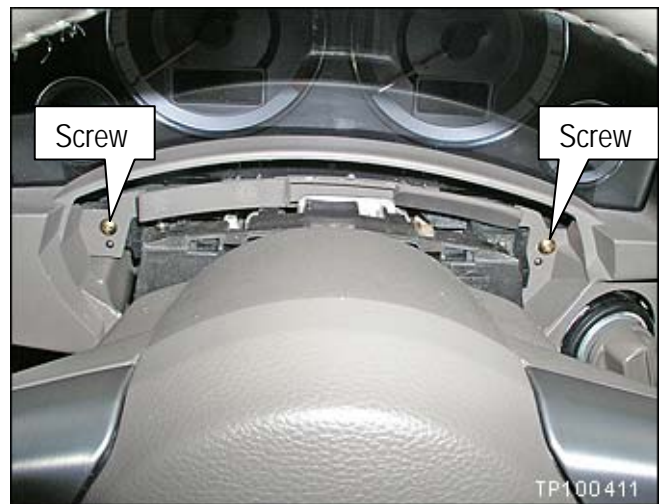
Figure 7

- a. Remove the 2 screws shown in Figure 7.

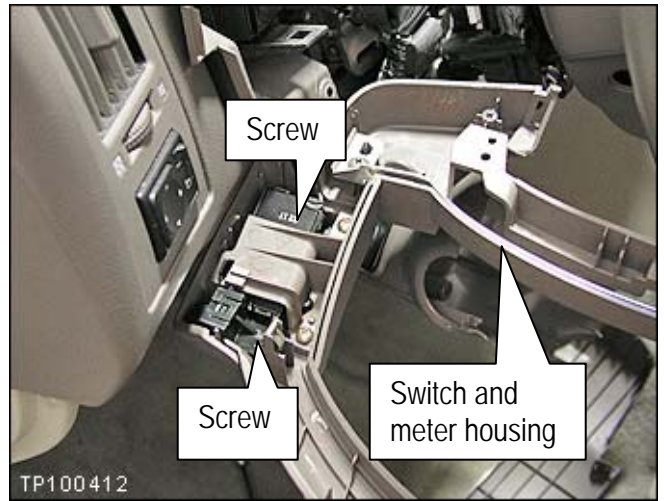
Figure 9

a. Remove the 2 screws shown in Figure 9.

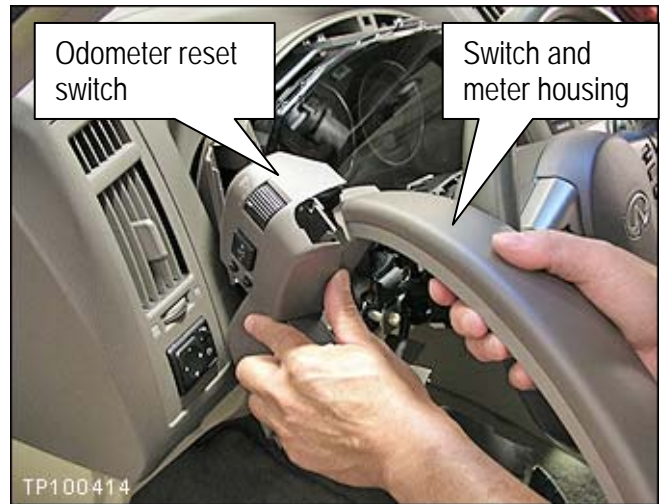
Figure 10

b. Carefully separate the switch from the housing.

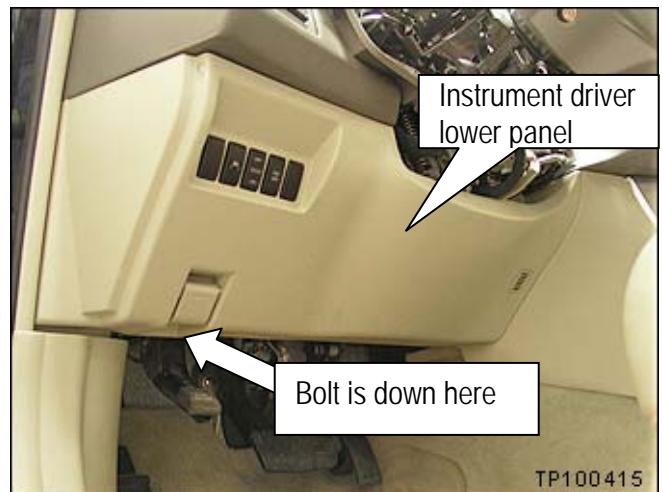
Figure 11

a. Remove the bolt under the hood release handle.

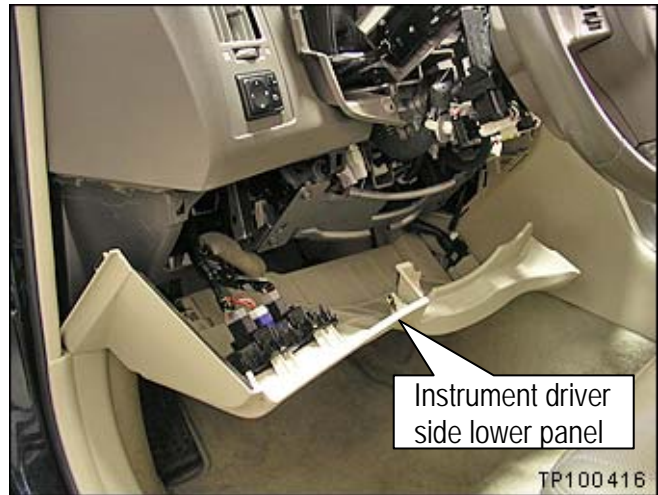
- b. Carefully pull the panel to unsnap the clips.

NOTE: The instrument drive side lower panel can stay in the position shown in Figure 12 while the rest of the procedure is completed.

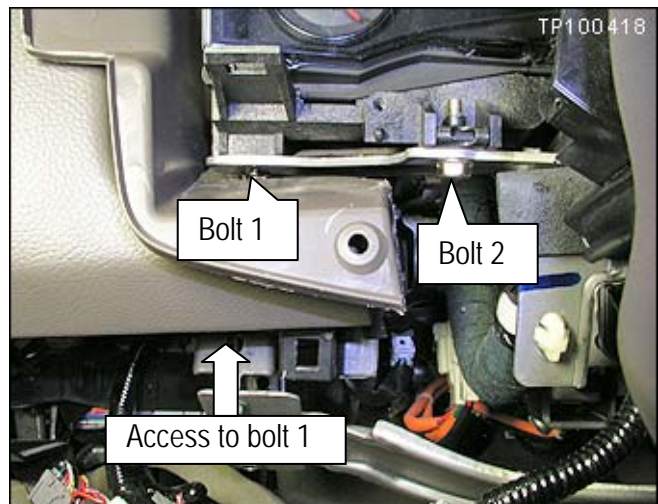
Figure 14

- b. On the lower left side of the meter assembly, remove the 2 bolts shown in Figure 14.

- You will need to access bolt 1 from under the instrument panel.
- There is a hole (covered by tape) in the soft portion of the panel that allows access to bolt 1.

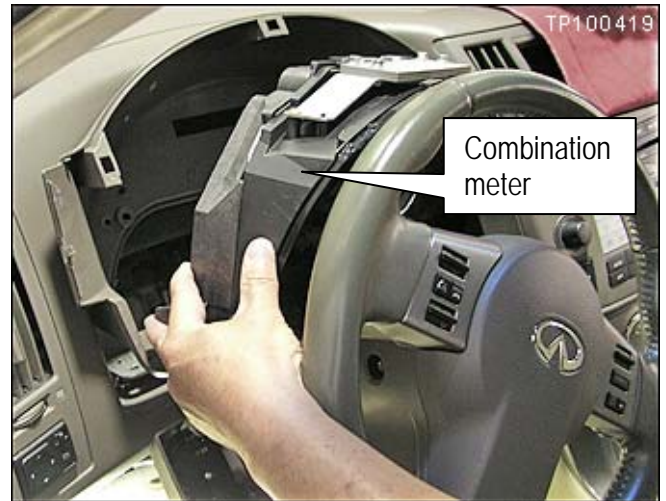
Figure 15

- c. Carefully pull the combination meter out far enough to access the harness connector.

- Do not scratch the clear plastic meter lens.
- Use a cover if needed.

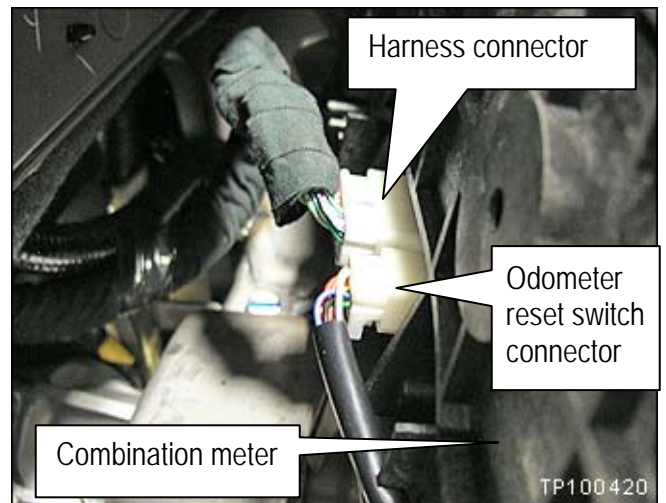
Figure 16

- d. Disconnect the harness connector shown in Figure 16.

NOTE: The odometer reset switch can remain connected.

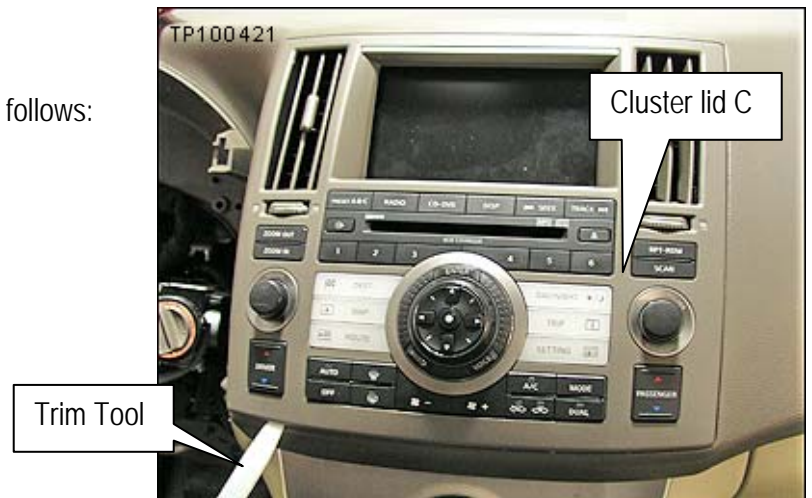
Figure 17

11. Snap loose and remove cluster lid C as follows:

- a. Use a plastic trim tool as needed.

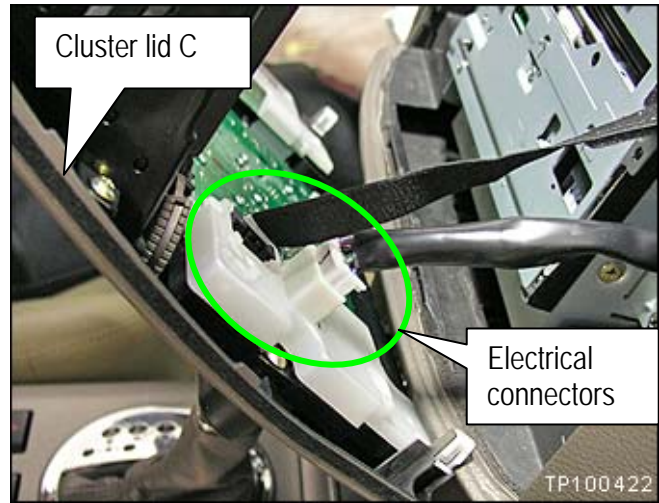
Figure 18

- b. Disconnect 2 electrical connectors from the right side of cluster lid C.

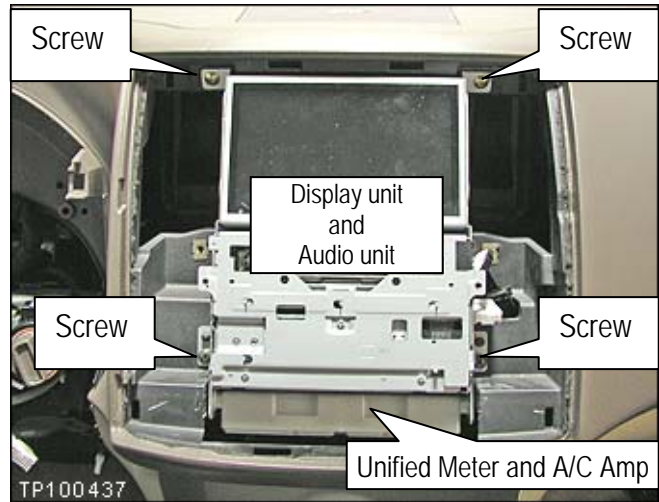
Figure 19

- a. Remove the 4 screws shown in Figure 19.

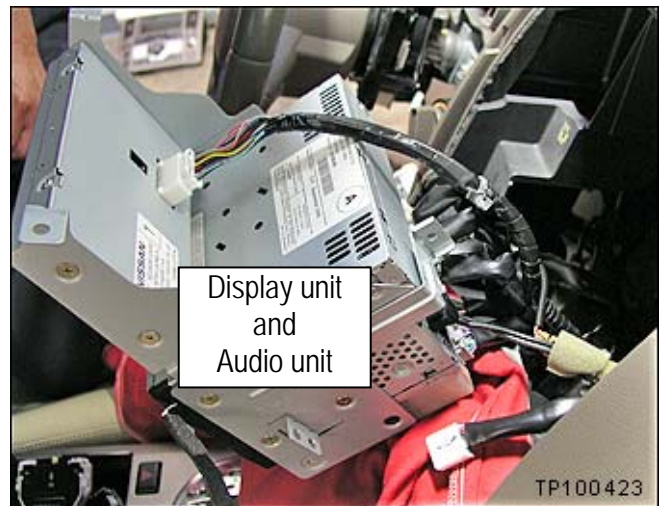
Figure 20

- b. Pull out the display and audio unit and disconnect all of their electrical connectors on the back side of the unit.
- c. Remove the display and audio unit, and then set it in a clean working area.

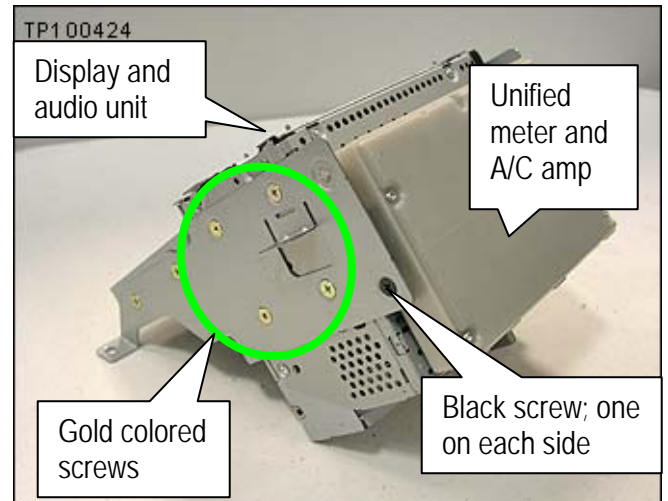
Figure 21

13. Separate the unified meter and A/C amp from the display and audio unit brackets.

- a. Remove 2 black screws.
 - One on each side of the unified meter and A/C amp.
- b. Loosen 4 gold colored screws on one side.
 - Loosen about 2 to 3 turns.

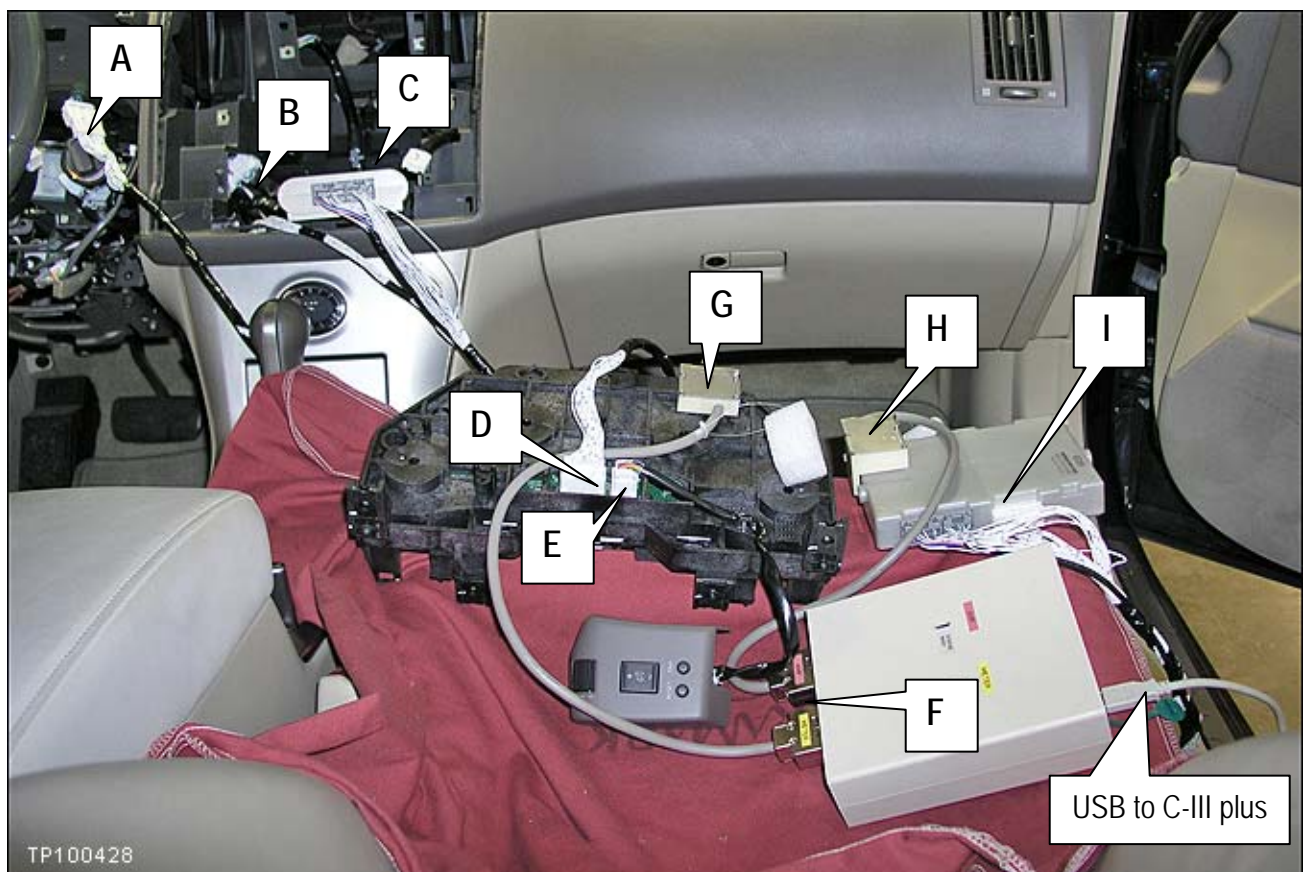
15. Attach the Meter Reprogramming Kit (J-50419) as shown in Figure 22.

- Detail (close up) of each attachment is found on the following pages with corresponding letter.
- Make sure all connections are securely connected.

- a. Turn the ignition OFF.
- b. Turn the CONSULT PC OFF.
- c. Disconnect and reconnect all of the reprogramming cables (see Figure 22 on page 11). Make sure all connectors are securely connected.
- d. Make sure the USB cables and A/C power supply are securely connected to the CONSULT PC.
- e. Make sure the plus VI is securely connected to the vehicle.
- f. Go back and restart with Step 1 above.

- a. Turn the ignition OFF.
- b. Turn the CONSULT PC OFF.
- c. Disconnect and reconnect all of the reprogramming cables (see Figure 22 on page 11). Make sure all connectors are securely connected.
- d. Make sure USB cable and A/C power supply are securely connected to the CONSULT PC.
- e. Make sure the Internet connection is working.
- f. Go back to page 16 and restart with Step 1.

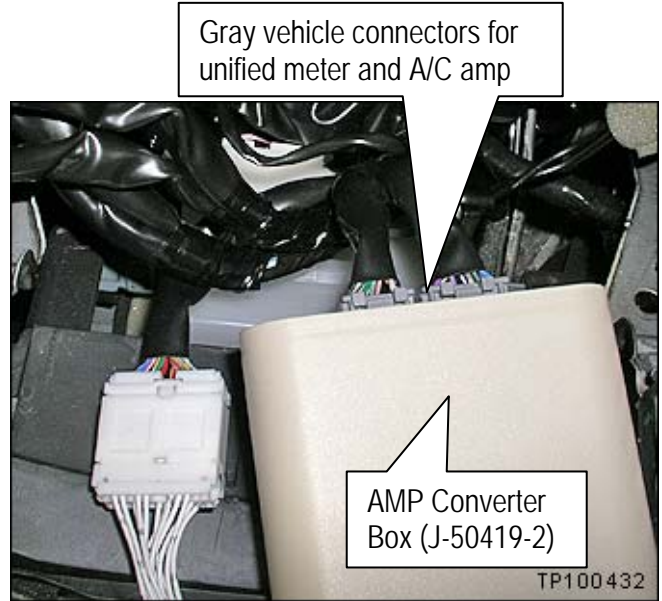
Figure 25

NOTE: The connectors on the front and rear of the Amp Converter Box (J-50419-2) are interchangeable (reversible). They can be plugged in on either side.

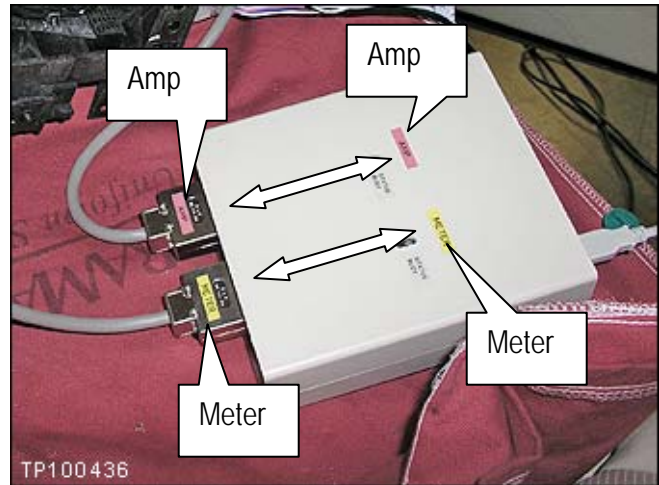
Figure 28

- Make sure the Amp Probe is connected to Amp side and the Meter Probe is connected to the Meter side of the PC Power Converter Box (J-50419-1).

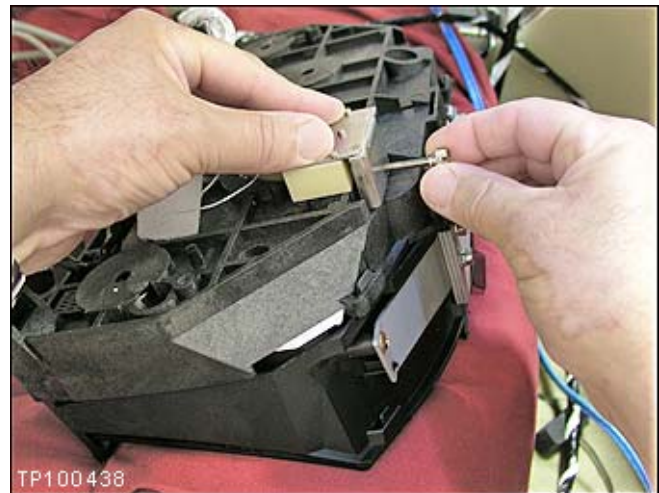
Figure 29

- Push and hold the Meter Probe into the back of the combination meter, and then tighten the lock screw.

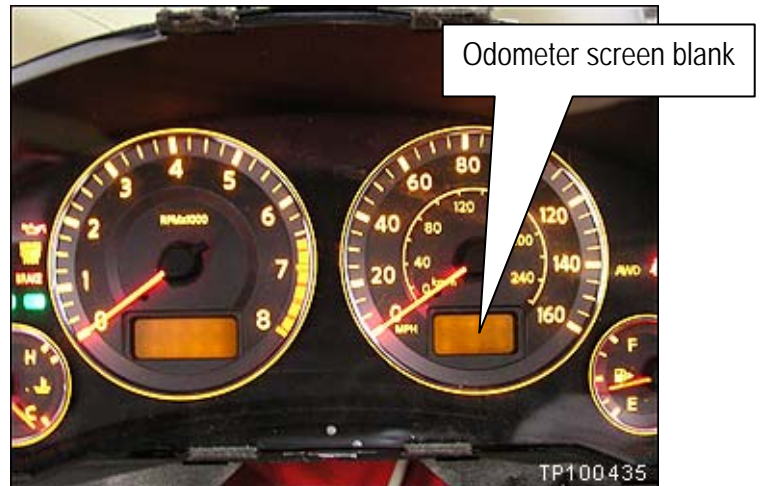
Figure 1a

With the ignition ON, the odometer screen should be blank.

If the odometer screen is **not blank**:

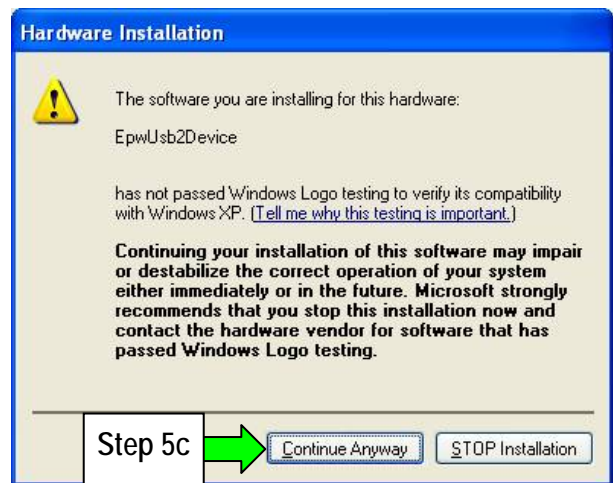
Figure 1c

c. Select **Continue Anyway**.

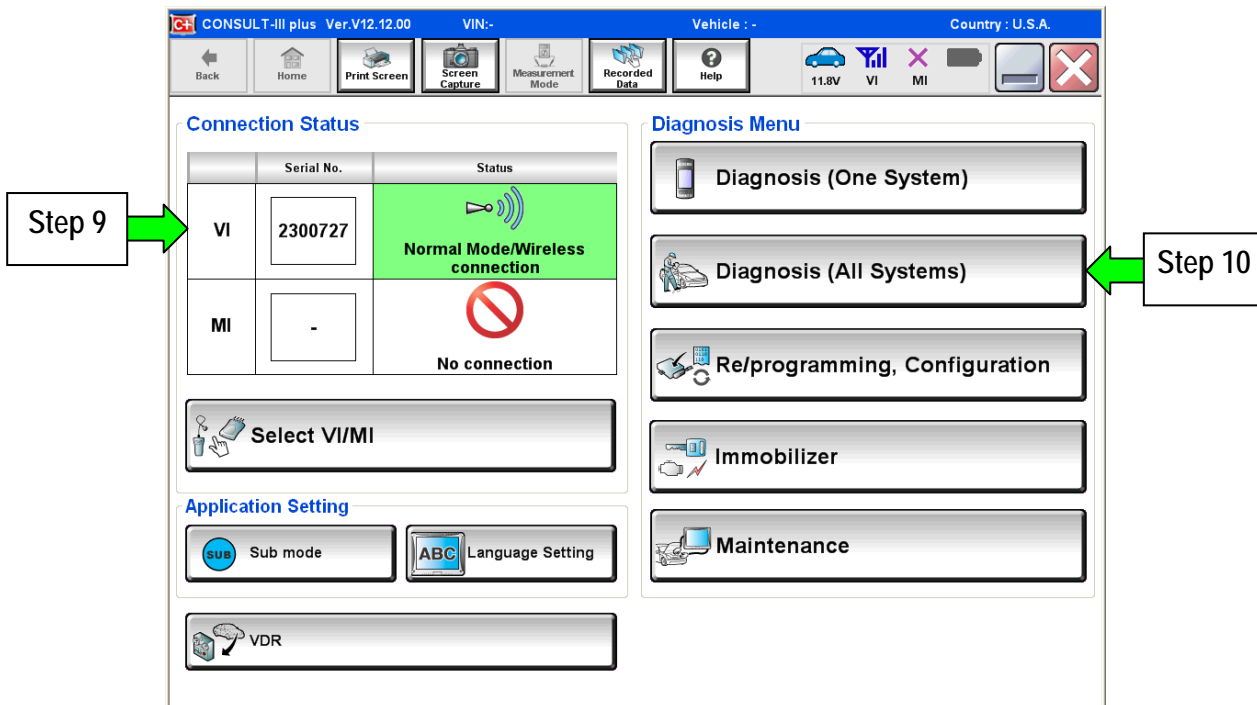
Figure 1f

9. After C-III plus has launched, wait for the plus VI to be recognized.
 - Serial number will display when the plus VI is recognized.
10. Select **Diagnosis (All Systems)**.

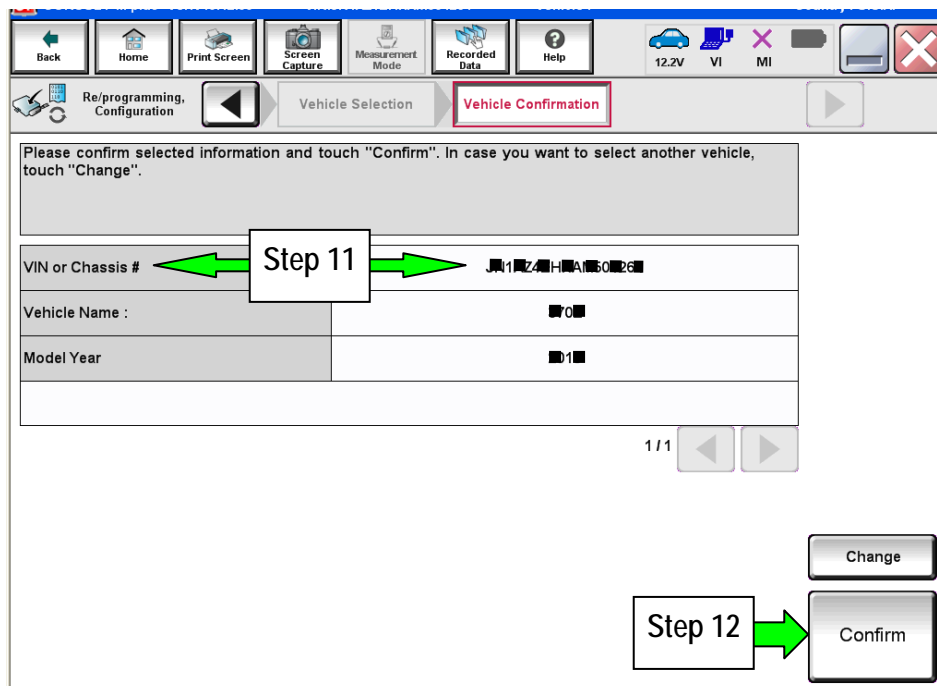
Figure 1g

11. Make sure **VIN or Chassis #** matches the vehicle's VIN.
12. Select **Confirm**.

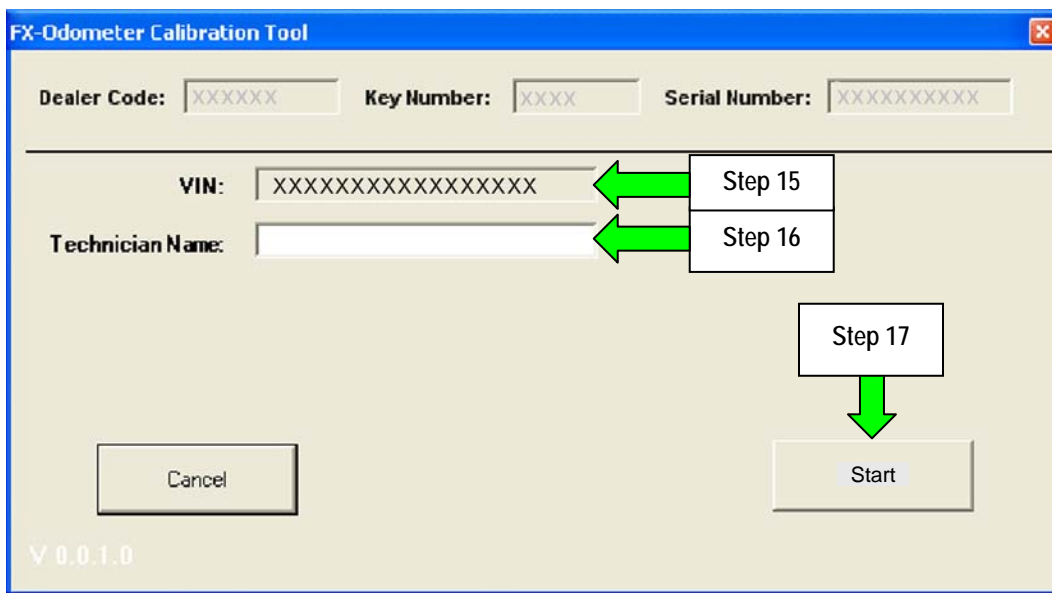
Figure 1h

13. Wait for a few seconds while the progress bar completes.
14. The **FX Odometer Calibration Tool** will launch automatically (see Figure 1h).
15. The VIN will automatically display.
 - Make sure the displayed VIN matches the vehicle's VIN.
16. Enter the Technician Name.
17. Select **Start**.

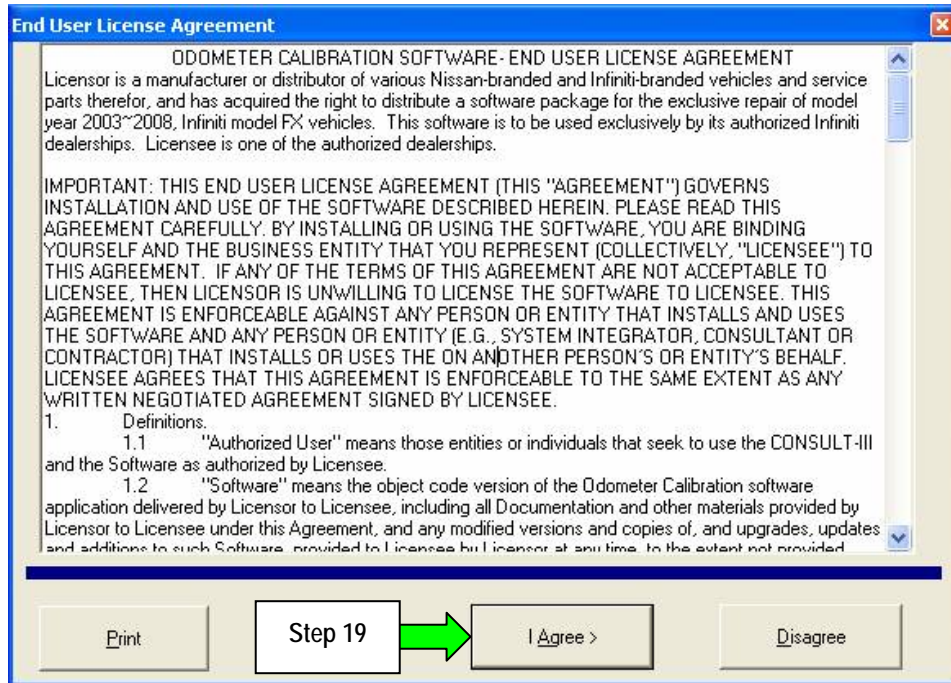
Figure 1i

18. Select I Agree.

- After selecting **I Agree**, the reprogramming / calibration process will begin automatically and take only a few seconds to complete.

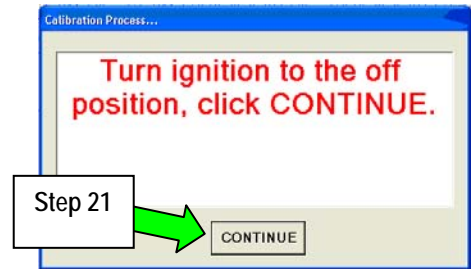
19. When the calibration process has completed successfully, the message in Figure 1j will display.

20. Turn the ignition OFF, and then select **Continue**.

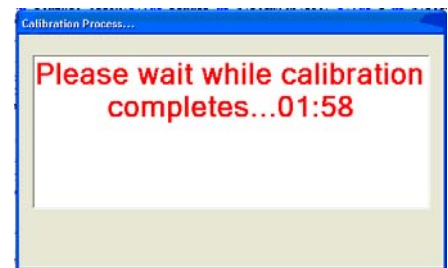
21. With the ignition OFF, wait for 2 minutes.

- The screen in Figure 1k will display with a 2 minute countdown.

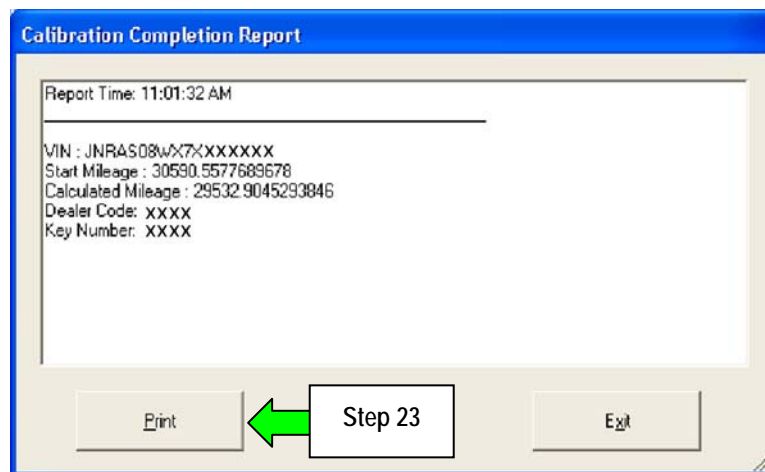
Figure 1L

22. After waiting 2 minutes, the **Calibration Completion Report** will display (see Figure 1L).

23. Print the **Calibration Completion Report**, and then attach it to the repair order for warranty documentation.

NOTE: The Calculated Mileage on the above Calibration Report must be used to update the mileage in Infiniti Net.
