SERVICE BULLETIN

EC12-034a

2013 SENTRA; ENGINE HAS HESITATION OR STOPS RUNNING AT IDLE OR VERY LOW SPEEDS

APPLIED VEHICLE: 2013 Sentra (B17)

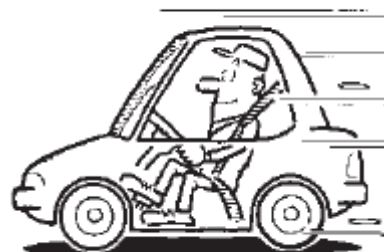
Figure A

- Take the vehicle for a 10 minute drive in order to meet the following Idle Air Volume Learn (IAVL) conditions:
 - Engine coolant temperature: 70 -100°C (158 - 212°F)
 - Battery voltage: More than 12.9V (At idle)
 - Transmission: Warmed up
