SERVICE CAMPAIGN BULLETIN

SUBJECT:			No: SC-13-001
i-MiEV EV-ECU SOFTWARE UPDATE FOR CLIPPER CREEK EVSE – SERVICE CAMPAIGN			DATE: January, 2013
			MODEL: 2012 i-MiEV
CIRCULATE TO:	<input checked="" type="checkbox"/> GENERAL MANAGER	<input type="checkbox"/> PARTS MANAGER	<input checked="" type="checkbox"/> TECHNICIAN
<input checked="" type="checkbox"/> SERVICE ADVISOR	<input checked="" type="checkbox"/> SERVICE MANAGER	<input checked="" type="checkbox"/> WARRANTY PROCESSOR	<input checked="" type="checkbox"/> SALES MANAGER

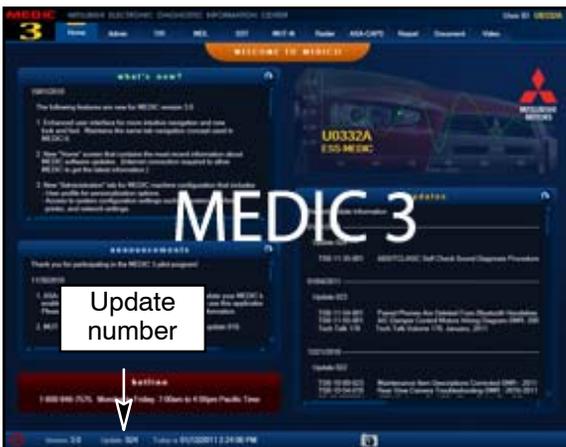
1. Verify the MEDIC 3 is at update **163** or higher.

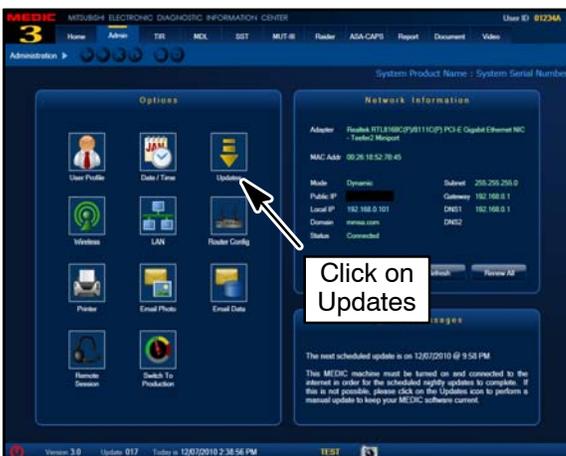
2. Select the MEDIC 3 "Admin" tab. Click on "Updates."

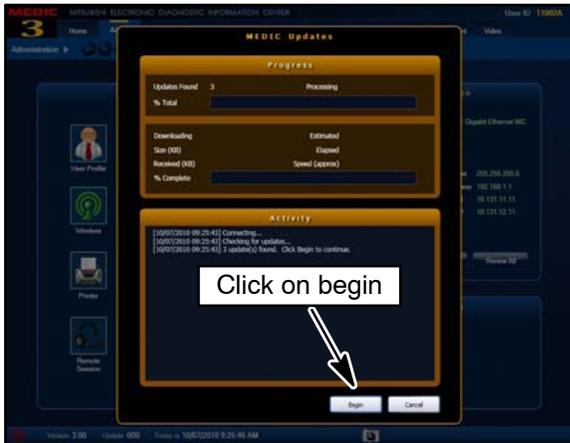
3. If the MEDIC Updates screen advises updates are available, click the “Begin” button.
4. Once MEDIC 3 is at update 163 or higher, continue to the **REPROGRAMMING PROCEDURE** on the following pages.

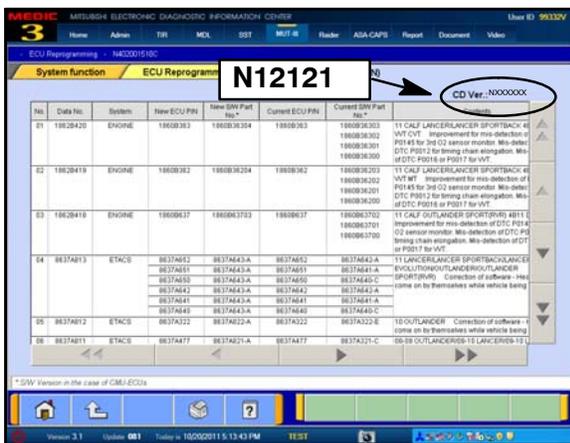
5. **Standalone MUT-III Scan Tool Viewer (STV) ONLY: (MEDIC 3 USERS go to the REPROGRAMMING PROCEDURE below).** Verify that your MUT-III has the most current version of the reprogramming database:
 - a. From the MUT-III Main Page:
 - Select “Special Function”
 - Select “ECU Reprogramming”
 - Select “Database File Display-CAN”
 - Confirm the database number displayed at the top right of the chart is **N12121**.
 - (1) If the database number displayed on your MUT-III is N12121 or greater, continue to the Reprogramming Procedure below.
 - (2) If the database number displayed on your MUT-III is lower than N12121, locate the Yellow MUT-III Reflash CD 01/13 and follow the instructions on the CD label to update your MUT-III.

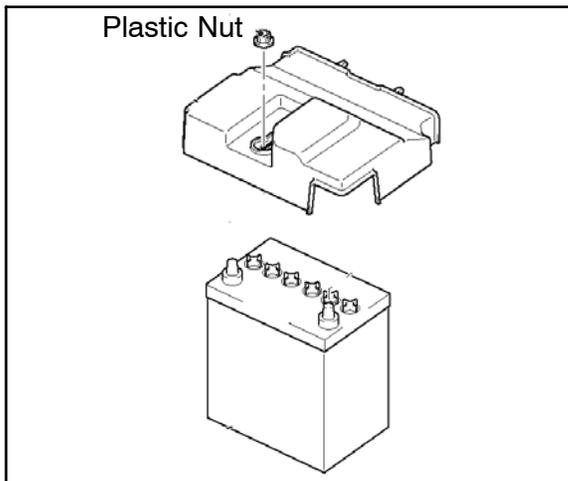
1. With the vehicle parked, set the parking brake and open the hood.
2. Remove the 12V auxiliary battery cover. Unscrew the plastic nut (pull up while turning).

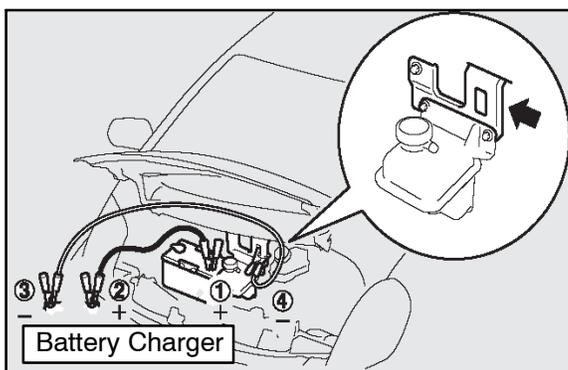
3. Attach the battery charger (with a charging rate not to exceed 10 amps) to the 12V auxiliary battery.

Connect the positive (+) terminal of the 12V auxiliary battery (1) to the positive (+) battery charger cable (2). Connect the negative (-) battery charger cable (3) to the designated ground location (4).

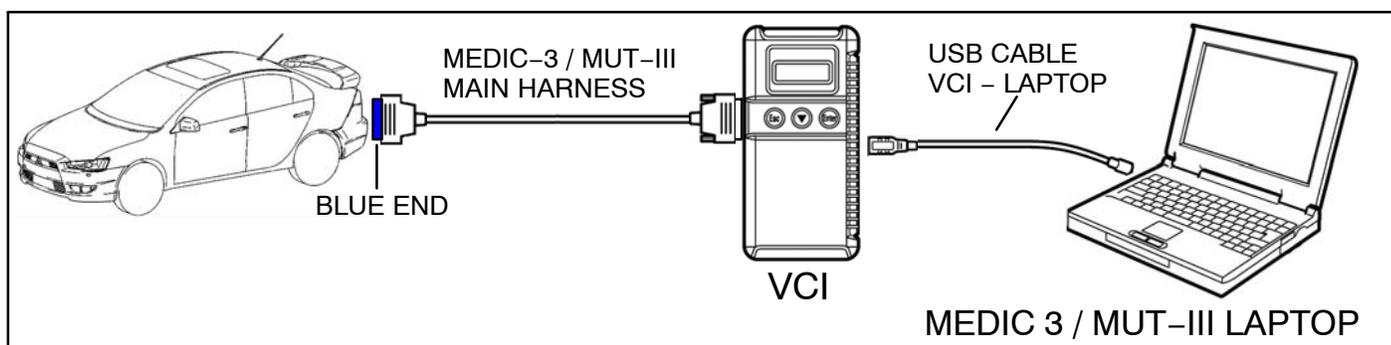
- Turn the laptop computer on. If you're running on battery power and the charge indicator in the lower right hand corner of the screen does not show a full charge, it is recommended that either the laptop battery be charged prior to beginning, or that reprogramming be completed with the A/C power adaptor connected to the laptop.
- Connect the USB cable to the VCI.
- When the laptop displays the MUT-III main screen, connect the USB cable to the laptop.
- Connect the MUT-III main harness with the blue DLC connection to the VCI.
- Connect the blue connector of the MUT-III main harness to the vehicle's data link connector.
- Turn the VCI power switch ON. Verify that the indicator lamp in the upper right corner of the screen is green.

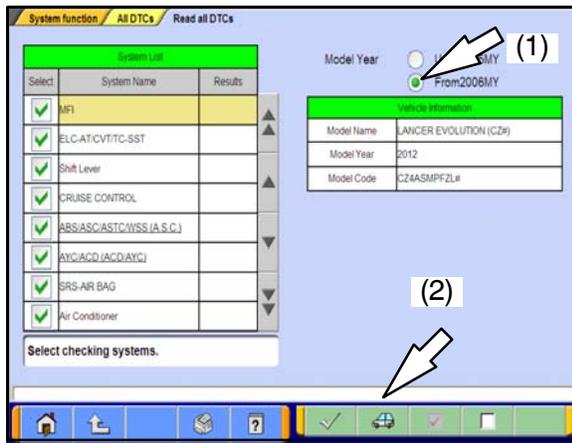
- e. Make sure the “From 2006MY” field is selected (1). Click on the car icon at the bottom of the page to select your vehicle (2).

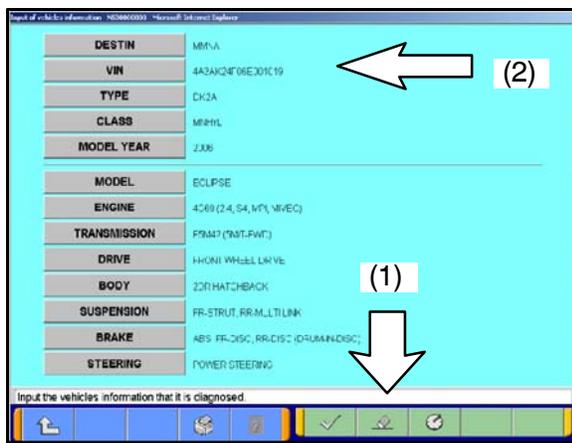
- f. If the VIN listed does not match the vehicle you are working on, click on the eraser icon at the bottom of the page (1).

Click on the VIN button (2).

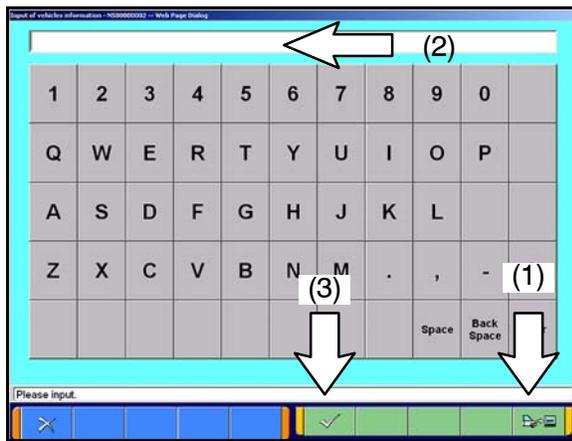
- g. Click on the icon in the lower RH corner of the screen to have the MUT-III automatically read the VIN (1). If a message appears saying that the VIN cannot be read automatically, manually type the 17 digit VIN into the VIN field (2).

When the VIN is entered correctly, click on the check mark icon to continue (3).

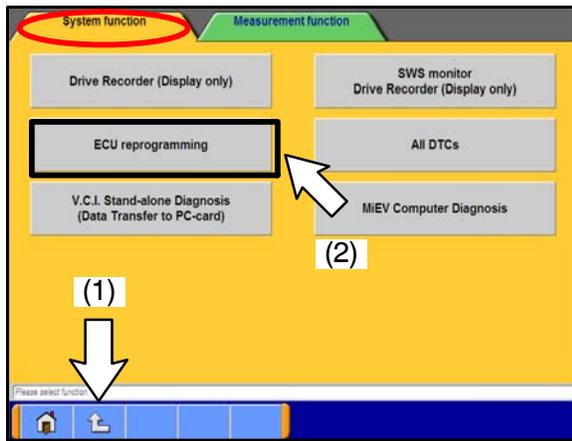
k. Click the back arrow icon (1) twice to arrive at the “System Function” screen. Select “ECU reprogramming” (2).

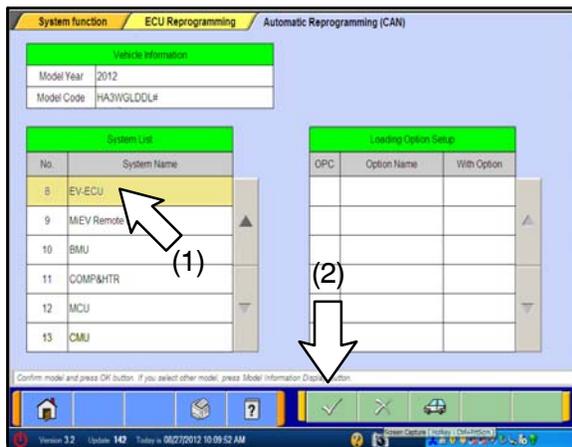
m. In the lower left column labeled “Systems List”, scroll down and select “No. 8, EV-ECU” (1). Click on the check mark icon (2) to continue.

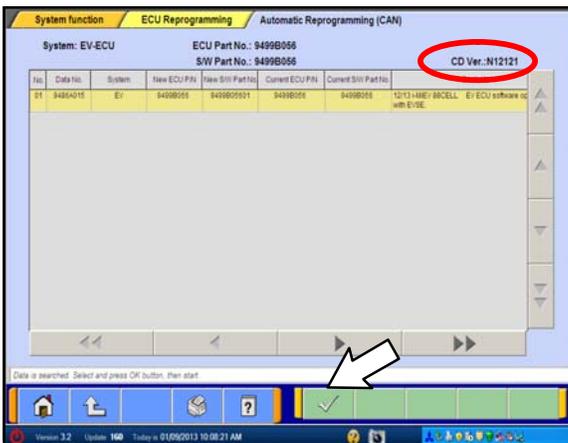
- o. The CAN database screen will display.

Confirm the database number at the top right of the table is **N12121** or higher.

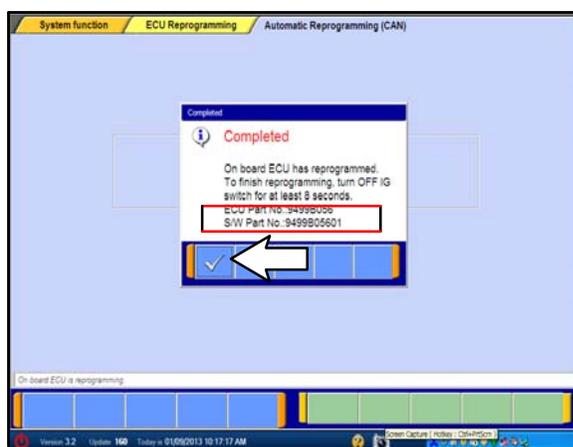
- q. Once the reprogramming has completed, confirm the new software version is “9499B05601”. Click on the check mark icon to continue.
7. Turn the electric motor switch to the OFF position. Wait approximately 10 seconds, and turn it back ON. Confirm that the “READY” light is illuminated.
 8. Turn OFF the electric motor switch. Disconnect the MUT-III and the battery charger.
 9. Reinstall the 12V auxiliary battery cover and plastic nut. Close the hood.
