Service Campaign Bulletin

Campaign No. 2012120005, August 2013

SUBJECT: **Model 451, Model Year 2011**
Update Electric Drive Software with Latest Software Release

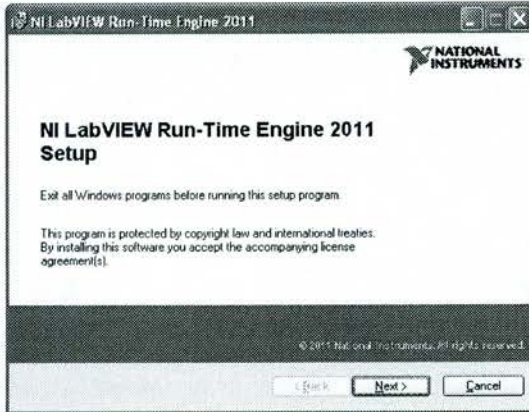
- Double click on the "LVRTE2011min.exe" file
- Unzip file.
- The following window opens

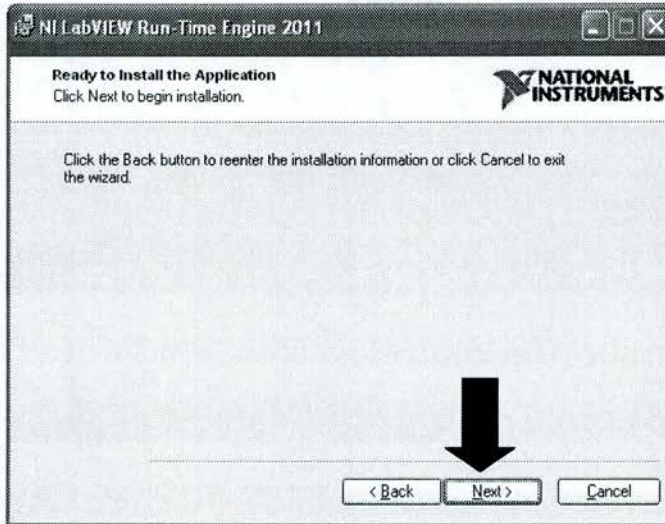
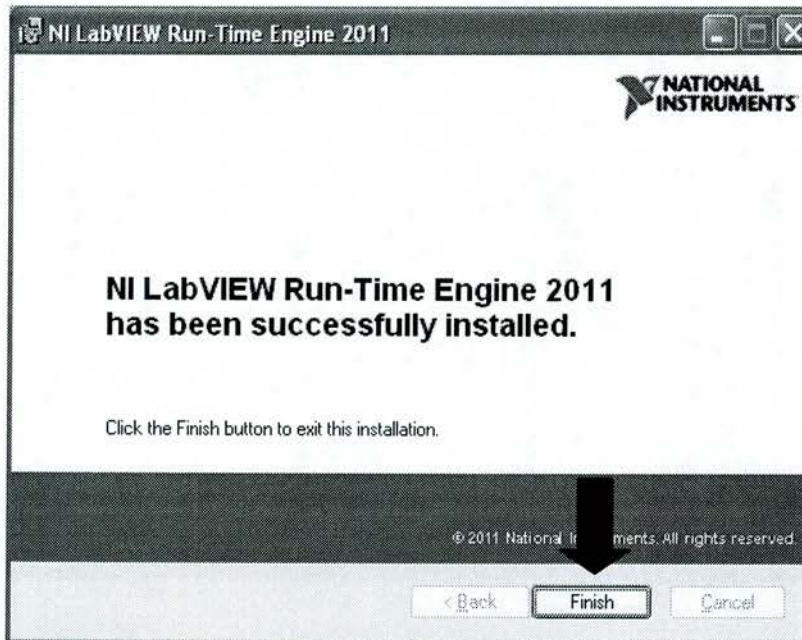
- Please now follow the installation wizard (following windows appear in succession – see red arrow)

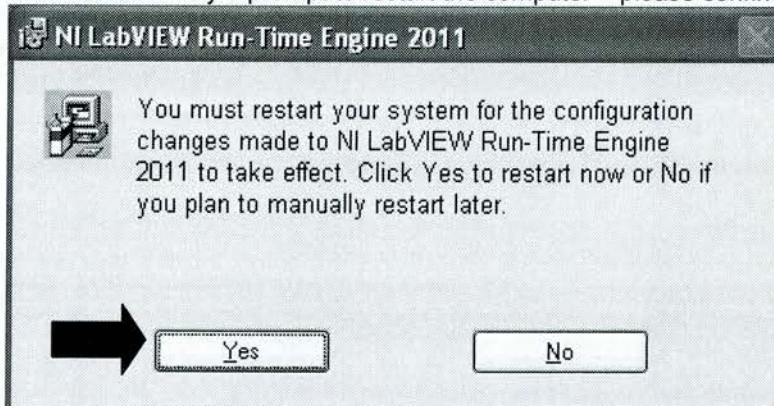
- This is followed by a prompt to restart the computer – please confirm this message

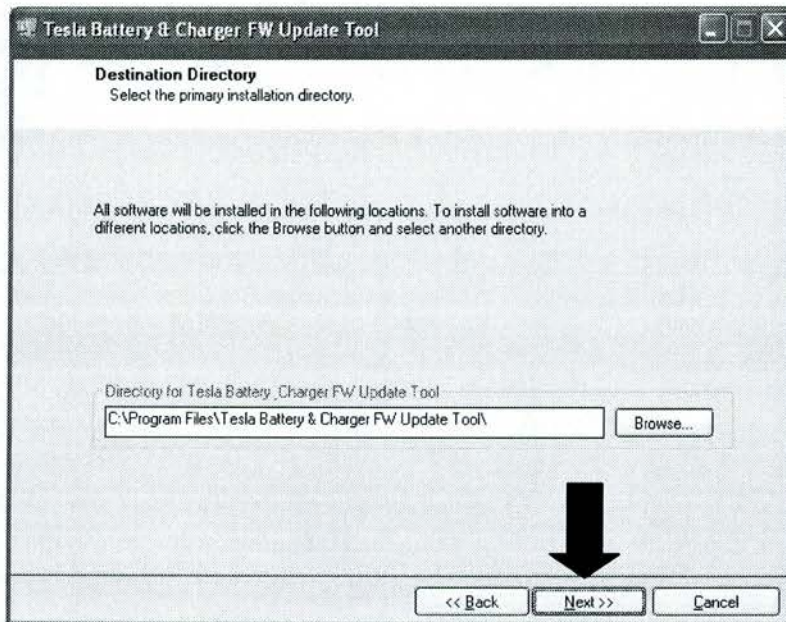
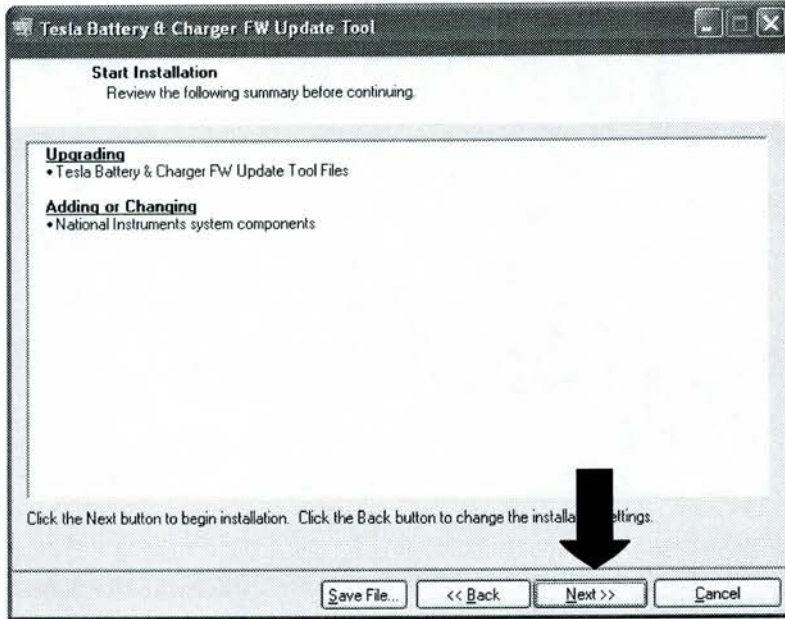
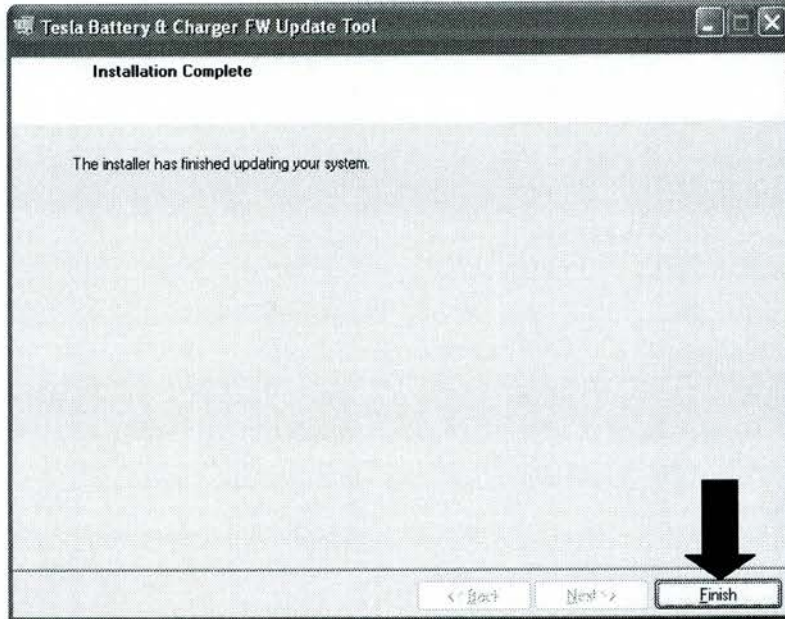
- Copy the "Tesla Battery & Charger Firmware Update Tool 2.0.8.81.zip" file and extract the contents of the file, also in the folder "SW-Temp" on the desktop (right click on file then select extract).
- The folder now contains the following files
 - bin
 - license
 - supportfiles
 - nidist.id
 - setup.exe
 - setup.ini
- Now run the "setup.exe" file there
- Please now follow the installation wizard (following windows appear in succession – see red arrow)

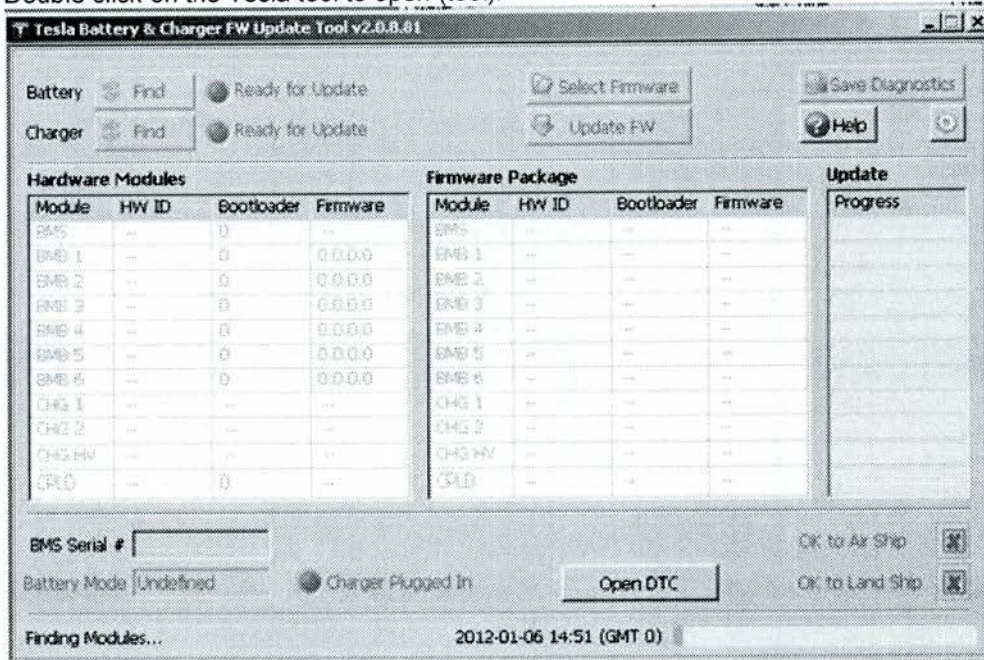
- Double click on the Tesla tool to open (tool).

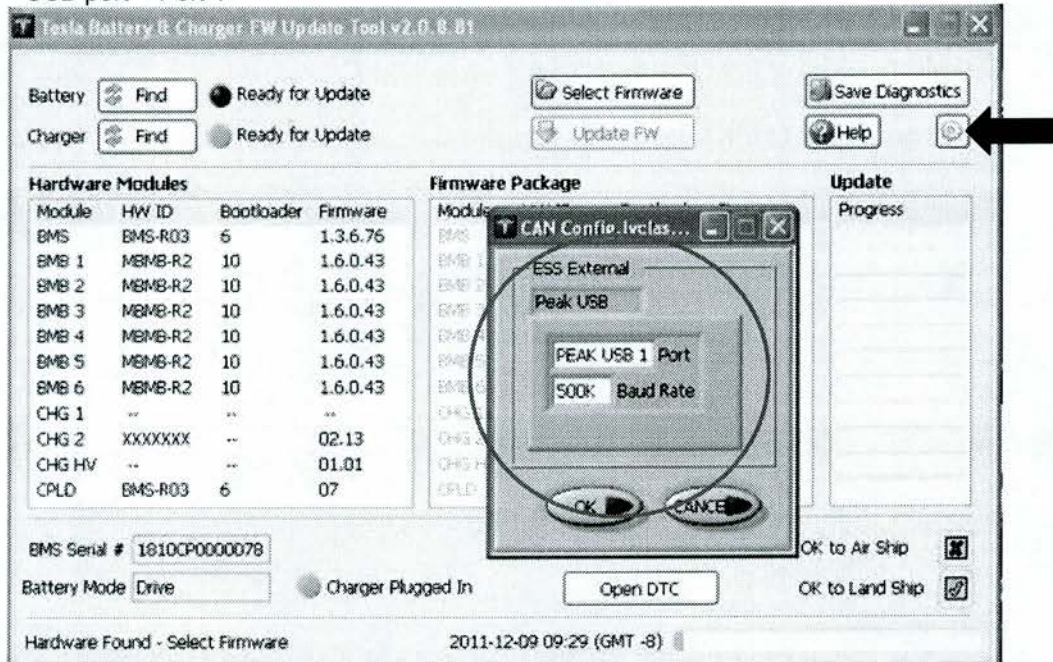
- Click on button (arrow, below) then check the setting after the update of the Tesla tool (circled, below):
 - Adapter selection = Peak USB
 - Baud rate = 500 K
 - USB port = Port 1

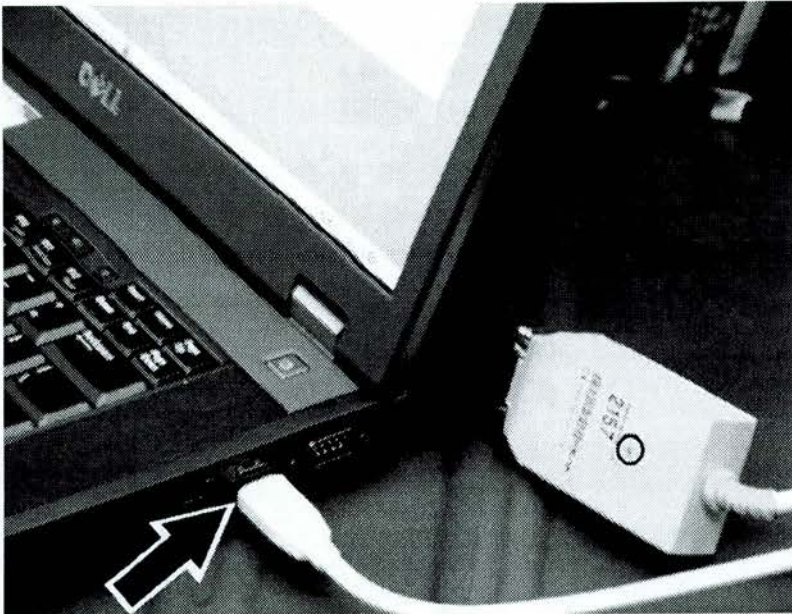
- Plug in the USB to OBDII interface adapter into the laptop's bottom right USB port (arrow) nearest the serial port (which is USB Port 1). This will force the laptop to load the driver you just loaded onto the laptop.
- Acknowledge any pop-up messages to load this driver. The LED (circled) on the USB to OBDII interface should go solid red in color. This indicates that you found the USB Port 1. If for any reason this LED does not go to solid red, then try a different USB port until it does

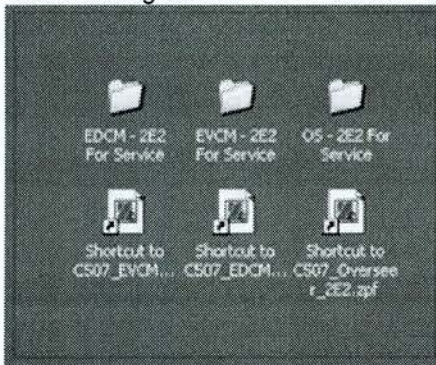
The following folders and shortcuts are now on the desktop.

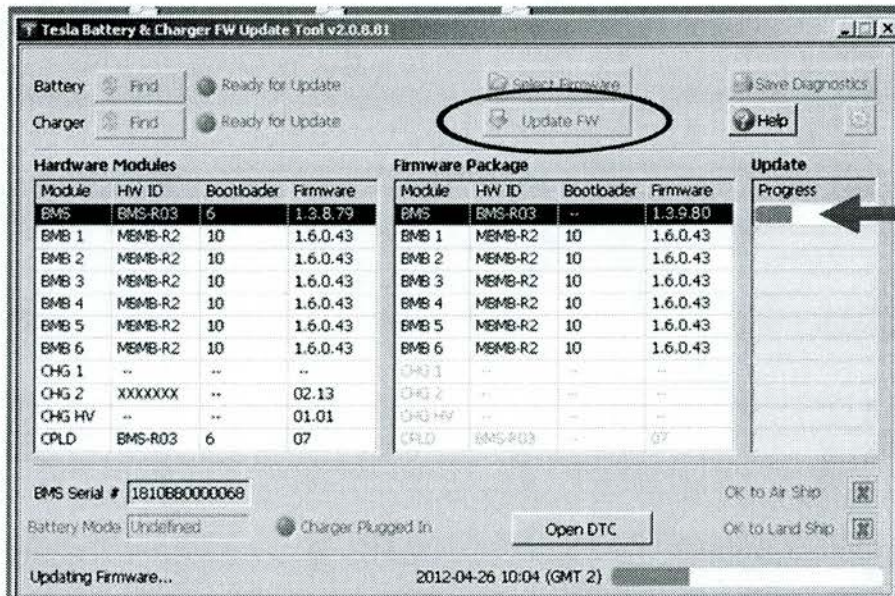
Figure 6

1.7. Start automatic update: Select: "Update FW" (circled, Figure 6).

- When automatic update process begins the indicator bar (arrow) in the update field displays the update progress.
- The percentage value may be displayed in the lower left.

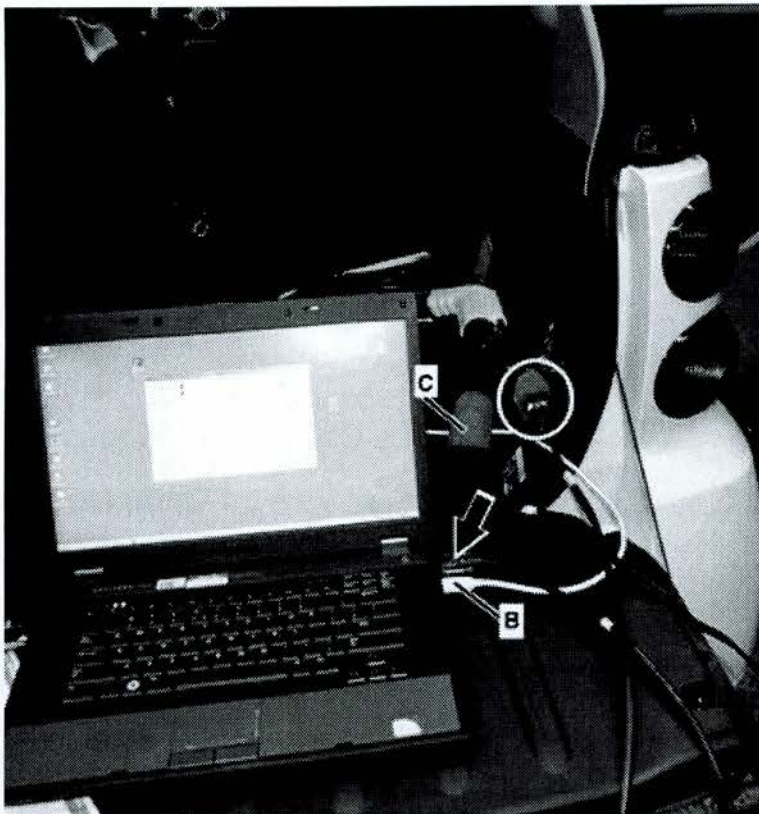
Figure 7

2.1. Start Zytec diagnosis computer, connect the round pinned connector end of the diagnostic cable (2 0-040-0551) to vehicle's 6-pin EV diagnostic socket (circled, Figure 7).

A: HV charging cable

B: USB connector

C: 9 pin traction drive diagnostic socket

- Connect traction drive diagnostic cable (2 0-040-0551) to vehicle's 9-pin diagnostic socket (refer to Figure 7).
- Connect serial port connector of diagnostic cable (2 0-040-0551) to serial port of laptop (refer to Figure 7).

2.17. Connect traction drive diagnostic cable (2 0-040-0551) to vehicle's **6**-pin diagnostic socket (Refer to Figure 7).

The other serial port connector of diagnostic cable 2 0-040-0551 should be already connected to serial port of laptop (refer to Figure 7)

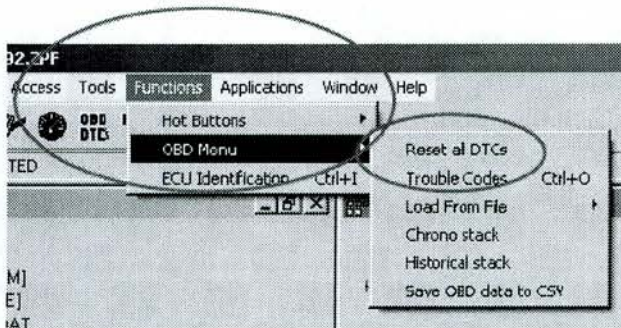
Figure 9

2.3. Erase the fault memory (Functions>OBD Menu>Reset all DTCs) and confirm with: **YES**

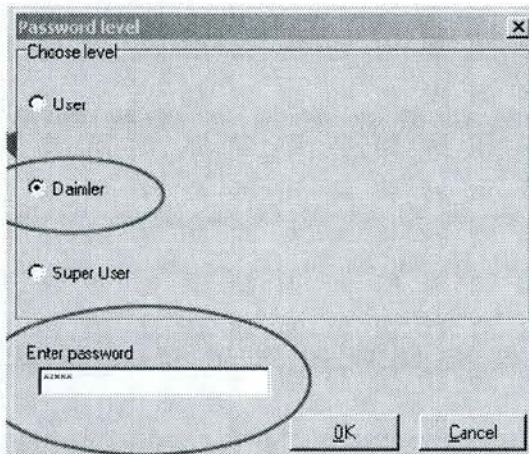
Figure 11

2.7. Log in (Access>Enter Password Level) and enter the user data:

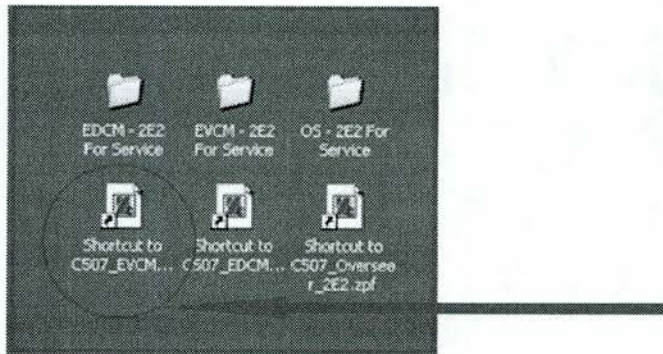
Figure 17

2.18. Double click on the "EVCM 2E2" shortcut on the desktop (arrow, Figure 17) to open the calibration tool.
