Service Campaign Bulletin

Campaign No. 2012120005, February 2013

TO: ALL MERCEDES-BENZ CENTERS
SUBJECT: **Model 451, Model Year 2011**
Update Electric Drive Software with Latest Software Release

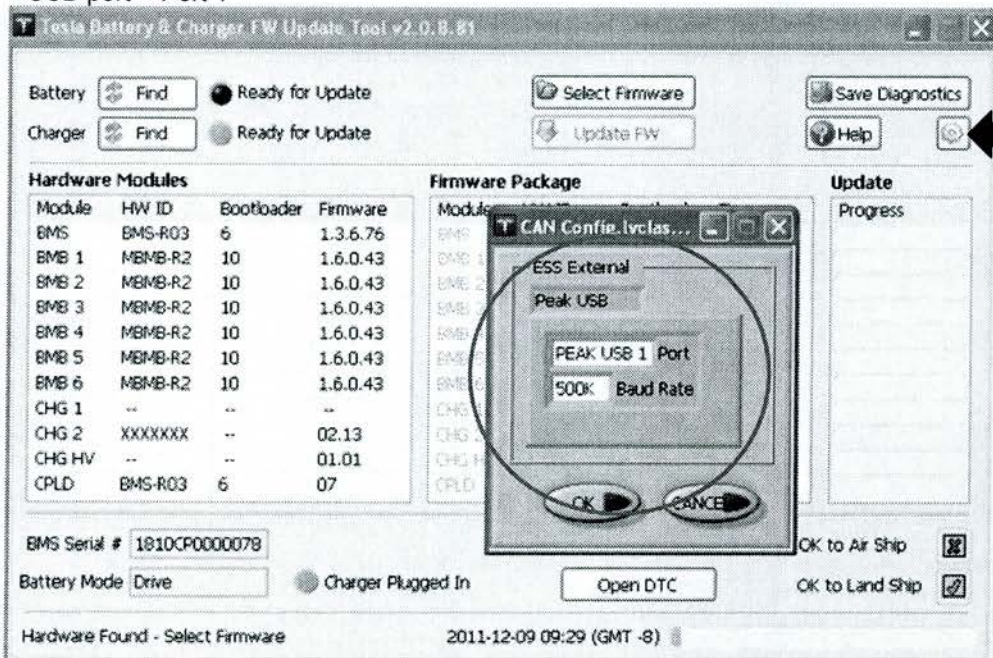
- Click on button (arrow, below) then check the setting after the update of the Tesla tool (circled, below):
 - Adapter selection = Peak USB
 - Baud rate = 500 K
 - USB port = Port 1

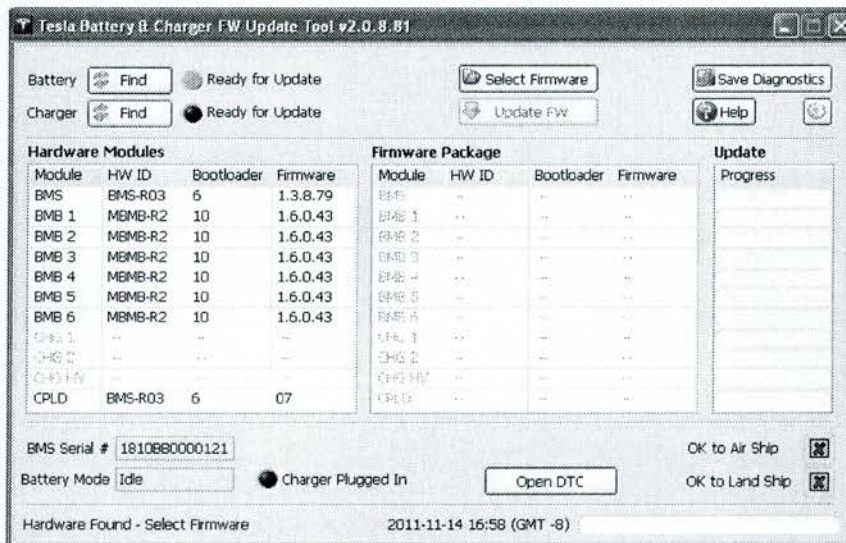
Figure 2

1.4 Start the "Tesla Battery & Charger FW Update Tool v2.0.8.81 application"

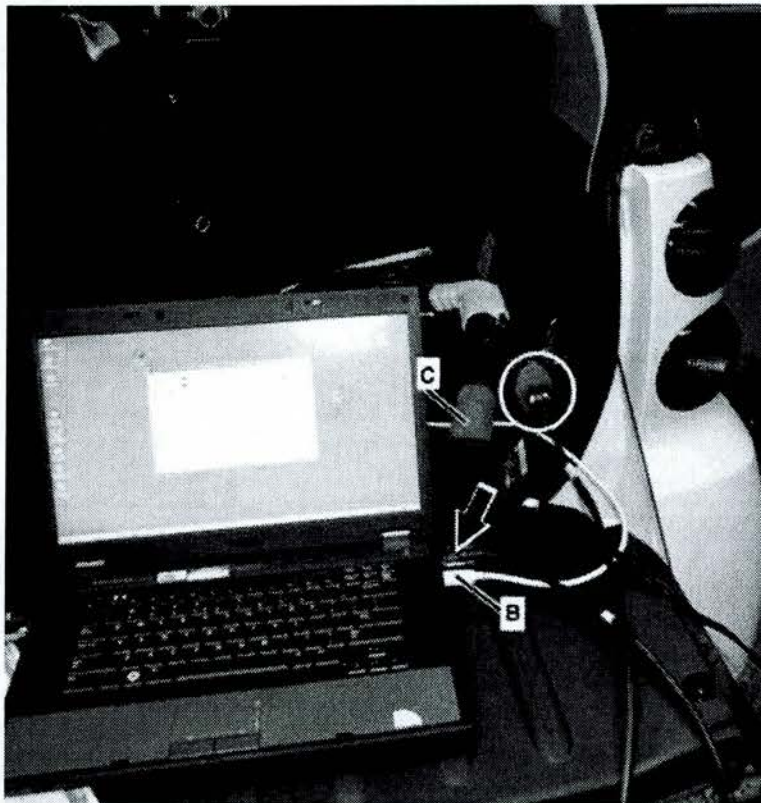
Figure 7

2.1. Start Zytec diagnosis computer, connect the round pinned connector end of the diagnostic cable (2 0-040-0551) to vehicle's 6-pin EV diagnostic socket (circled, Figure 7).

- A: HV charging cable
- B: USB connector
- C: 9 pin traction drive diagnostic socket

- Connect traction drive diagnostic cable (2 0-040-0551) to vehicle's 9-pin diagnostic socket (refer to Figure 7).
- Connect serial port connector of diagnostic cable (2 0-040-0551) to serial port of laptop (refer to Figure 7).

2.17. Connect traction drive diagnostic cable (2 0-040-0551) to vehicle's 6-pin diagnostic socket (Refer to Figure 7).

The other serial port connector of diagnostic cable 2 0-040-0551 should be already connected to serial port of laptop (refer to Figure 7)

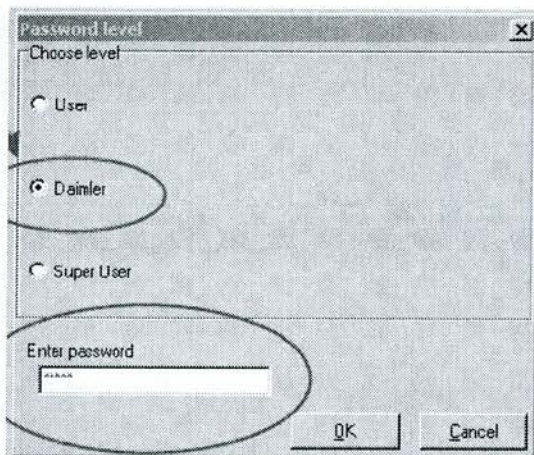
Figure 11

2.7. Log in (Access>Enter Password Level) and enter the user data:

User = **Daimler**; Password = **451ed**

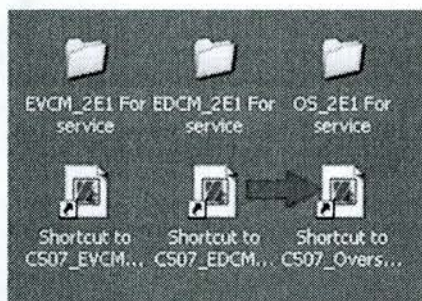
Figure 14

2.11. Double click on the "Overseer 2E1" shortcut (arrow Figure 14) on the computer's desktop to launch the calibration tool.
