## Product Update: 2014 RLX Audio-Navigation Unit Software Update

### BACKGROUND

There are several known audio and navigation system software bugs that can be repaired by updating the software in the audio-navigation unit.

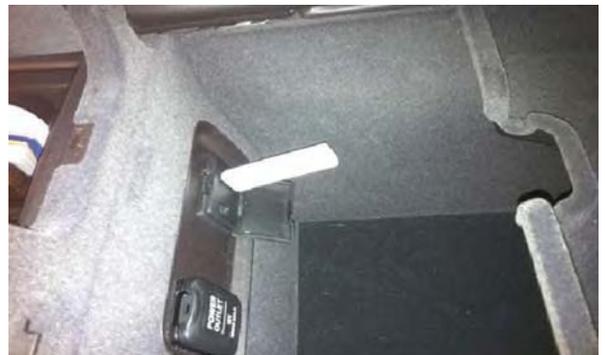
3. Wait for the navigation system to finish booting up, then insert the USB update device into the USB port in the center console. See TOOL INFORMATION.

NOTE: **The ignition must remain ON during the entire update procedure. If the ignition is turned OFF, the engine is started, or the USB update device is removed at any time *during* the update process, the audio-navigation unit will lock up and you will need to use the RECOVERY PROCESS.**

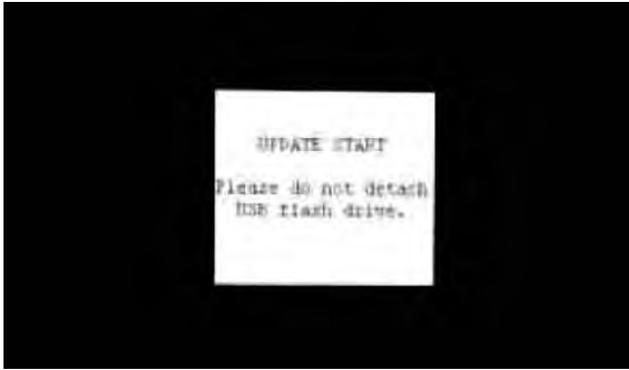
4. Both screens will shut off for about 10 seconds and reboot with the notification below flashing on the navigation screen.

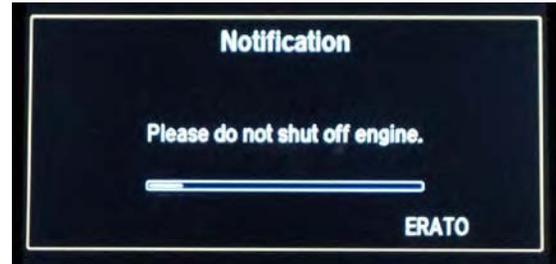
*Navigation screen*

5. The software update will begin. A Notification screen loading bar will display on both screens.

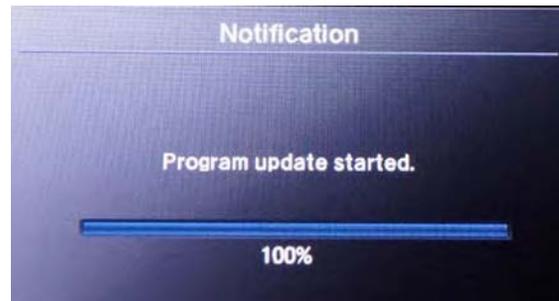
*Touch screen*

On the touch screen, the progress bar will stop at 100% after ERATO is updated and remain at 100% throughout all SH and Utility updates. The progress bar will go back to 0% and resume when the BUuCOM update starts.

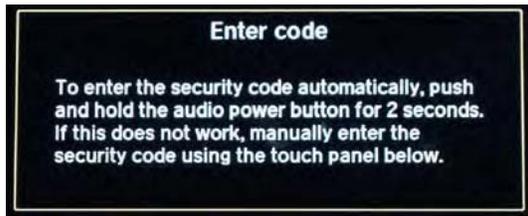
Navigation screen

- When the update is complete, the system will reboot two times to the AcuraLink screen, and the Enter code message and keypad will appear on the screens, although they may not appear at the same time. **Wait for both screens to appear**, then press the engine start/stop button to select the vehicle OFF mode.

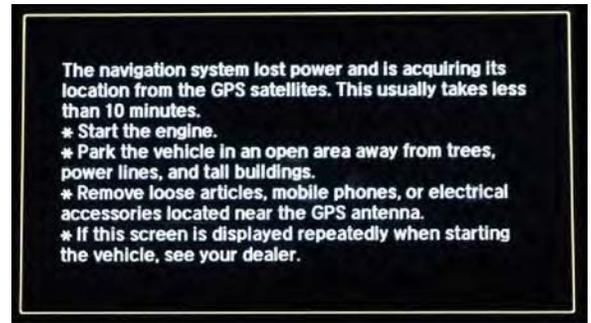
- The navigation screen will show the GPS initialization message.

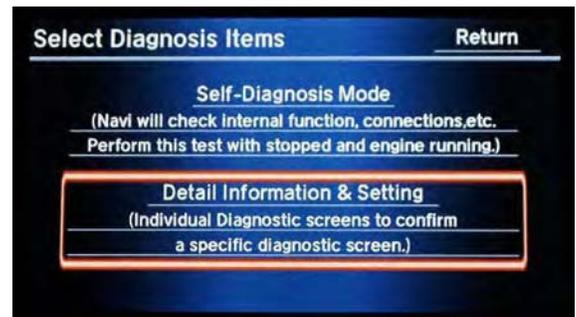
- Press and hold the NAVI, BACK, and MENU buttons until the Select Diagnosis Items screen appears.

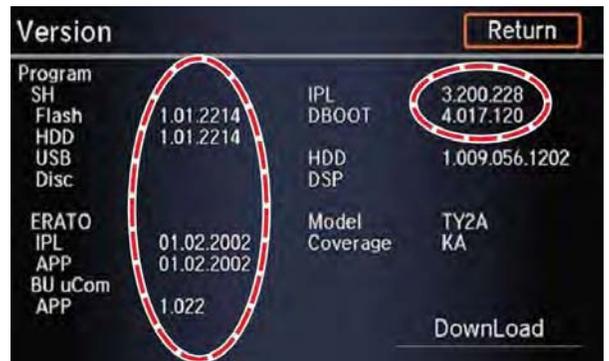
- Verify that the software was updated to the new version as shown below. If the software is not updated, turn the vehicle to the OFF mode, and go back to step 2 and repeat the update procedure.
