HYUNDAI NEW THINKING. NEW POSSIBILITIES. Technical Service Bulletin	GROUP CAMPAIGN	MODEL GENESIS COUPE (BK)
	DATE MARCH 2013	NUMBER 13-01-014
SUBJECT: GENESIS COUPE (BK) 2.0L TURBO ECM UPDATE (SERVICE CAMPAIGN TM7)

This bulletin provides information for an ECM software update of some 2013MY 2.0L Turbo-MPI vehicles.

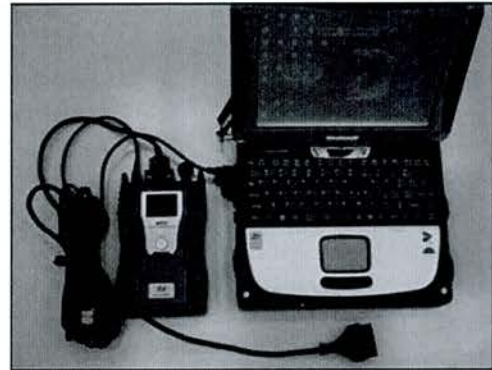
- Connect the USB cable between the GDS and the VCI.
- Connect the 16-pin DLC connector from the VCI into the DLC located under the driver's side dash.

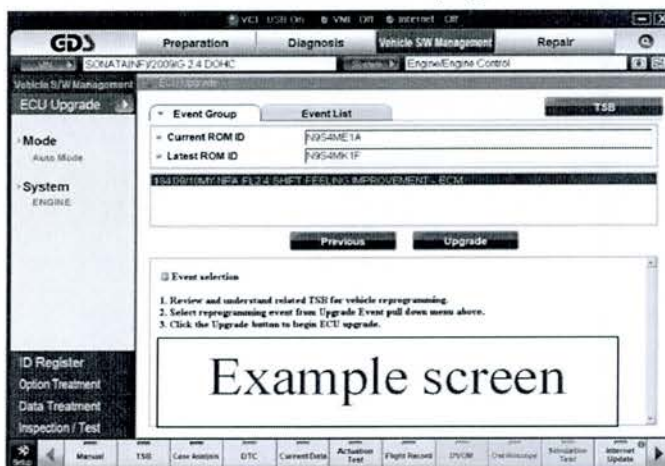
5. Select update event as listed on the **GDS Event list of page-1**. Select **Upgrade**.

6. If the screen indicates "**Voltage is OK**" (voltage > 12volts), select **OK**. If not, select **CANCEL** and charge the vehicle battery by running the engine for 10 minutes.
7. Updating will occur until 100% is reached on the bar graph. At the prompt, turn the ignition key OFF for 10 seconds, then turn it ON and select **OK**.
8. The GDS will confirm that ECM reprogramming is successfully finished. Select **OK**.
9. If the ECM update was not successful, go to **GDS MANUAL MODE ECM UPDATE PROCEDURE**.
10. Check for DTC in all systems and Erase All DTC that stored due to loss of CAN communication during the ECM Update.
11. Turn **OFF** ignition **10 seconds** then turn **ON** before going to engine start.
12. **ETC Learning Procedure - IMPORTANT:**
Turn ignition **ON** with engine not running for **5 seconds** then turn off ignition.
