# SERVICE BULLETIN

EC13-007

## 2013 ALTIMA SEDAN; ENGINE STOPS ON ACCELERATION FROM A STOP AFTER 15 MINUTE IDLE, OR AFTER REFUELING

**APPLIED VEHICLE:** 2013 Altima Sedan (L33) with QR25DE (4-cyl) engine **ONLY**

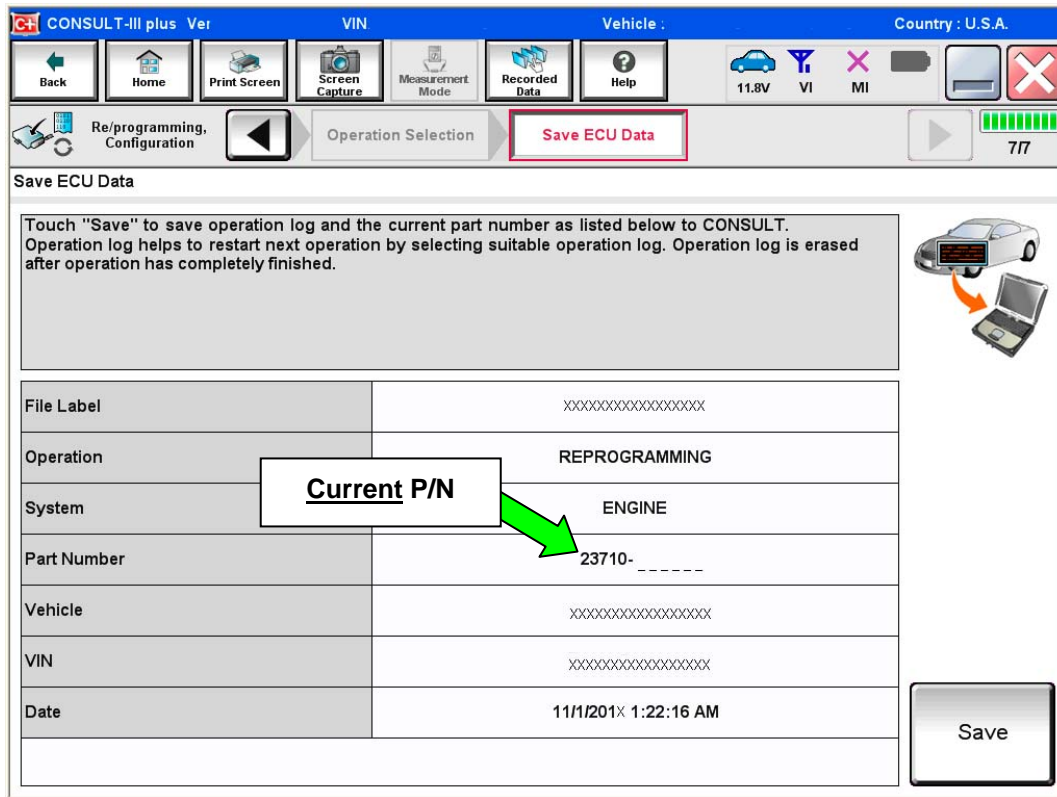
6. When you get to the screen shown in Figure 2, confirm this bulletin applies as follows:

A. Find the ECM **Part Number** and write it on the repair order.

**NOTE:** This is the current ECM Part Number (P/N).

5. Follow the C-III plus on-screen instructions and navigate to the screen shown in Figure 2 on the **next page**.

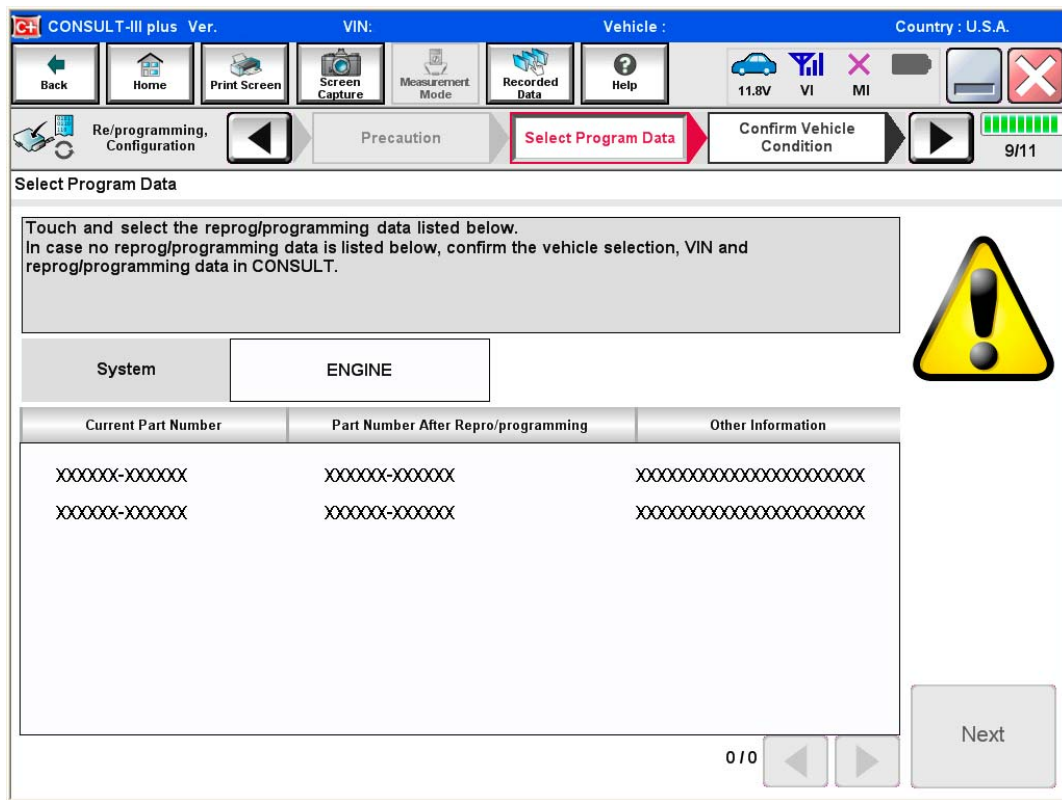
- In some cases, more than one new P/N for reprogramming is available.
  - In this case, the screen in Figure 3 displays.
  - Select and use the reprogramming option that **does not** have the message “Caution! Use ONLY with NTBXX-XXX”.
- If you get this screen and it is blank (no reprogramming listed), it means there is no reprogramming available for this vehicle.

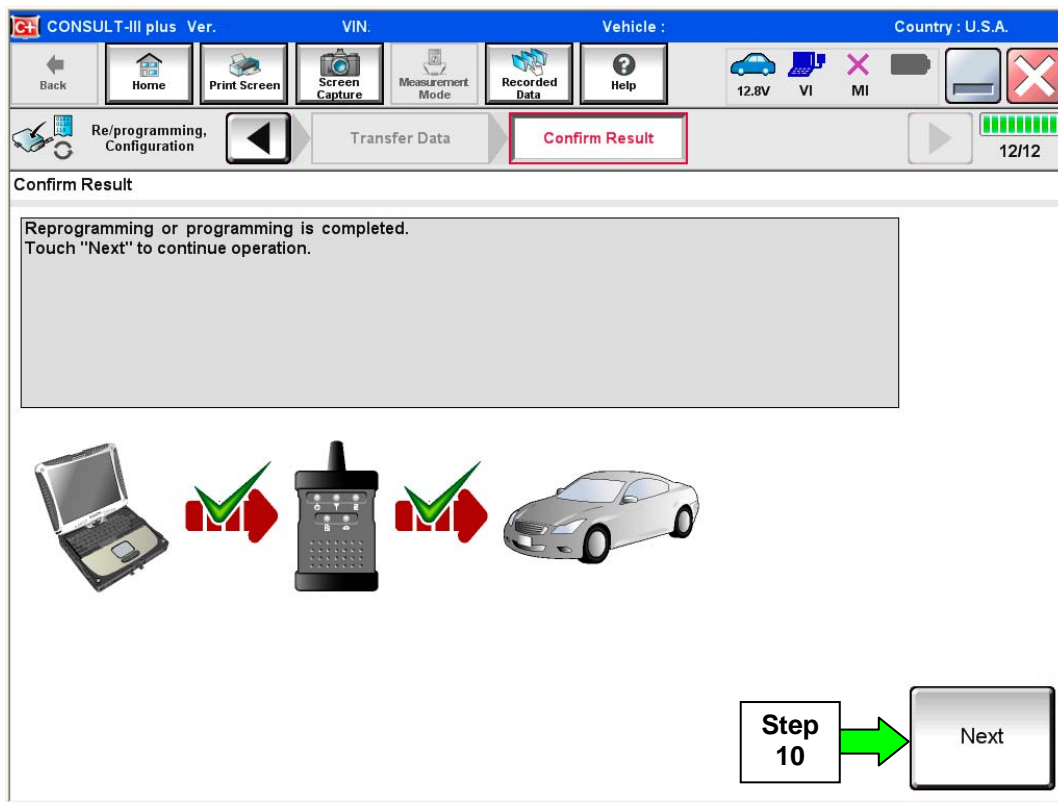
8. When the screen in Figure 4 displays, reprogramming is complete.

**NOTE:** If the screen in Figure 4 does not display (reprogramming does not complete), refer to the information on the next page.

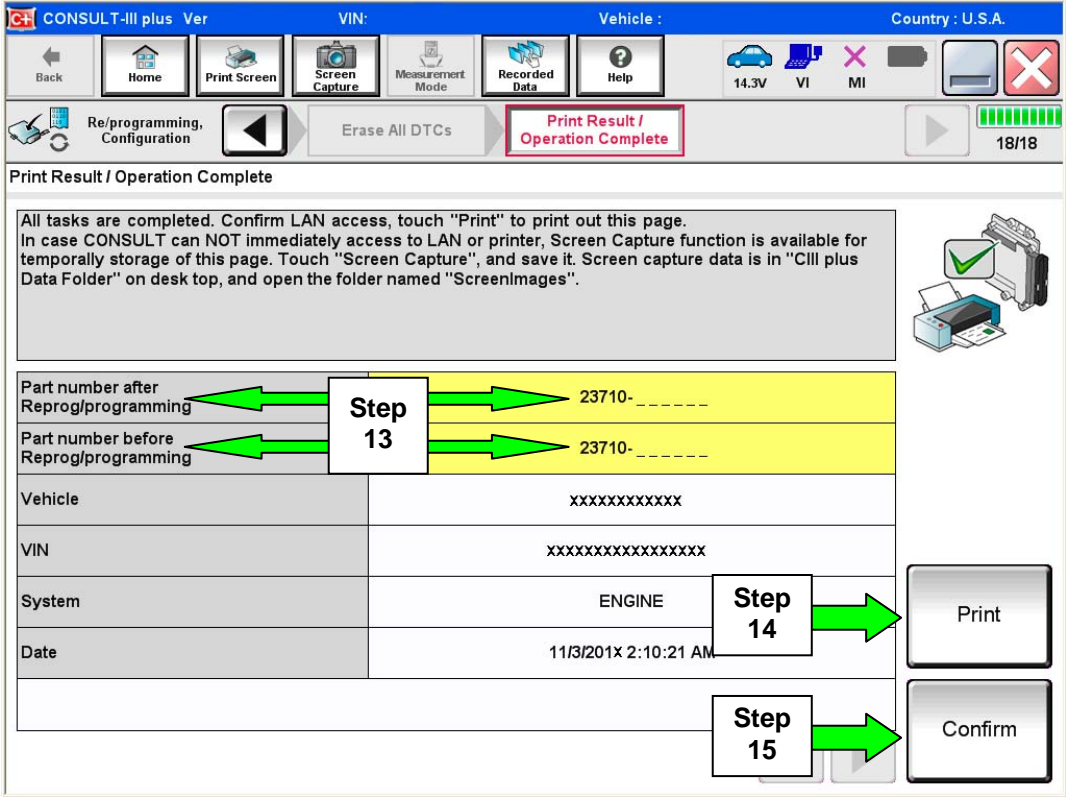
- 12. When the entire reprogramming process is complete, the screen in Figure 7 will display.
- 13. Verify the before and after part numbers are different.
- 14. Print a copy of this screen (Figure 7) and attach it to the repair order for warranty documentation.
- 15. Select **Confirm**.
