Service Bulletin

Bulletin No.: PIP5131

Subject: SPARK EV (BEV) 1ET35 Drive Unit Exchange Program

Models: 2014 Chevrolet Spark EV (BEV)
Equipped with 1ET35 Transaxle (RPO MME)

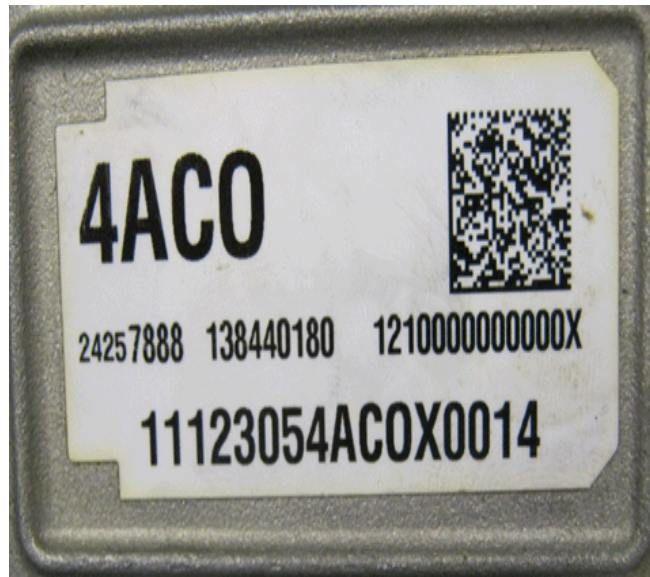
3471383

The Drive Unit Tag Number must be supplied to TAC when calling for a Drive Unit exchange.
