WD31 - Re-programming Rear-Differential Lock Control Unit (Workshop Campaign)

Vehicle Type: **Cayenne (92A) / Cayenne S Diesel (92A) / Cayenne S (92A) / Cayenne GTS (92A) / Cayenne Turbo (92A) / Cayenne Turbo S (92A)**

Concerns: **Rear-differential lock control unit**

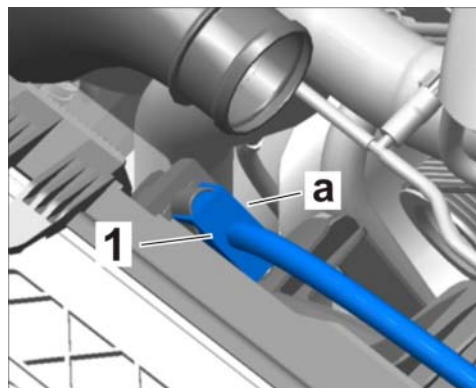
Electric plug connection for fan blower

- 1 Disconnect electric plug connection for the fan blower ⇒ *Electric plug connection for fan blower -1-* (⇒ *Electric plug connection for fan blower -a-*) to prevent the fan blower from coming on during control unit programming.
Having the fan on and the associated increased current draw can cause a drop in voltage, which can result in abnormal termination of control unit programming.

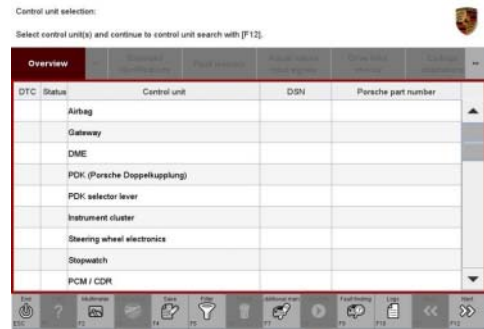
Control unit selection

- In the control unit selection screen (⇒ 'Overview' menu), press •F7" to call up the ⇒ 'Additional menu' (⇒ *Control unit selection*).

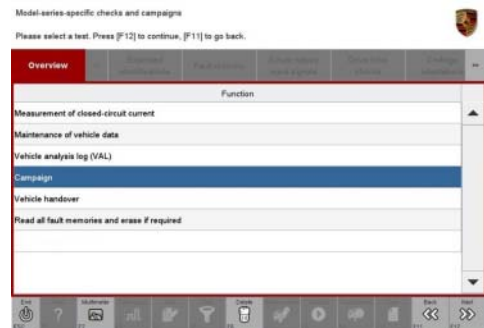
Additional menu - Campaign

- When the question "Create Vehicle Analysis Log (VAL)?" appears, either press •F12" to create a VAL or press •F11" if you do not want to create a VAL.
- Press •>>" to acknowledge the message informing you that campaigns for the vehicle are stored in the PIWIS information system.
- Select the ⇒ 'Campaign' function and press •>>" to confirm your selection ⇒ *Additional menu - Campaign*.

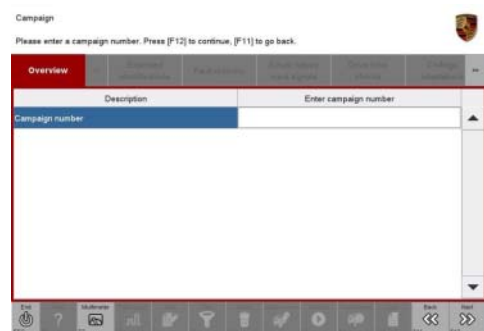
Programming code input field

- To enter the programming code, click in the relevant text box so that the cursor starts to flash ⇒ *Programming code input field*.
