<b>HYUNDAI</b>   NEW THINKING. NEW POSSIBILITIES. <b>Technical Service Bulletin</b>	GROUP	NUMBER
	CAMPAIGN	13-01-034
	DATE	MODEL(S)
	AUGUST 2013	ELANTRA (MD/UD)
SUBJECT:	ECM UPDATE – P2096 AND/OR MISFIRE DTC(s) (SERVICE CAMPAIGN TQ1)

**Description:** This bulletin provides an ECM update to revise the logic for the following DTC(s):

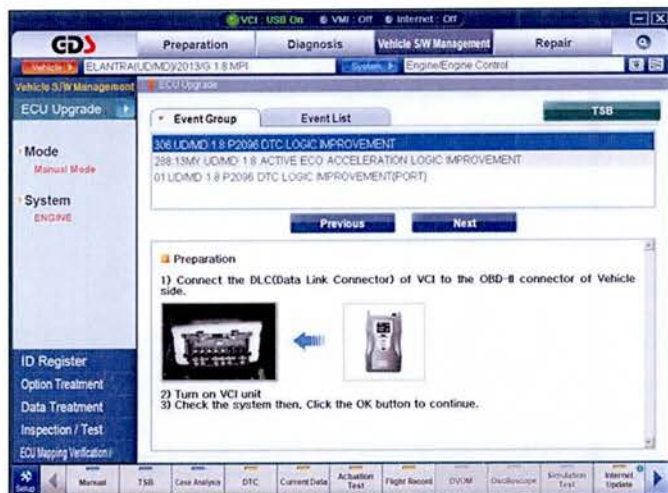
5. Update event "**306. UD/MD 1.8 P2096 DTC LOGIC IMPROVEMENT**" will display. Select **Upgrade**.
