| HYUNDAI NEW THINKING. NEW POSSIBILITIES. Technical Service Bulletin | GROUP | NUMBER |
| | FUEL SYSTEM | 13-FL-007 |
| | AUGUST, 2013 | SANTA FE SPORT (AN) |
| SUBJECT: | ECM UPDATE – DTC P0451 AND P0455 | |

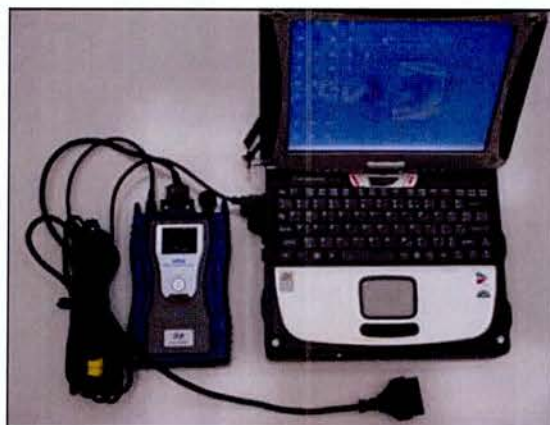
- Connect the USB cable between the GDS and the VCI.
- Connect the 16-pin DLC connector from the VCI into the DLC located under the driver's side dash.

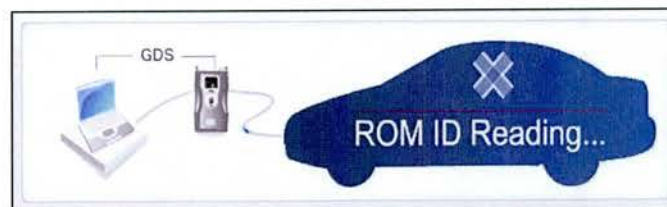
1. From the GDS home page, select **ECU Upgrade**. If necessary, select the VIN.
 2. Select **Engine** as the system and then select **OK**.
 3. Select **Auto Mode** and then select **Next**.
 4. From the **System** tab, select **Engine** and then select **OK**. The GDS will read the ROM ID. Confirm the ROM is applicable as shown on Page 2, "ECM ROM ID Information".
- NOTE:** Record the ECM ROM ID in case the auto update fails and a manual update is needed.

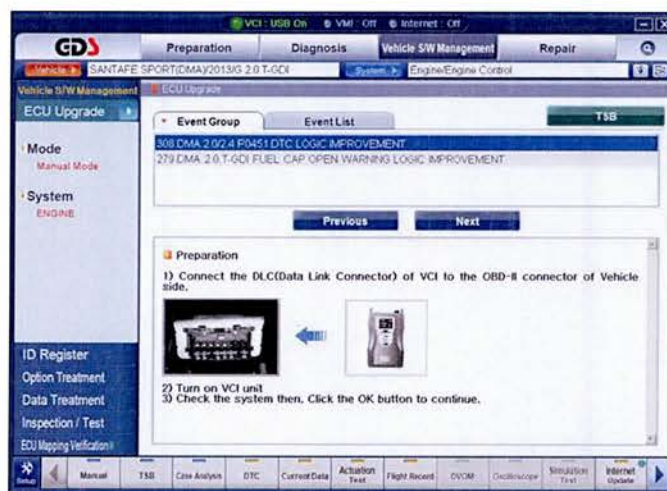
5. Update event "308.DMA 2.0/2.4 P0451 DTC LOGIC IMPROVEMENT" will display. Select **Upgrade**.
