# Technical Service Bulletin

SUBJECT:			No: <b>TSB-13-13-007</b>
<b>ECM REPROGRAMMING FOR MISDETECTION, DTC P2096/P2097 POST CATALYST FUEL TRIM SYSTEM</b>			DATE: <b>October, 2013</b>
			MODEL: <b>2014 Outlander V6</b>
CIRCULATE TO:	<input type="checkbox"/> GENERAL MANAGER	<input checked="" type="checkbox"/> PARTS MANAGER	<input checked="" type="checkbox"/> TECHNICIAN
<input checked="" type="checkbox"/> SERVICE ADVISOR	<input checked="" type="checkbox"/> SERVICE MANAGER	<input type="checkbox"/> WARRANTY PROCESSOR	<input type="checkbox"/> SALES MANAGER

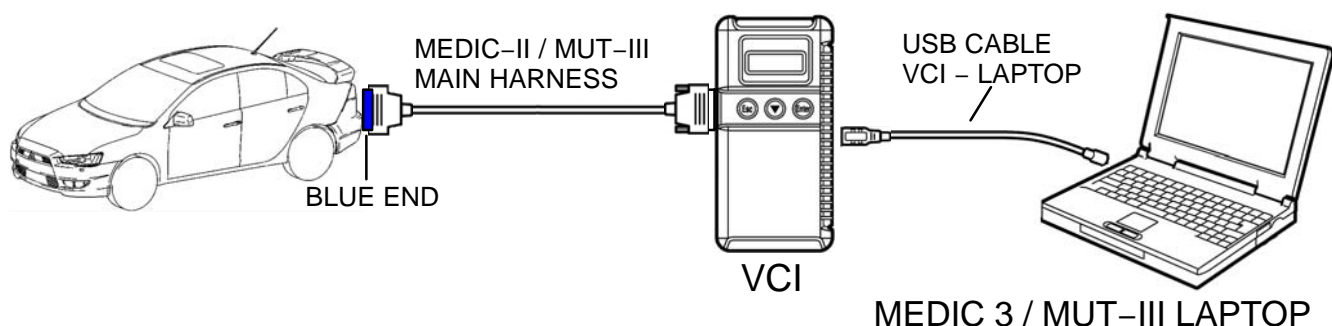
Connect the equipment as follows:

- Turn the laptop computer on. If you're running on battery power and the charge indicator in the lower right hand corner of the screen does not show a full charge, it is recommended that either the laptop battery be charged prior to beginning, or that reprogramming be completed with the A/C power adaptor connected to the laptop.
- Connect the USB cable to the VCI.
- When the laptop displays the MUT-III main screen, connect the USB cable to the laptop.
- Connect the MUT-III main harness (blue DLC connector) to the VCI.
- Connect the blue connector of the MUT-III main harness to the vehicle's data link connector.
- Turn the VCI power switch ON. Verify the indicator lamp in the upper right corner of the screen is green.

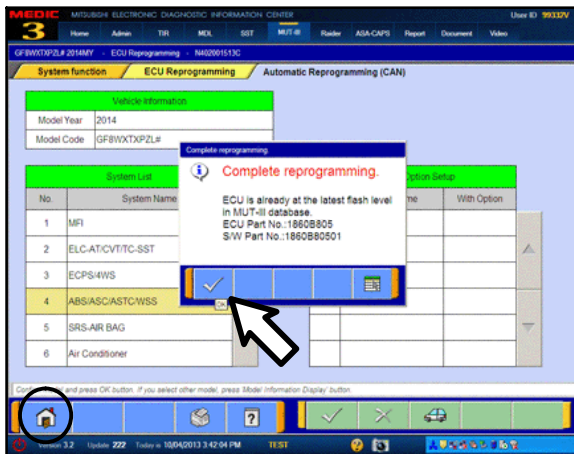
If a “Complete Reprogramming” or “Unnecessary Reprogramming” message **does not** appear, continue with step l.

If the message seen at left is displayed, the ECM software is already at the most current level. Do not continue with the reprogramming procedure. This TSB does not apply.

Click the check mark to clear the window, then click the Home icon at the lower left corner of the screen to return to the System Select main page.

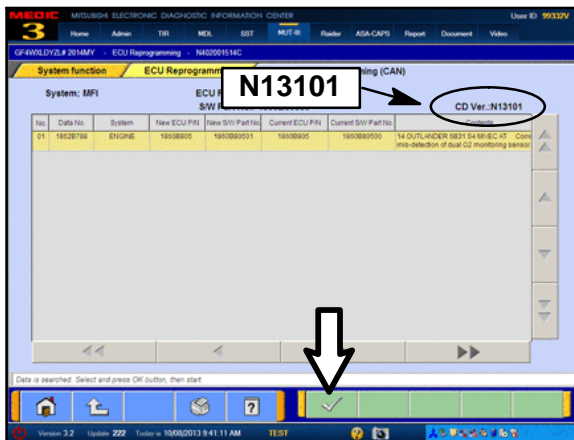
- l. The Automatic Reprogramming(CAN) database screen will display.

Confirm the database number at the top right of the table is **N13101** or higher.

If more than one row is displayed in the table, refer to the ECM Reprogramming Chart on Page 2 to select the correct row.

Click on the row to highlight it.

Click the check mark to continue.

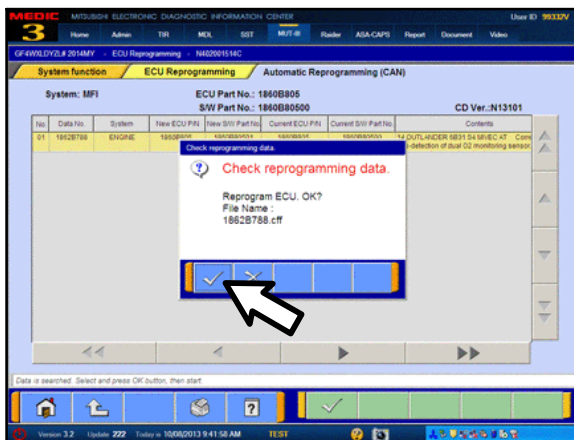
- m. A message will ask you to “Check reprogramming data.”
- n. Click the check mark to begin reprogramming.

Reprogramming will take up to 5 minutes to complete.

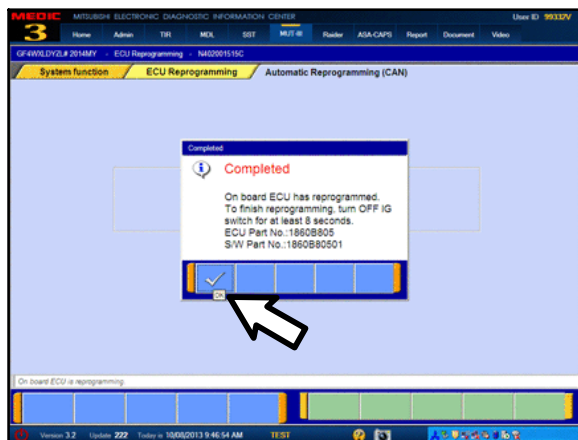
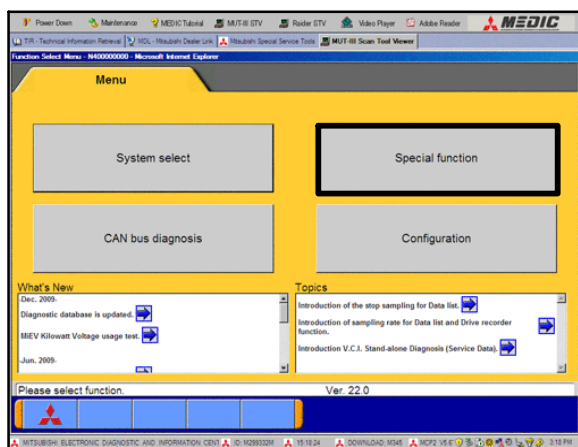
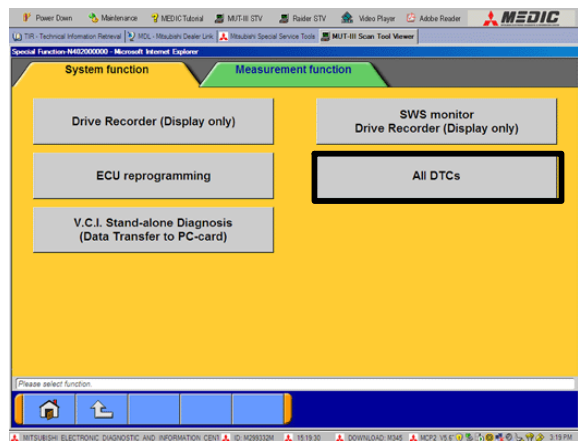
- o. This message will display when ECM reprogramming is successfully completed. Confirm the “New S/W P/N” displayed matches the table at the beginning of this TSB.
  - p. The message advises you to turn off the ignition for at least 8 seconds. Once the time has passed, turn the ignition on again.
2. Click the check mark in the message to return to the ECM Reprogramming page.
  3. Click the home icon at the bottom left corner of the page to return to the MUT-III main page.
  4. Using MUT-III, check and erase ALL DTCs from all systems as follows.
    - a. Select “Special Function.”
    - b. Select “All DTCs,” then select “ERASE AND READ ALL DTCs.”

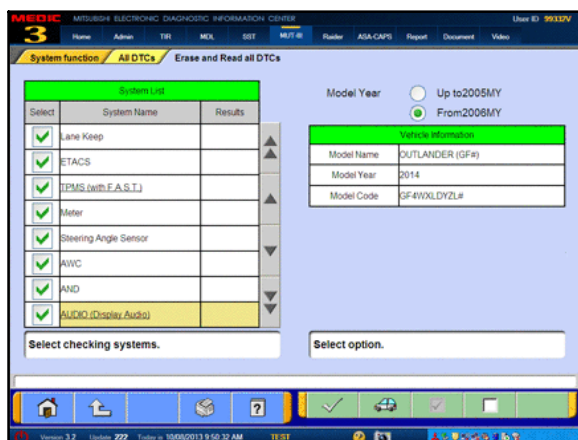
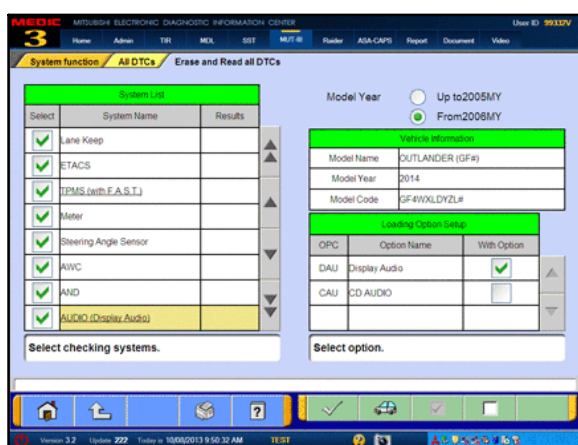
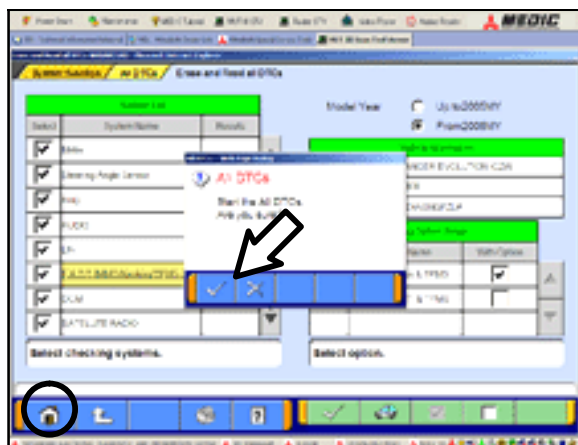
c. The "System List" on the left side of the screen will have all selections checked. Do not change these selections. DTCs may be set if the vehicle is equipped with options that are unchecked.

d. If the check mark at the bottom of the screen is highlighted, click it and proceed to step 5. If not, proceed to step e.
