HYUNDAI NEW THINKING. NEW POSSIBILITIES. Technical Service Bulletin	GROUP	NUMBER
	CAMPAIGN	13-01-029
	DATE	MODEL
	JULY 2013	ACCENT (RB)
ECM & TCM UPDATE (SERVICE CAMPAIGN TP7)

ECU Update

Description: This bulletin provides a procedure to update the ECM and TCM software logic for 2012 Accent (RB) 1.6L vehicles to revise:

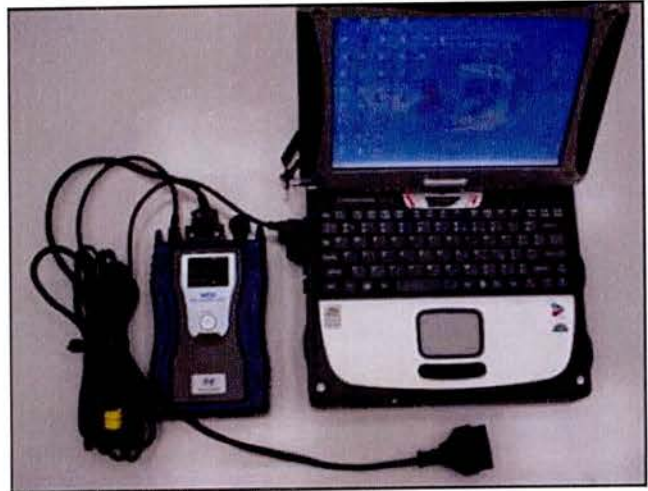
- Connect the USB cable between the GDS and the VCI.
- Connect the 16-pin DLC connector from the VCI into the DLC located under the driver's side dash.

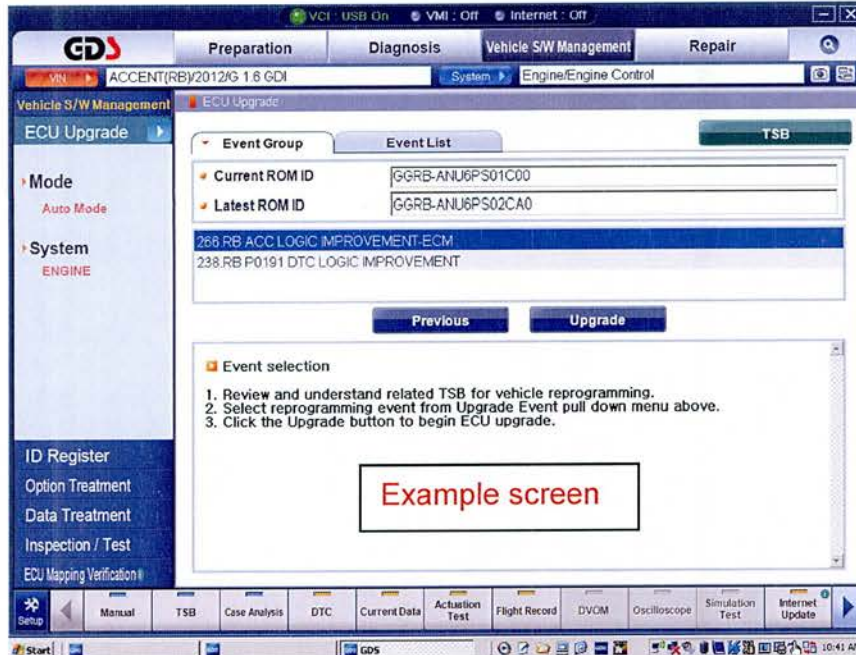
1. From the GDS home page, select **ECU Upgrade**. If necessary, select the VIN.
2. Select **Engine** as the system and then select **OK**.
3. Select **Auto Mode** and then select **Next**.
4. From the **System** tab, select **Engine** and then select **OK**. The GDS will read the ROM ID. Confirm the ROM is applicable as shown on Page 1, "ROM ID Information".
5. Select update event #**294.RB 1.6 AT P0456/0461/2192 DTC LOGIC IMPROVEMENT – ECM** or any later (higher) event number that shows in the GDS list. Select **Upgrade**.

6. If the screen indicates "**Voltage is OK**", select **OK**. If not, select **CANCEL** and charge the vehicle battery by running the engine for 10 minutes.
7. Updating will occur until 100% is reached on the bar graph. At the prompt, turn the ignition key OFF for 10 seconds, then turn it ON and select **OK**.
8. The GDS will confirm that TCM reprogramming is successfully finished. Select **OK**.
9. If the TCM update was not successful, go to **GDS MANUAL MODE ECM UPDATE PROCEDURE**.
10. Check for Diagnostic Trouble Codes and erase any DTC.
11. Start the engine to confirm proper operation of the vehicle.

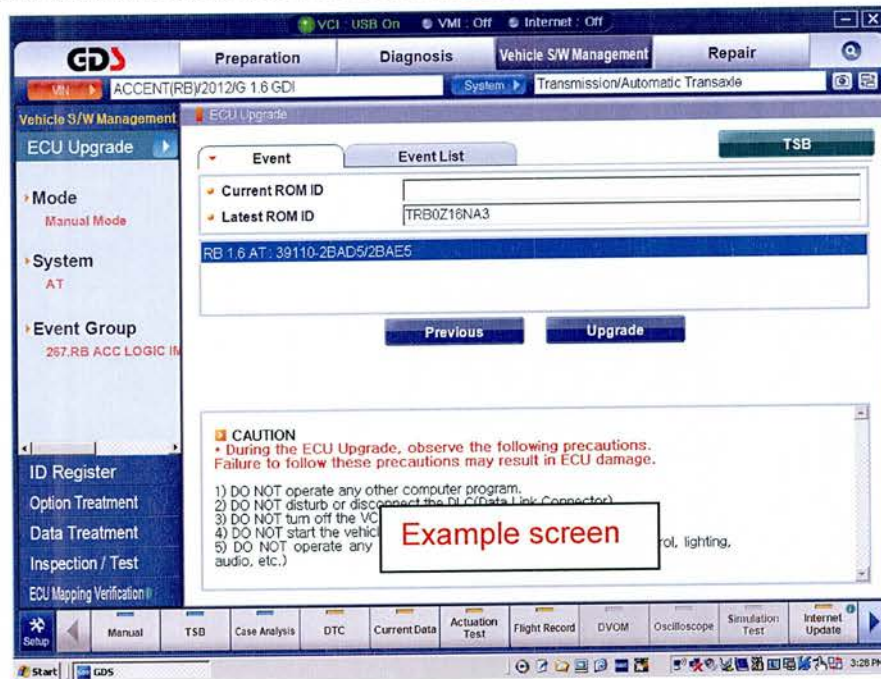
1. From the GDS home page, select **ECU Upgrade**. If necessary, select the VIN.
2. Select **AT** as the system and then select **OK**.
3. Select **Manual Mode** and then select **NEXT**.
4. From the **System** tab, select **AT** and then select **NEXT**.
5. Select update event **Upgrade Event #267 RB 1.6 AT 39110-2BAD5/2BAE5** or any later (higher) event number that shows in the GDS list. Select **Next**.

6. Enter the Password and click **OK**. The part number can be found on the PCM label.
