GROUP Fuel System	MODEL 2011-2012MY Optima (TF/QF) Turbo 2011-2012MY Sportage (SL) Turbo
	NUMBER 025	DATE September 2013

TECHNICAL SERVICE BULLETIN

SUBJECT: SERVICE ACTION: ECM UPGRADE – MIL ON WITH DTC P0300 AND/OR P0301, P0302, P0303 AND P0304 (SA151)

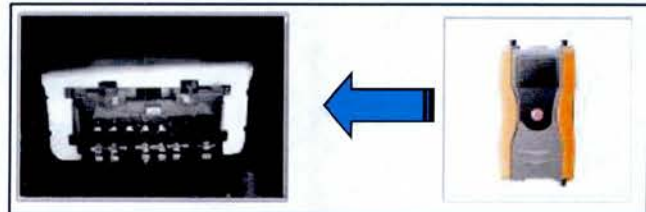
3. Connect the Main 16-pin DLC cable (GHDM – 241000) to the VCI.

4. Connect the Main 16-pin DLC cable (GHDM – 241000) to the OBD-II connector, located under the driver's side of the instrument panel.

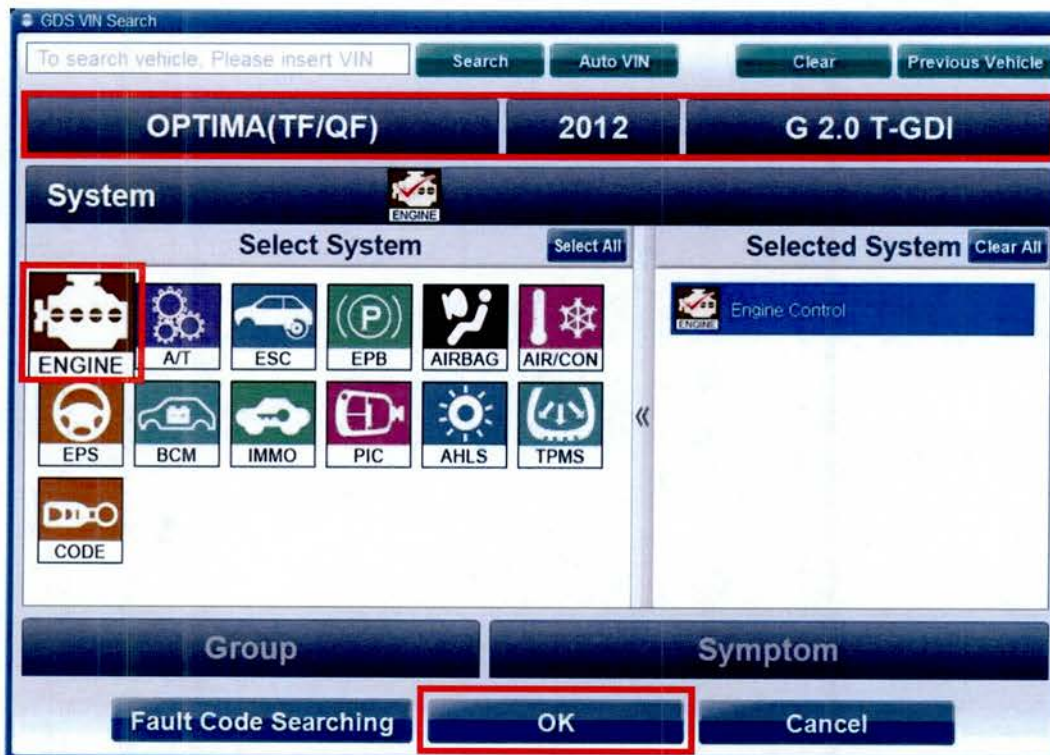
5. With the ignition key ON, turn ON the VCI and GDS tool. Access the GDS vehicle identification number (VIN) screen and configure the vehicle using the VIN AUTO DETECT Function.
