GROUP Engine	MODEL 2011-2013MY Sorento (XM), 2011, 2012 & 2014MY Sedona (VQ)
	NUMBER 133	DATE September 2013
TECHNICAL SERVICE BULLETIN		
SUBJECT: SERVICE ACTION: ECM UPGRADE – MIL ON WITH DTC P0638 AND ETC CARBON CLEANING (SA153)

This bulletin provides information related to the ECM software upgrade for some 2011-2013MY Sorento 3.5L MPI vehicles, produced from October 25, 2009 through January 31, 2013, and 2011, 2012 & 2014MY Sedona 3.5L MPI vehicles, produced from March 03, 2010 through July 12, 2013, which may experience a Malfunction Indicator Lamp illuminated with the ECM (Electronic Control Module) system-related DTC P0638. To prevent and/or correct this condition, the ECM should be reprogrammed and the carbon cleaning process performed using GDS, as described in this bulletin. For confirmation that the latest reflash has been done to the vehicle you are working on, verify ROM ID using the tables in this TSB.

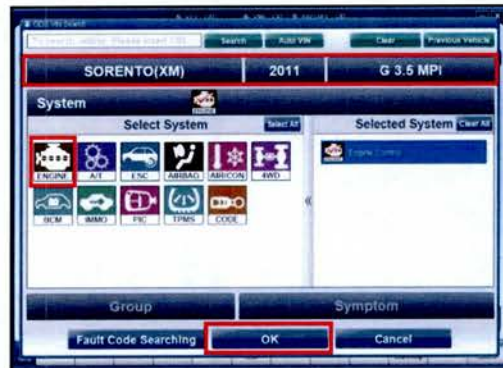
6. Select **ENGINE** system and click **OK**.

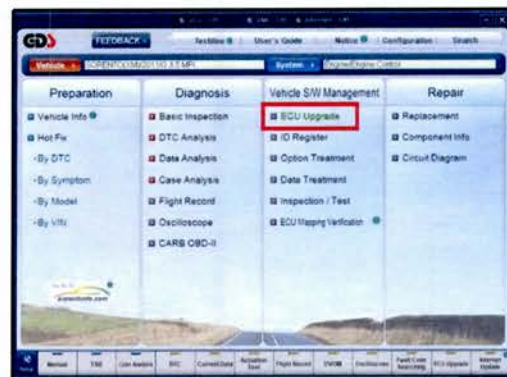
7. Select **ECU Upgrade**.

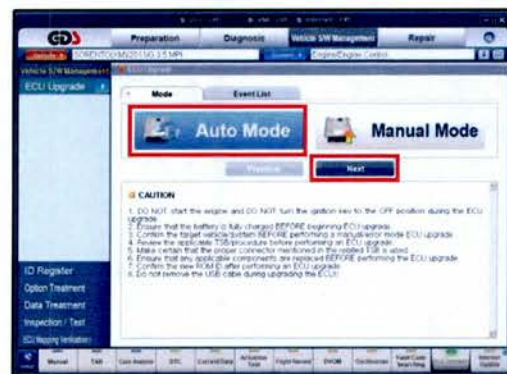
8. Select **Auto Mode**, and then **Next**.

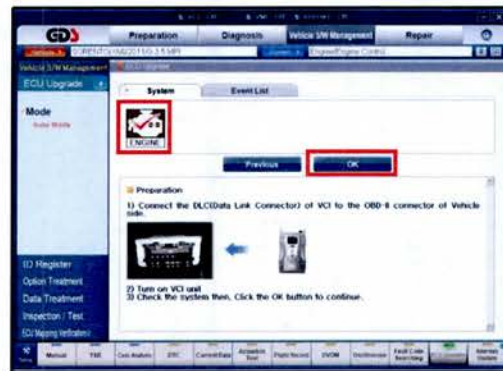
9. Select **Engine** and click **OK**.

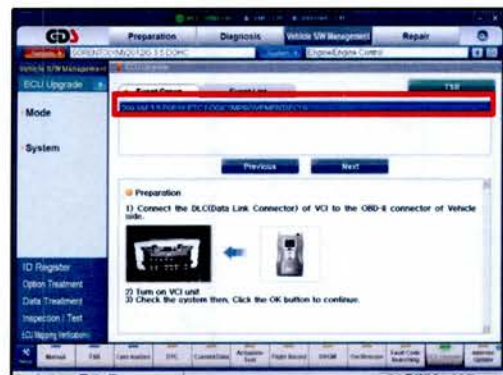
10. Select Upgrade Event: **208.VQ 3.5 P0638 ETC LOGIC IMPROVEMENT (ECU)** or **209.XM 3.5 P0638 ETC LOGIC IMPROVEMENT(ECU)**, then click **Upgrade** button and **OK** on battery voltage check screen.

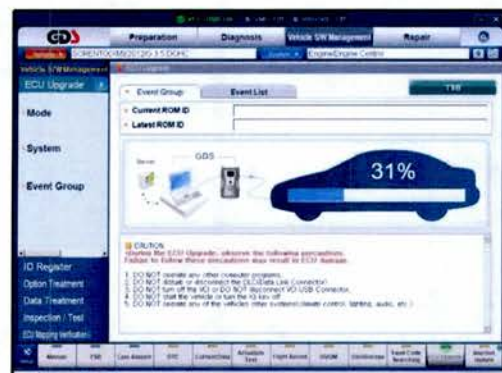
11. Upgrade will begin and the progress of the upgrade will appear on the bar graph.

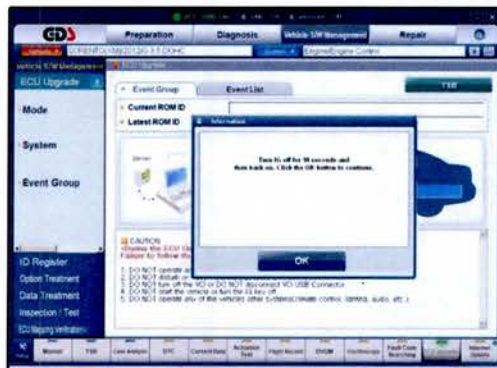
- 12. Follow the guidelines displayed on the screen during upgrade procedure and make sure to cycle the ignition **OFF** ↔ **ON** once.

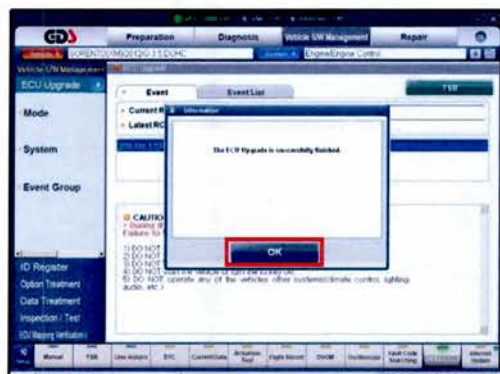
- 13. Click OK on the final screen. Upgrade events 208 or 209 are now complete.

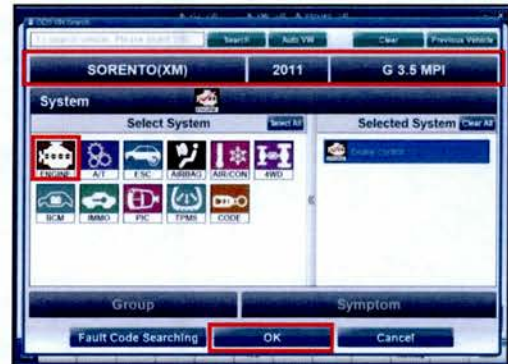
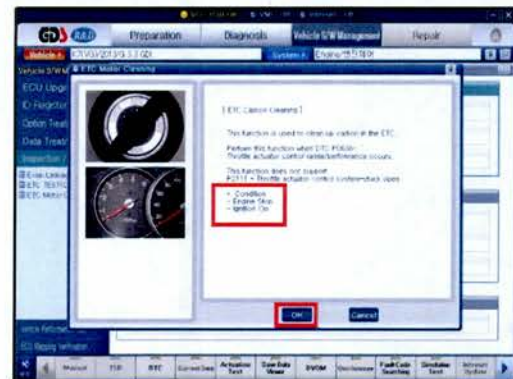
1. Select **ENGINE** System and click the **ETC Carbon Cleaning**.
2. Click **OK** on the screen with the engine **OFF** and ignition in the **ON** position.

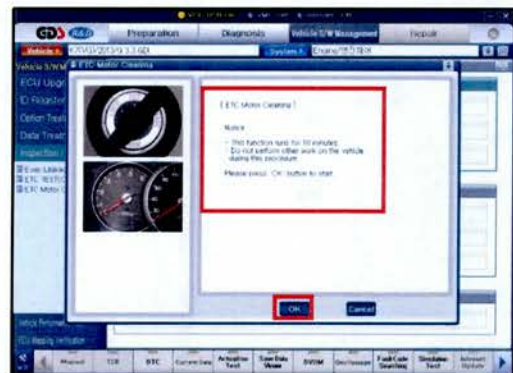
3. Click **OK** after reading the on-screen notice.

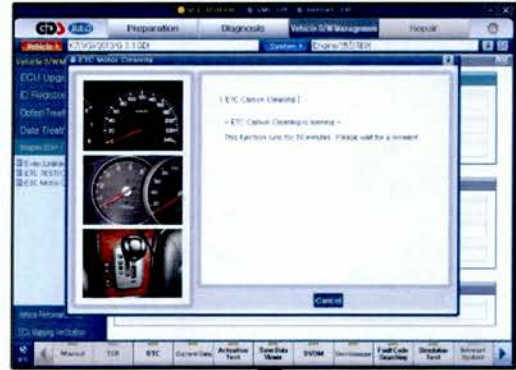
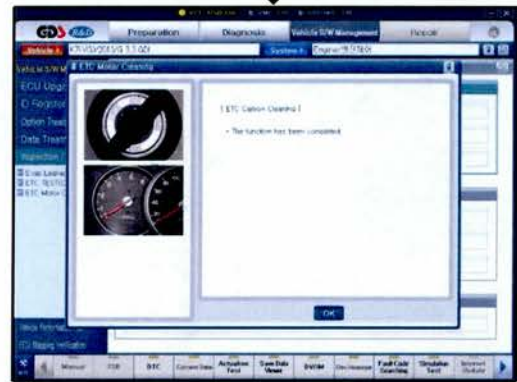
- 4. It will take approximately 10 minutes to complete the carbon cleaning function.

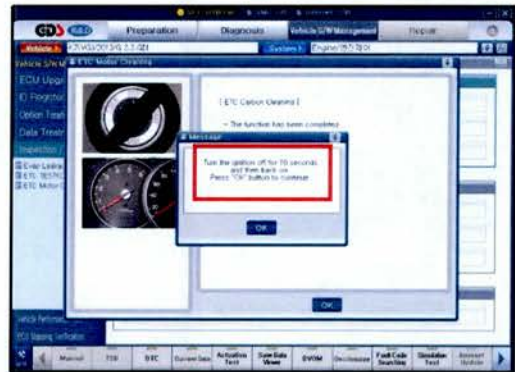
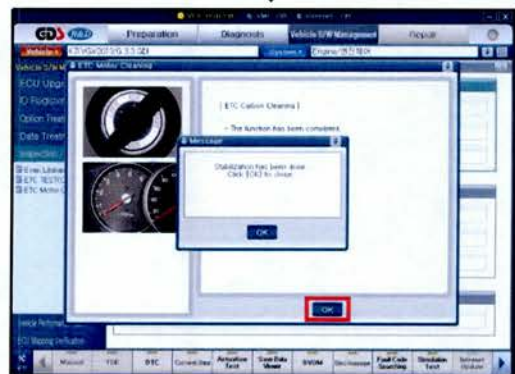
- 5. Once the carbon cleaning function has been completed, cycle the ignition once, as directed.

- 6. Start the engine to confirm proper operation.
