Audi

Emissions Service Action

Subject: 2009 - 2012 Audi Q7 3.0L TDI

Differential Pressure Sensor/ECM Software Update

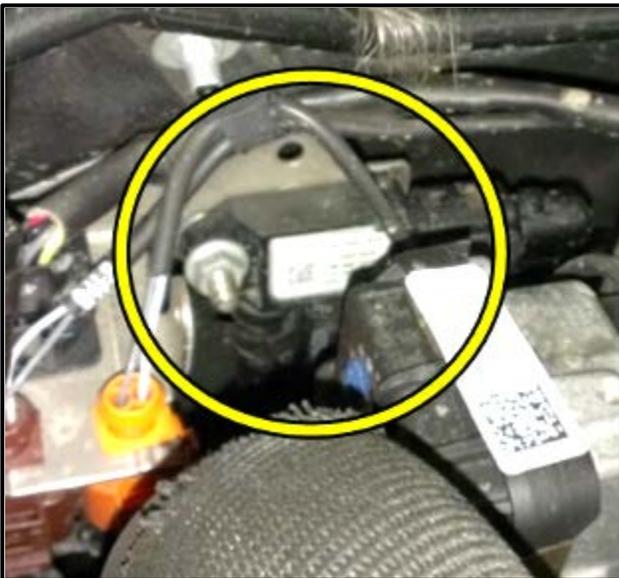
← The differential pressure sensor is mounted in the center of the bulkhead, below the wiper cowl <circle>.

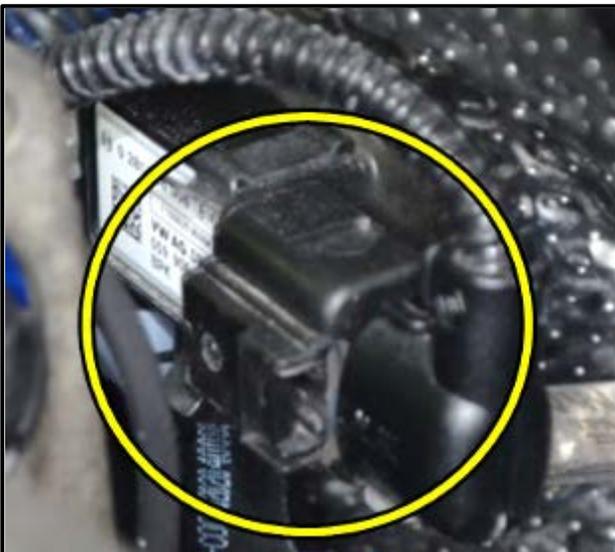
← Disconnect the electrical connector from the differential pressure sensor <circle>.

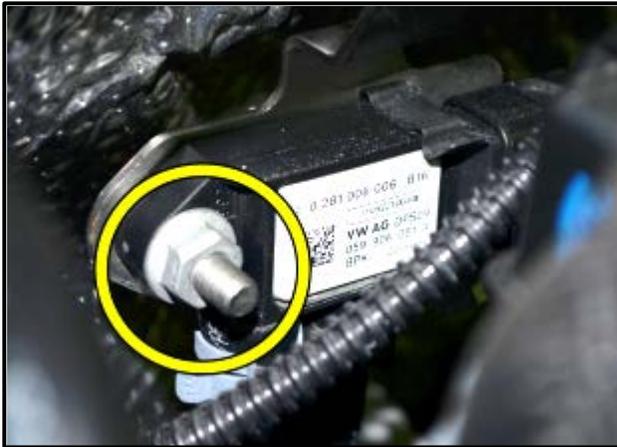
⇐ Remove the differential pressure sensor mounting nut <circle>.

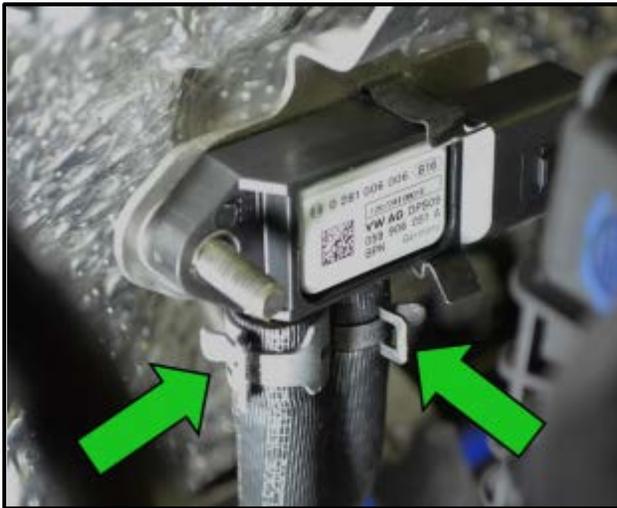
⇐ Reposition the spring clamps on both of the particulate filter hoses to allow removal of the hoses from the differential pressure sensor <arrows>.

- Remove both of the particulate filter hoses from the differential pressure sensor and remove the sensor itself from the mounting bracket.

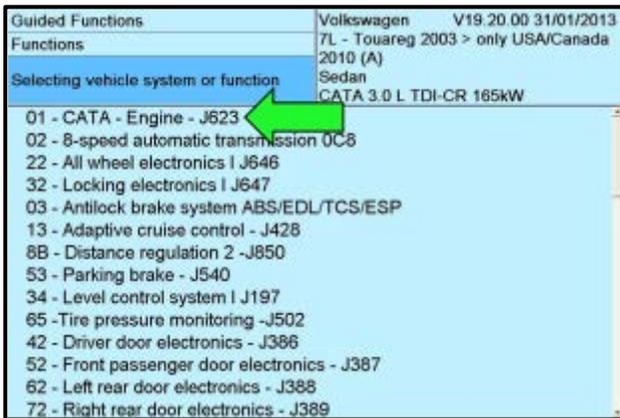
⇐ Select “01 – CATA – Engine – J623” <arrow>.

- Start the engine.
- Using a VAS 6150A or equivalent enter “Guided Functions”.
- Select the appropriate model, model year, and engine code.

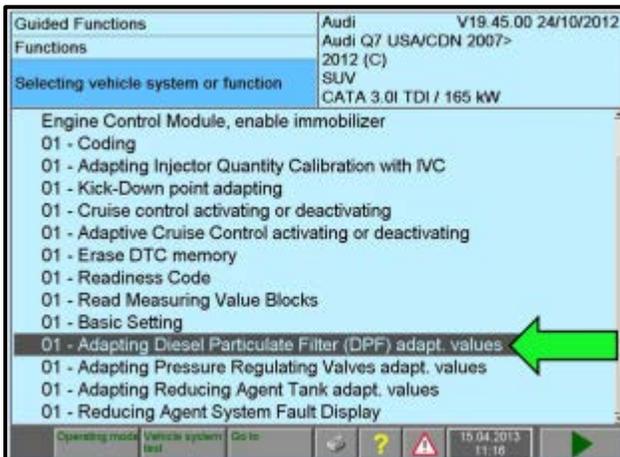
⇐ Select “Engine Control Module, enable immobilizer”.

⇐ Select “01 – Adapting Diesel Particulate Filter (DPF) adapt. values” <arrow>.

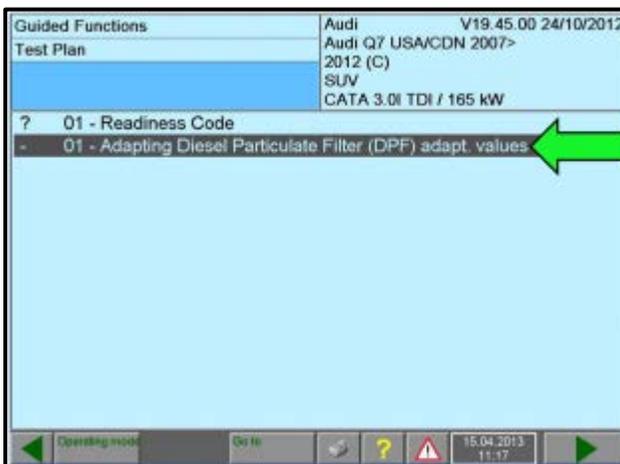
⇐ Select “01 – Adapting Diesel Particulate Filter (DPF) adapt. values” <arrow>.

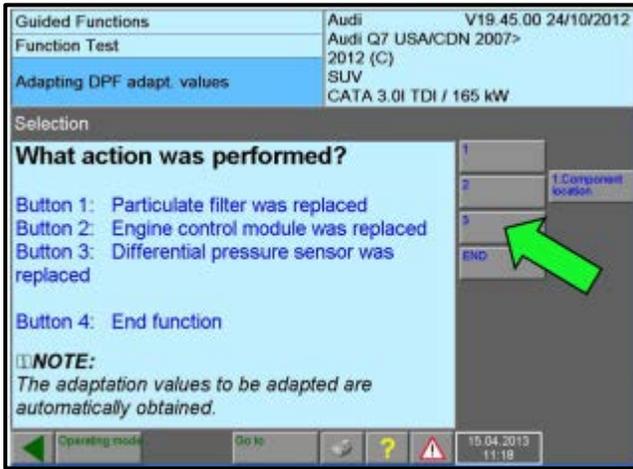
← Select “Button 3: Differential pressure sensor was replaced” <arrow>.

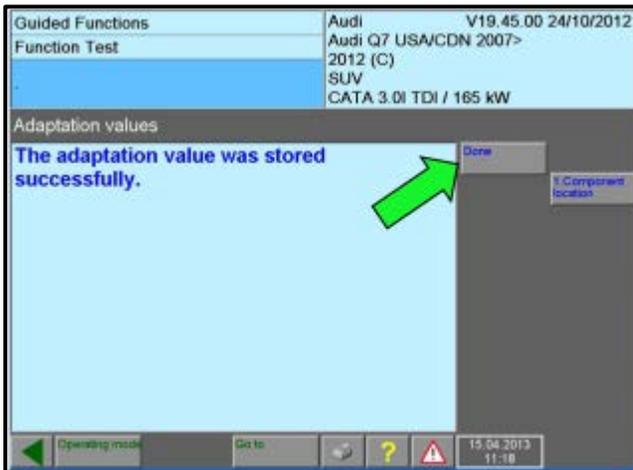
← Select “Done” <arrow>.
