HYUNDAI NEW THINKING. NEW POSSIBILITIES. Technical Service Bulletin	GROUP	NUMBER
	FUEL SYSTEM	13-FL-008
	DATE	MODEL(S)
	OCTOBER, 2013	ELANTRA GT (GD)
SUBJECT: ECM UPDATE – DTC P0507

Description: This bulletin provides an ECM update to revise the logic for the following DTC(s):

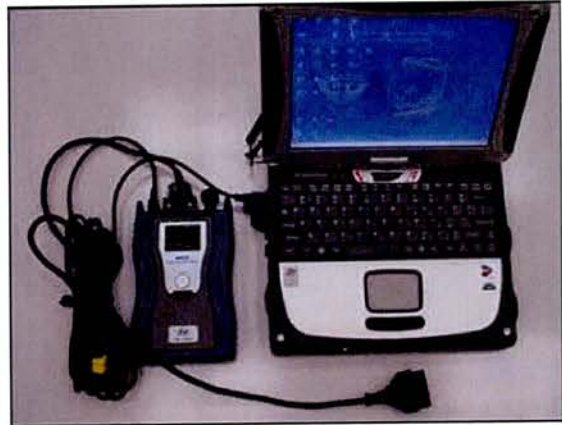
- Connect the USB cable between the GDS and the VCI.
- Connect the 16-pin DLC connector from the VCI into the DLC located under the driver's side dash.

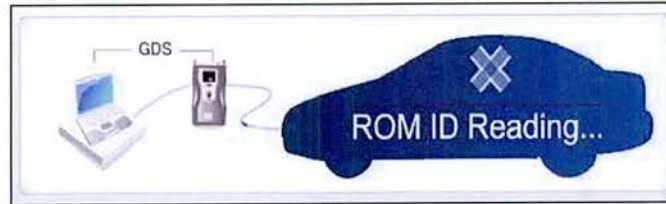
1. From the GDS home page, select **ECU Upgrade**. If necessary, select the VIN.
2. Select **Engine** as the system and then select **OK**.
3. Select **Auto Mode** and then select **Next**.
4. From the **System** tab, select **Engine** and then select **OK**. The GDS will read the ROM ID. Confirm the ROM is applicable as shown on Page 2, "ECM ROM ID Information".
NOTE: Record the ECM ROM ID in case the auto update fails and a manual update is needed.
