**WARRANTY**  
CAMPAIGN**SIDE-BY-SIDE  
VEHICLES****WARRANTY  
Bulletin**

Campaign no.: 2013-11

June 28<sup>th</sup>, 2013Subject: **Vehicle Control Module (VCM) Reflash**

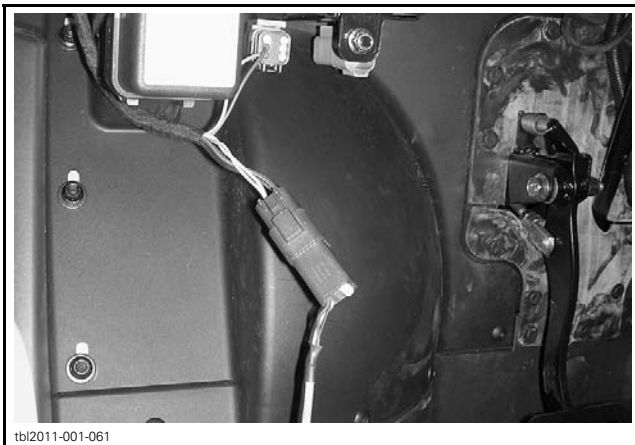
tbl2011-001-061

1. Locate the 6-pin diagnostic connector underneath dashboard on driver's side.
2. Disconnect the 6-pin diagnostic connector from it's holder (protective cap).
3. Connect one end of the MPI-2 diagnostic cable to the vehicle connector.

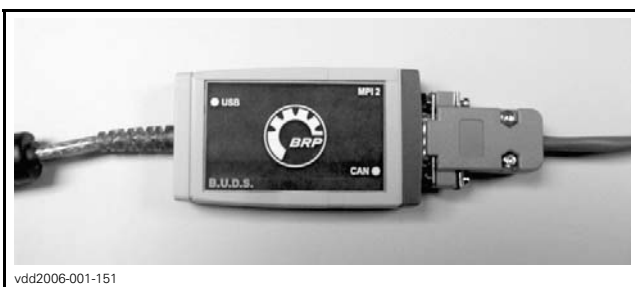
vdd2006-001-151

4. Connect the other end of diagnostic cable to the MPI-2 interface card.

DIAGNOSTIC CABLE CONNECTED TO MPI-2 INTERFACE CARD

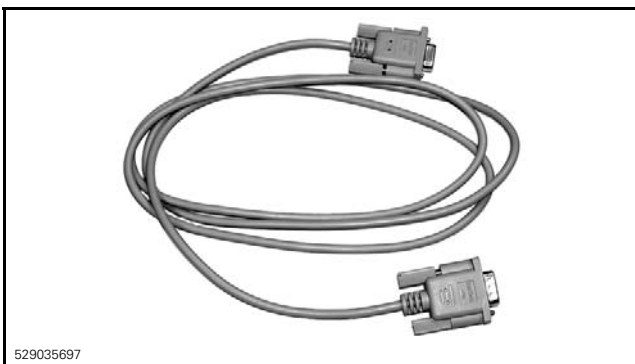
529035697

**NOTE:** An optional MALE-FEMALE EXTENSION SERIAL CABLE (P/N DB9) available at electronic retail outlets can be used between diagnostic cable and MPI-2 interface. Do not exceed 7.6 m (25 ft).

OPTIONAL MALE-FEMALE EXTENSION SERIAL CABLE

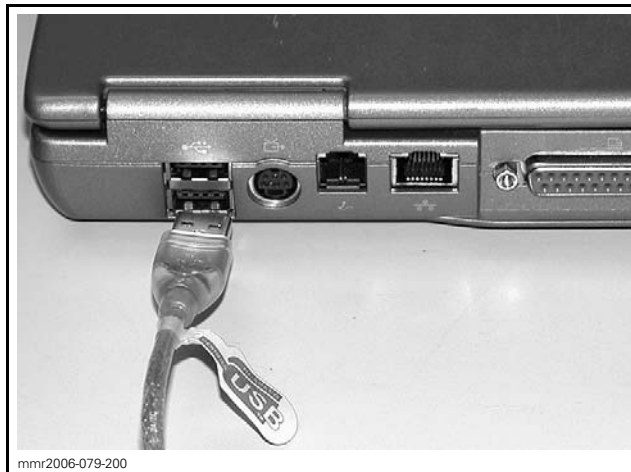
mmr2006-079-200

5. Connect the MPI-2 interface card to the USB port of a PC (personal computer).

MPI-2 INTERFACE CARD CONNECTED TO USB PORT

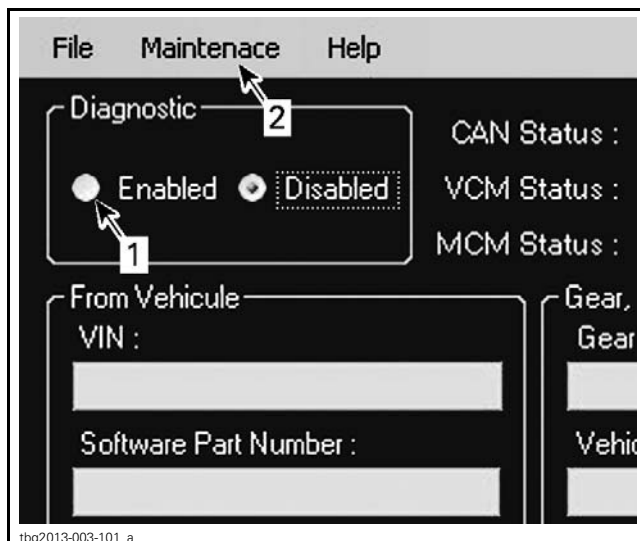
4. Click on **Enabled** and then on **Maintenance**.

**⚠ CAUTION** Vehicle will be in **NEUTRAL** as parking brake will be released.

1. First: click Enabled
2. Secondly: click Maintenance

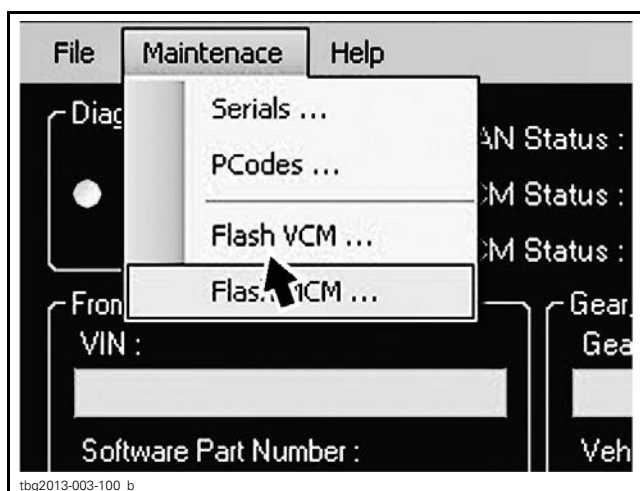
5. Select Flash VCM.
