Technical Service Bulletin

SUBJECT:			No: TSB-13-13-009
ECM REPROGRAMMING FOR MIL ILLUMINATES, DTC P1235 OR P0068 STORED IN ECM			DATE: December, 2013
			MODEL: See below
CIRCULATE TO:	<input type="checkbox"/> GENERAL MANAGER	<input checked="" type="checkbox"/> PARTS MANAGER	<input checked="" type="checkbox"/> TECHNICIAN
<input checked="" type="checkbox"/> SERVICE ADVISOR	<input checked="" type="checkbox"/> SERVICE MANAGER	<input checked="" type="checkbox"/> WARRANTY PROCESSOR	<input type="checkbox"/> SALES MANAGER

This TSB provides field fix procedures to reprogram the ECM with new software to address false MIL illumination with boost/air flow plausibility monitor DTCs P1235 (2008–2010 models) or P0068 (2011–2014 models) stored in memory.

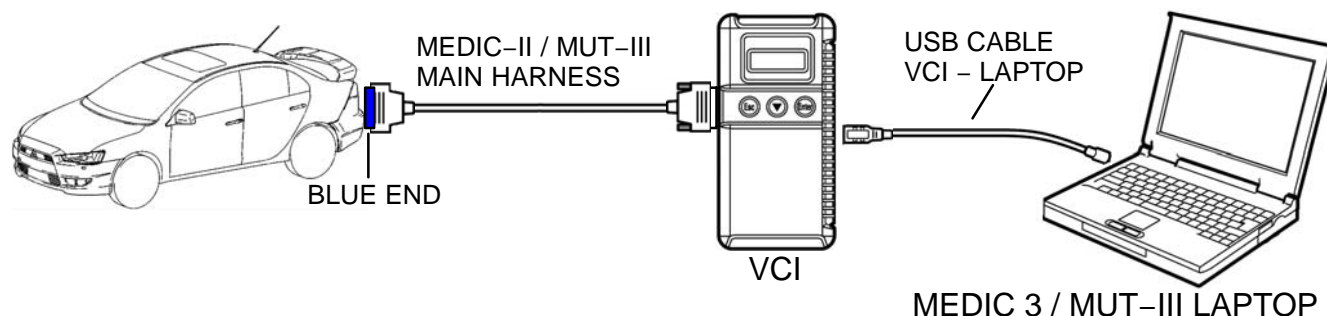
Connect the equipment as follows:

- Turn the laptop computer on. If you're running on battery power and the charge indicator in the lower right hand corner of the screen does not show a full charge, it is recommended that either the laptop battery be charged prior to beginning, or that reprogramming be completed with the A/C power adaptor connected to the laptop.
- Connect the USB cable to the VCI (or VCI-LITE).
- When the laptop displays the MUT-III main screen, connect the USB cable to the laptop.
- Connect the MUT-III main harness (blue DLC connector) to the VCI.
- Connect the blue connector of the MUT-III main harness to the vehicle's data link connector.
- Turn the VCI power switch ON. Verify the indicator lamp in the upper right corner of the screen is green.

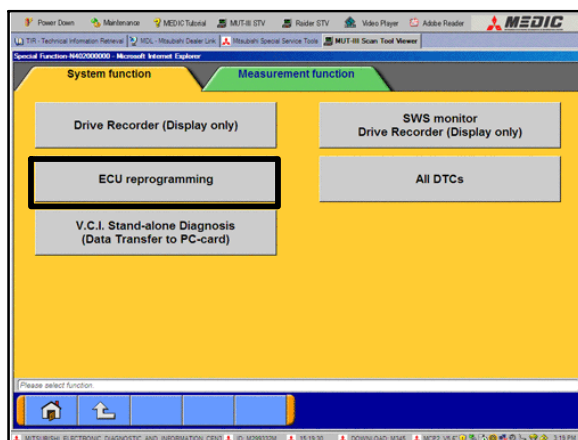
- b. If using MEDIC 3, from the main page, click the MUT-III STV icon at the top center of the screen.
- c. From the MUT-III Main Menu, select "Special Function."
- d. Select "ECU Reprogramming."

- e. Select "Automatic Reprogramming (CAN)."

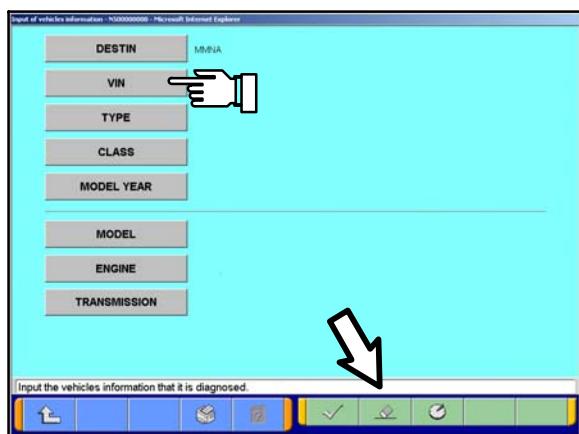
g. If the VIN or vehicle description displayed does not match the vehicle you are working on, click on the eraser icon at the bottom of the page to erase vehicle data.

Then click on the VIN button.

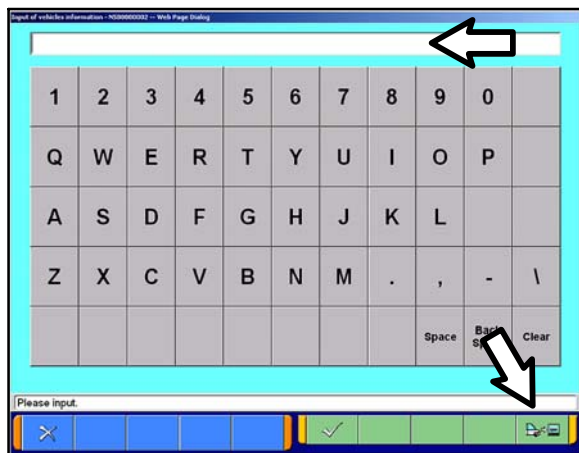
h. Click the icon in the lower RH corner of the screen to have MUT-III automatically read the VIN. If a message appears saying the VIN cannot be input automatically, manually type the 17 digit VIN into the VIN field at the top of the page.

Make sure the VIN is correct and click on the check mark.

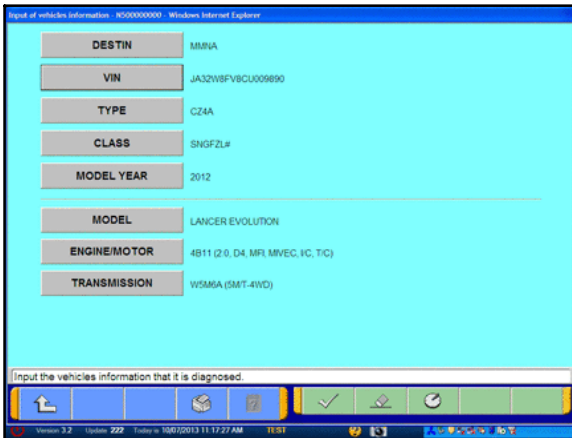
i. Confirm all data matches the vehicle and click the check mark at the bottom of the page.

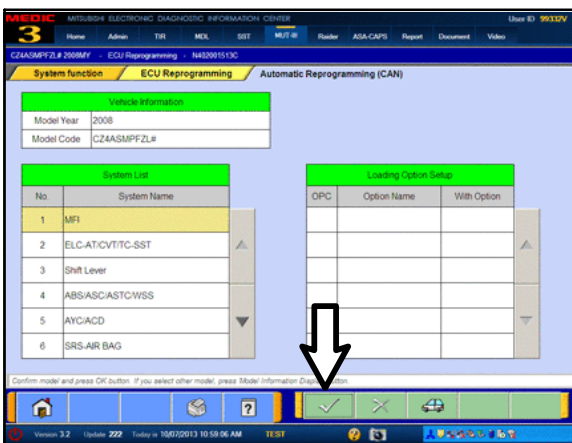
j. MFI should be highlighted as the default. If not, click on it to highlight it.

Click the check mark at the bottom of the page.

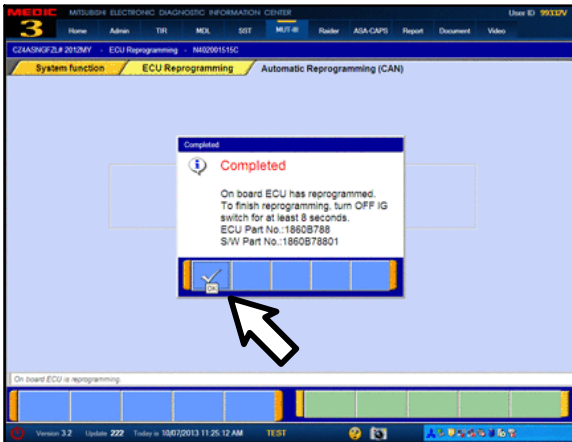
o. This message will display when ECM reprogramming is successfully completed. Confirm the “New S/W P/N” displayed matches the table at the beginning of this TSB. Then click the check mark to clear the message.

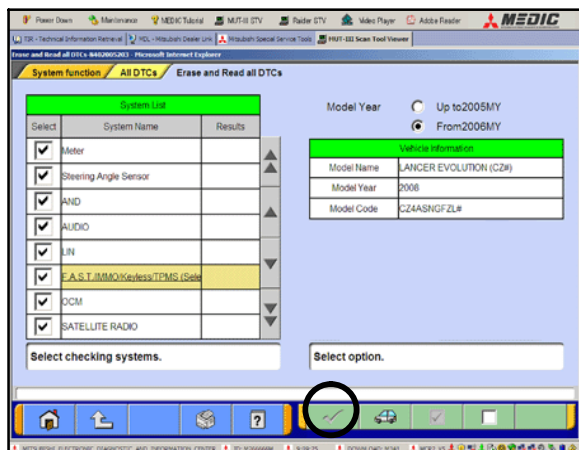
- c. The “System List” on the left side of the screen will have all selections checked. Do not change these selections. DTCs may be set if the vehicle is equipped with options that are unchecked.
- d. If the check mark at the bottom of the screen is highlighted, click it and proceed to step 4. If not, proceed to step e.

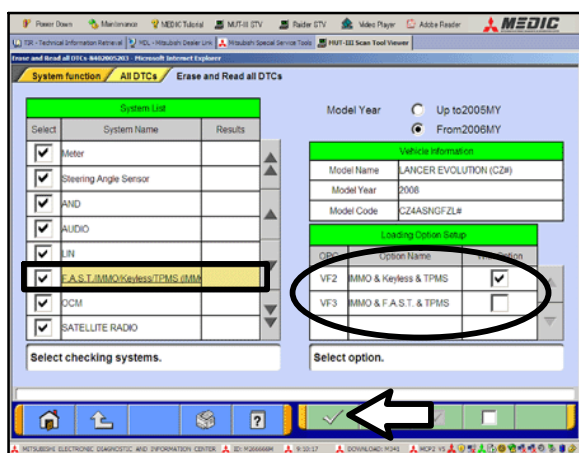
- e. In the left column, scroll to and click FAST/IMMOB/KEYLESS/TPMS. In the right column, check the correct option code (VF#) from the Loading Options Setup list. This will activate the check mark at the bottom of the page.
 - Vehicles with regular keyless entry (buttons on a multi-function key), select VF2.
 - Vehicles with F.A.S.T. Key, select VF3.
- f. In the left column, scroll to and select METER. A window will display. Check the correct display type for the vehicle.
