Topic	2012MY onwards Continental family and Flying Spur - Infotainment unit (RNS) – Replacement Process
Market area	Worldwide Bentley (1WBE)
Brand	Bentley
Transaction No.	2030765/2
Level	EH
Status	Approval
Release date

2012MY onwards Continental family and Flying Spur - Infotainment unit
(RNS) – Replacement Process

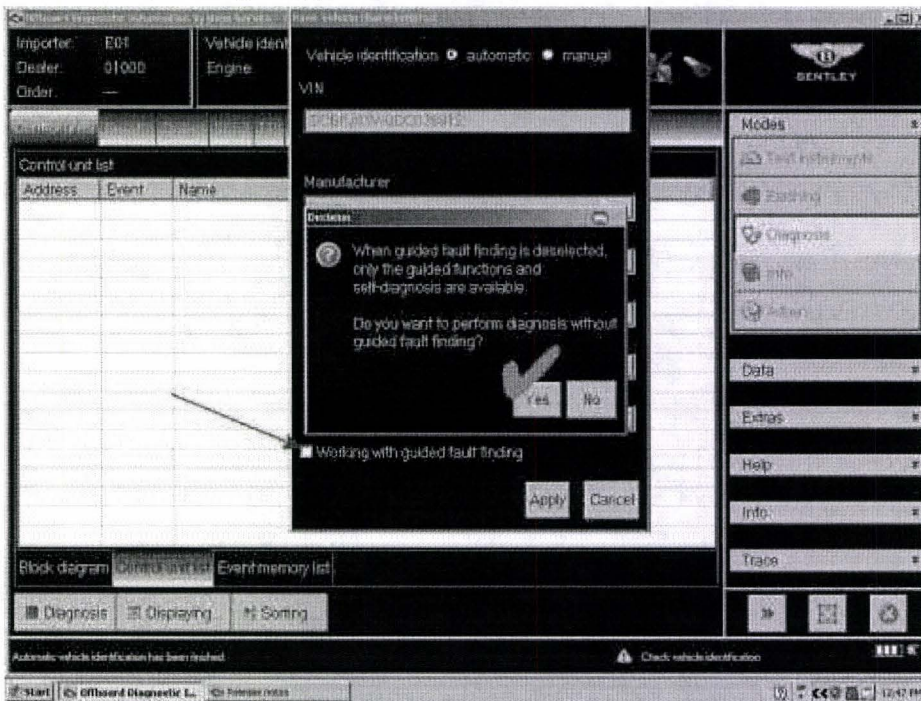
Figure 1

3. De select *Working with guided fault finding* (see Figure 1)

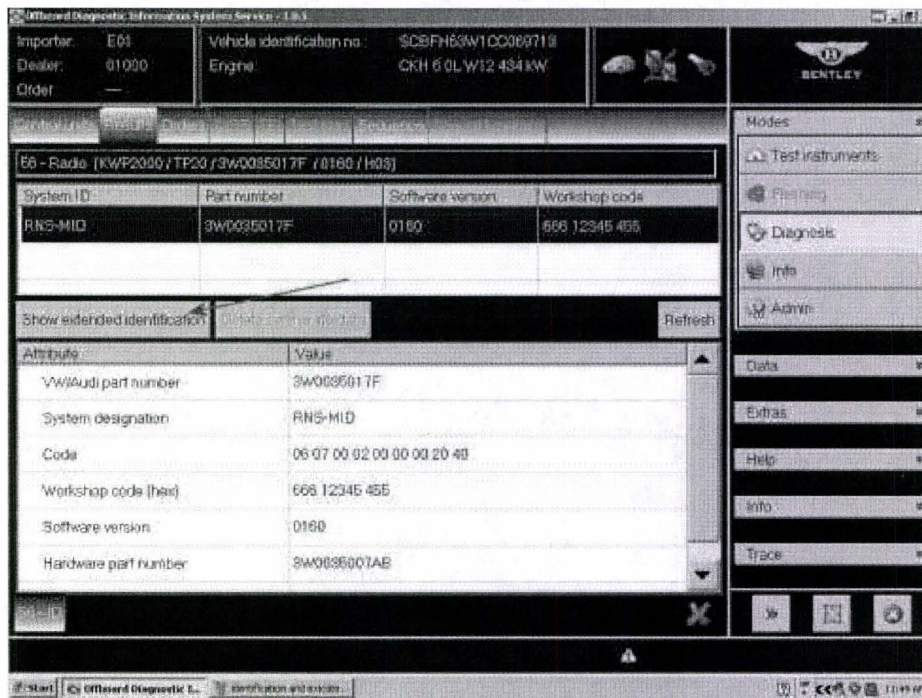
Figure 5

7. Select *Show extended identification* (see Figure 5)
