**HYUNDAI**NEW THINKING.
NEW POSSIBILITIES.**Technical Service Bulletin**

GROUP FUEL SYSTEM	MODEL ACCENT (RB)
DATE JUNE 2013	NUMBER 13-FL-005

SUBJECT	ECM UPDATE – MIL ON DTC P0456 / P0461 / P050A
----------------	--

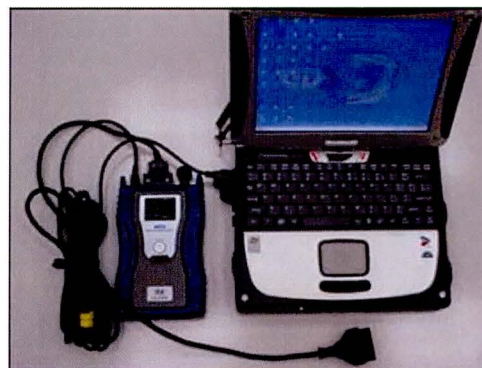
- Connect the USB cable between the GDS and the VCI.
- Connect the 16-pin DLC connector from the VCI into the DLC located under the driver's side dash.
