HYUNDAI | NEW THINKING.
NEW POSSIBILITIES.

Technical Service Bulletin

TUCSON (LM) ECM & TCM UPDATE (SERVICE CAMPAIGN TM9)

Description: This bulletin provides a procedure to update the ECM and TCM software for 2013 Tucson (LM) 2.4L vehicles to revise the shift feeling in ECO mode.

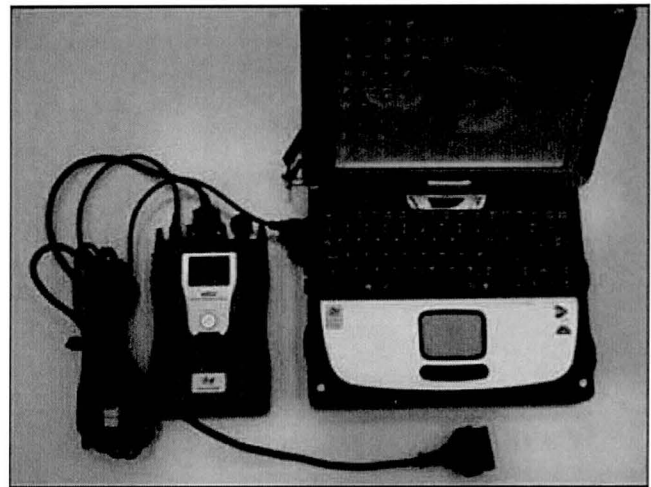
- Connect the USB cable between the GDS and the VCI.
- Connect the 16-pin DLC connector from the VCI into the DLC located under the driver's side dash.

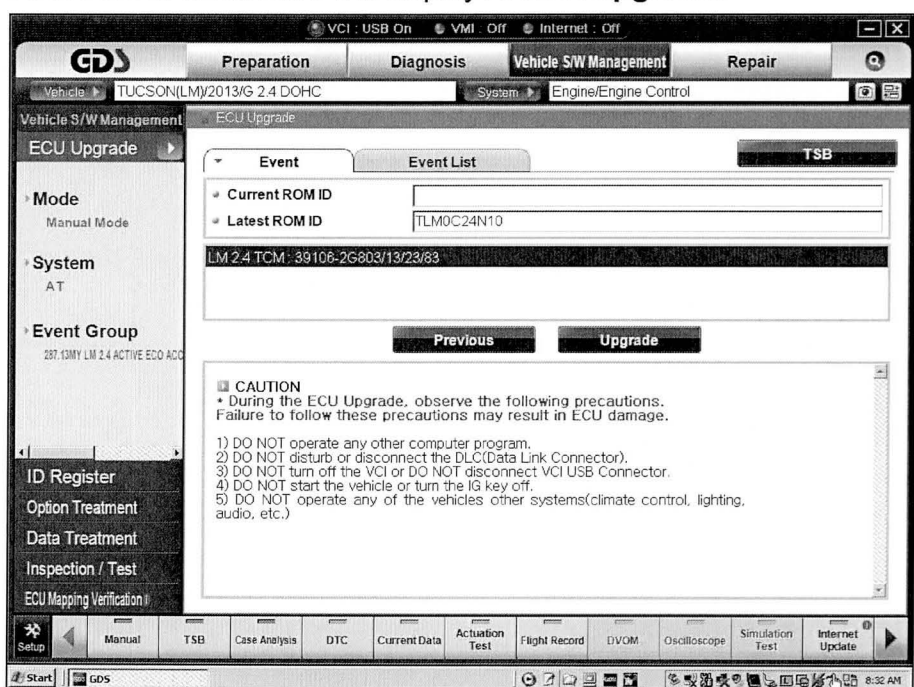
1. From the GDS home page, select **ECU Upgrade**. If necessary, select the VIN.
2. Select **AT** as the system and then select **OK**.
3. Select **Manual Mode** and then select **NEXT**.
4. From the **System** tab, select **AT** and then select **NEXT**.
5. Update event **287.13MYLM 2.4 ACTIVE ECO ACCELERATION LOGIC IMPROVEMENT - TCM** will display. Select **Next**.
6. **LM 2.4L TCM 39106-2G803/13/23/83** will display. Select **Upgrade**.

6. Enter the Password and click **OK**. The part number can be found on the PCM label.
