MODEL
2012-13MY Sorento (XM)
& 2012MY Sedona (VQ)

TECHNICAL SERVICE BULLETIN

SUBJECT: ECM UPGRADE - CYLINDER CONTRIBUTION / BALANCE

UPGRADE EVENT NAME
196. XMA 3.5 CYLINDER IMBALANCE DTC LOGIC IMPROVEMENT
197. VQ 3.5 CYLINDER IMBALANCE DTC LOGIC IMPROVEMENT

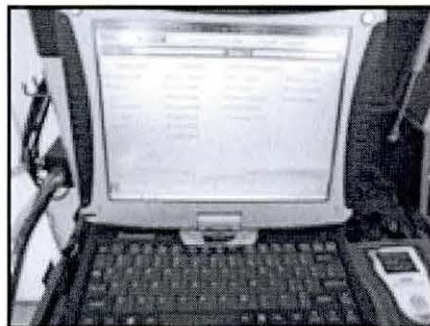
Global Diagnostic System (GDS)

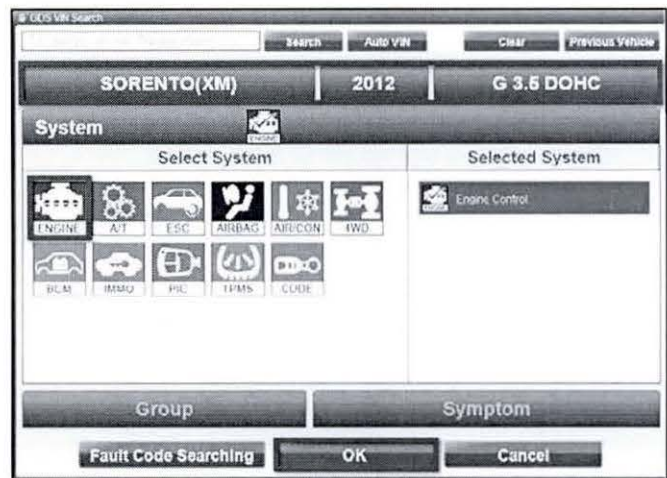
5. With the ignition key **ON**, turn on the VCI and GDS tool. Access the GDS vehicle identification number (VIN) screen and configure the vehicle using the VIN Auto Detect function.

Note: Screen image to the right is for demonstration purpose only.

6. Once back at the GDS Main Screen, select **ECU Upgrade** from the bottom right-hand corner. Next select **Auto Mode**, and then **Engine**. Perform the ECM upgrade in accordance with normal GDS tool ECM upgrade procedures.
