MODEL
2010-2011MY
Soul (AM) 1.6L

TECHNICAL SERVICE BULLETIN

SUBJECT: ECM UPGRADE – KNOCK IMPROVEMENT DTC P0328

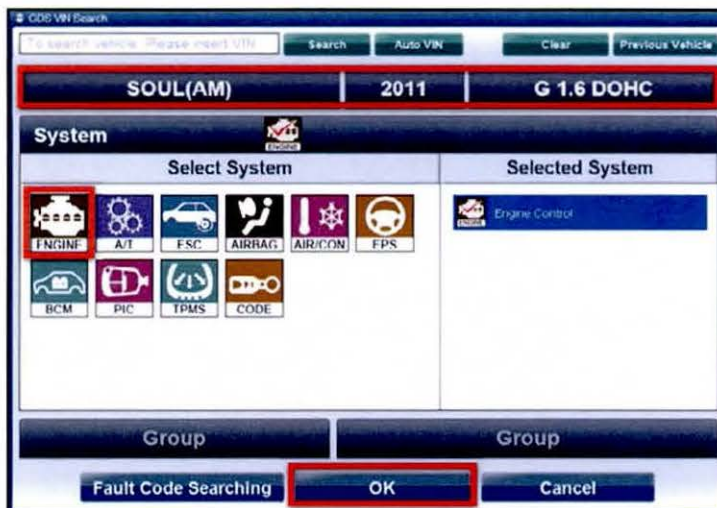
5. With the ignition key ON, turn ON the VCI and GDS tool. Access the GDS vehicle identification number (VIN) screen and configure the vehicle using the VIN Auto Detect function.
6. Select **ENGINE** system and click **OK**.

NOTE: Display screen to the right is for demonstrative purposes only and will vary depending on model.

7. Once back at the GDS Main Screen, select ECU Upgrade from the bottom right-hand corner. Next select Auto Mode, and then Engine. Perform the ECM upgrade in accordance with normal GDS tool ECM upgrade procedures.
