Subject: MAZDA SERVICE PROGRAM (MSP41) - MAZDA CONNECT INFOTAINMENT SYSTEM UPDATE	Bulletin No: 09-034/13
	Last Issued: 11/25/2013

2014 Mazda3 vehicles (with MAZDA CONNECT Infotainment System) after June 11, 2013

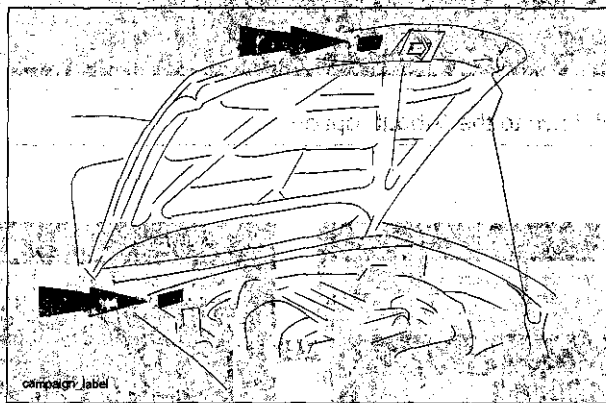
2. Perform a Warranty Vehicle Inquiry using your eMDCS System and inspect the vehicle for a Campaign Label **MSP41** attached either to the vehicle's bulkhead or to the vehicle's hood. Refer to eMDCS System - Warranty Vehicle Inquiry Results table below.

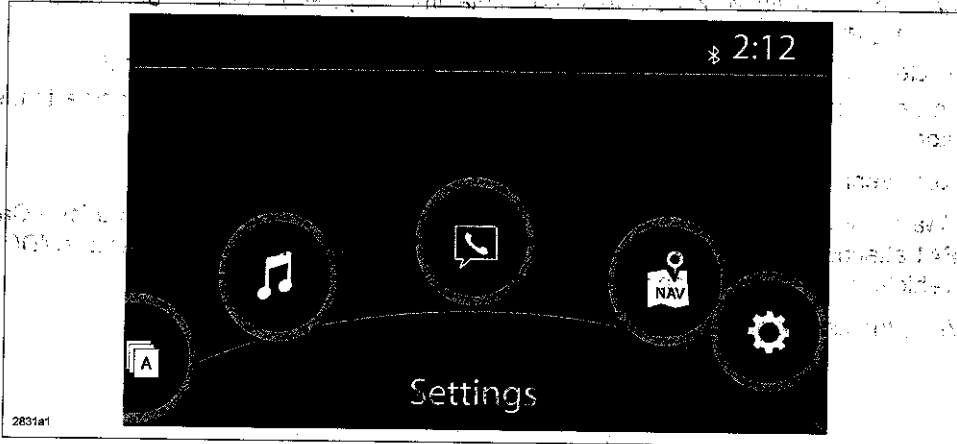
1. Select "Settings" from the Home screen to check the software version.

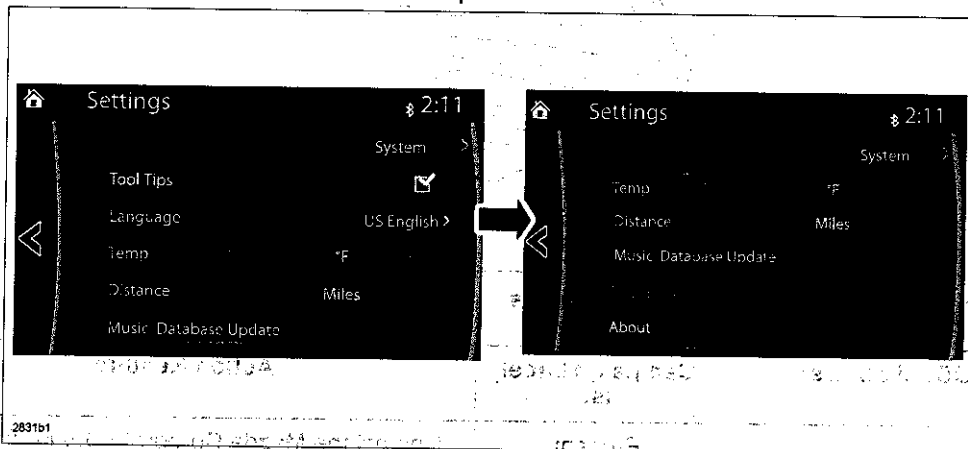
2. Select "System" and scroll down to the "About" option.

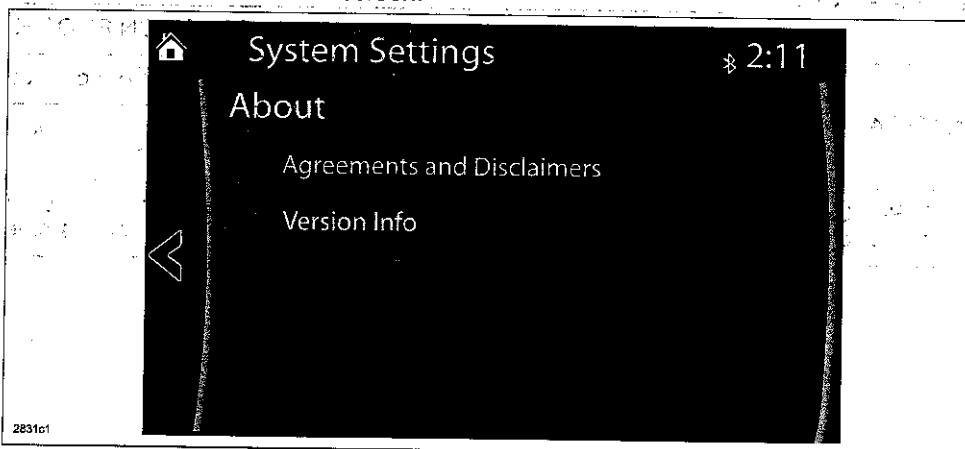
3. Select "Version Info" from the "About" screen.

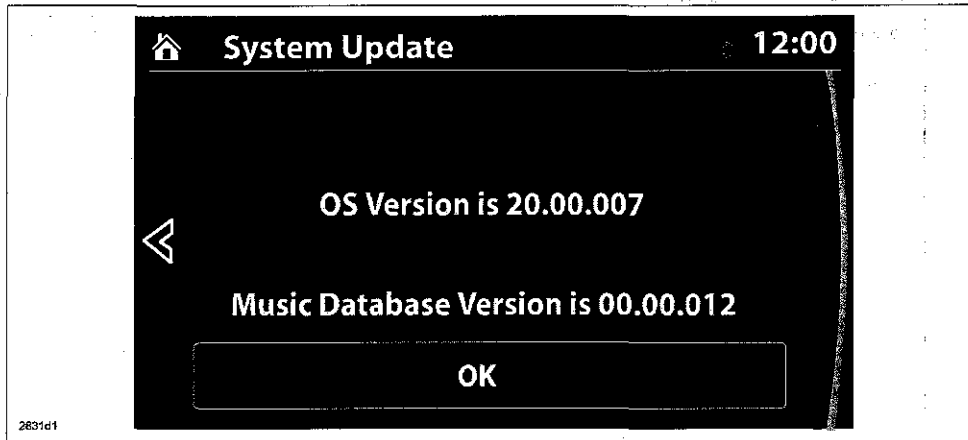
4. Make sure the software version is 25.00.400B or later, then select OK. If it is not 25.00.400B or later, update the system using a USB memory stick with the latest software according to the "Reflash Procedure." If needed, refer to "Downloading Update Software to a USB Memory Stick (for additional USB memory sticks)" below.

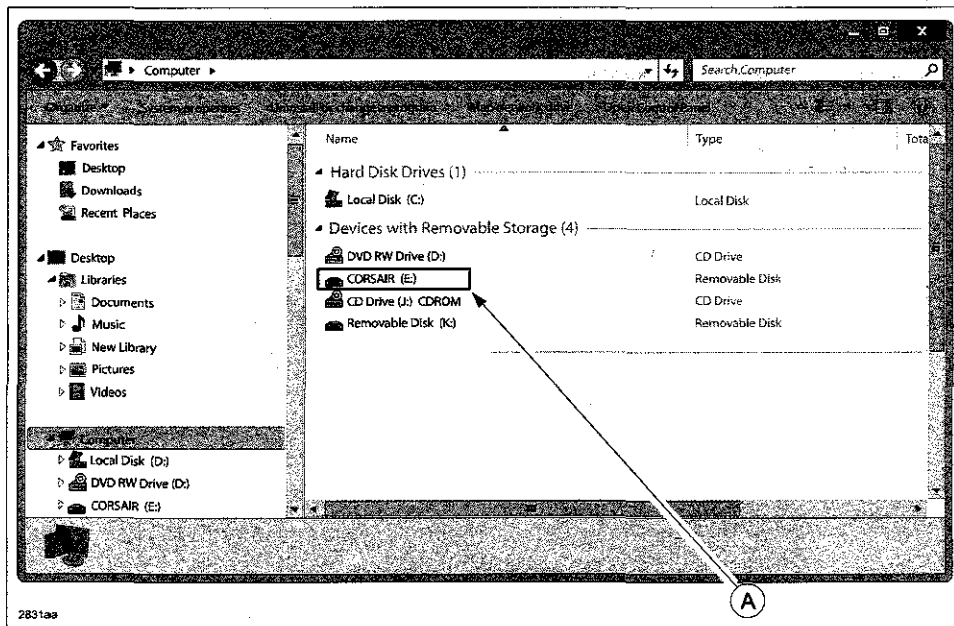
2. Go to "Start" and select "Computer," then double-click on the memory stick "removable disk" (A).

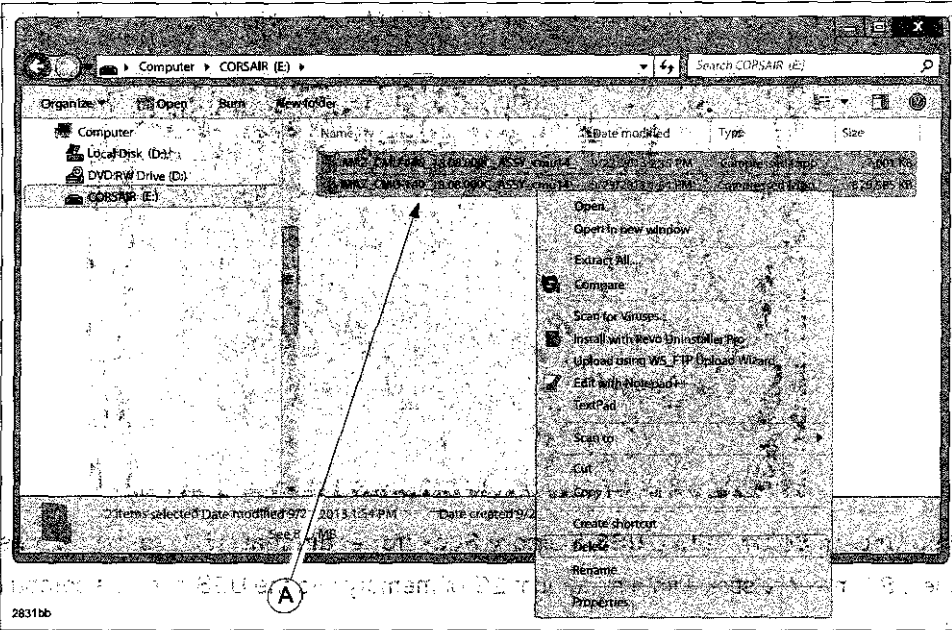
3. Delete any existing files (A).

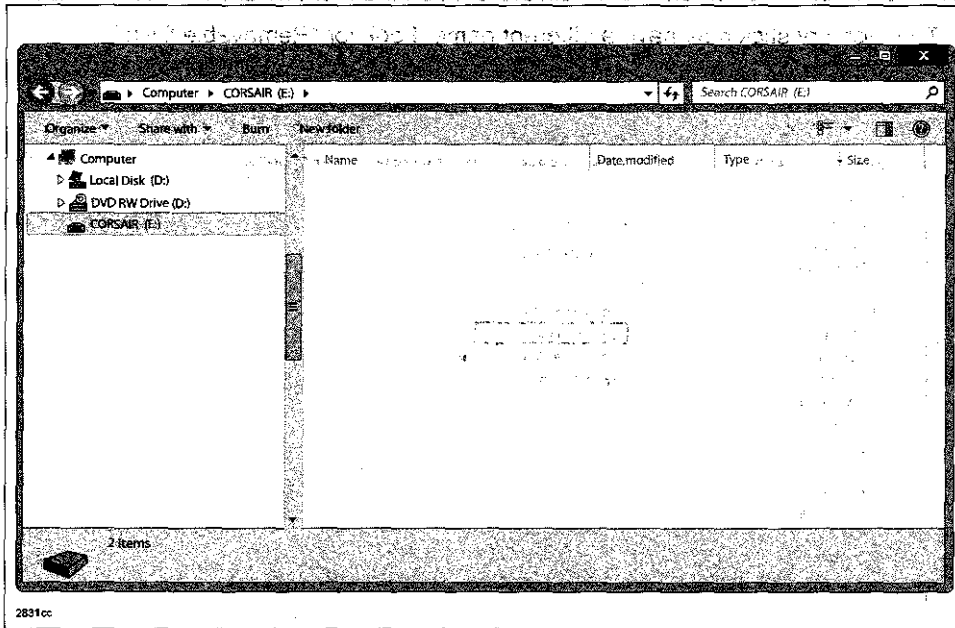
4. Confirm that no files are left on the memory stick.

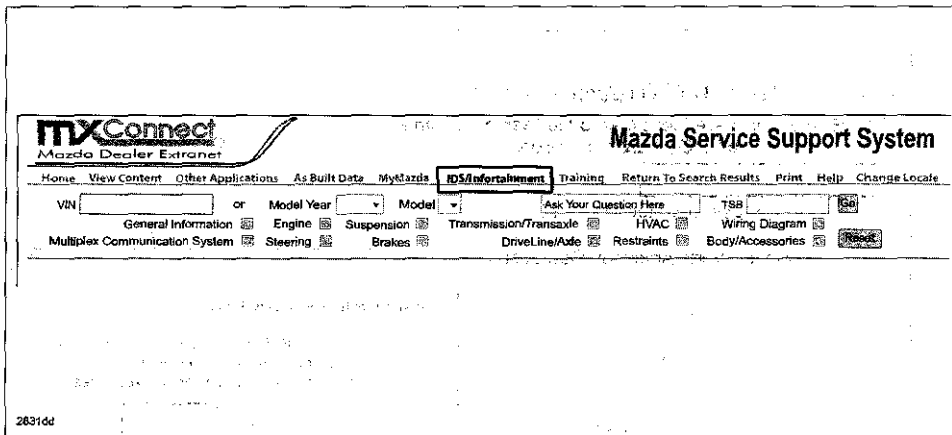
5. Log on to MS3 and select "IDS/Infotainment."

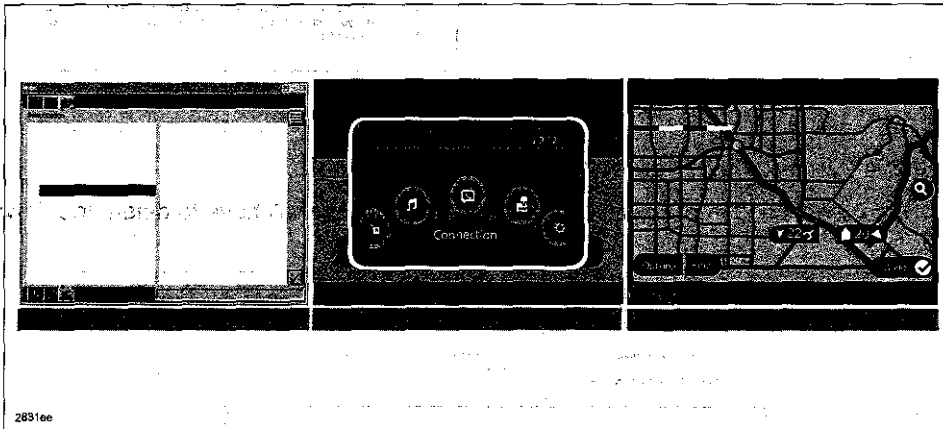
6. Select "Mazda Connect Updates."

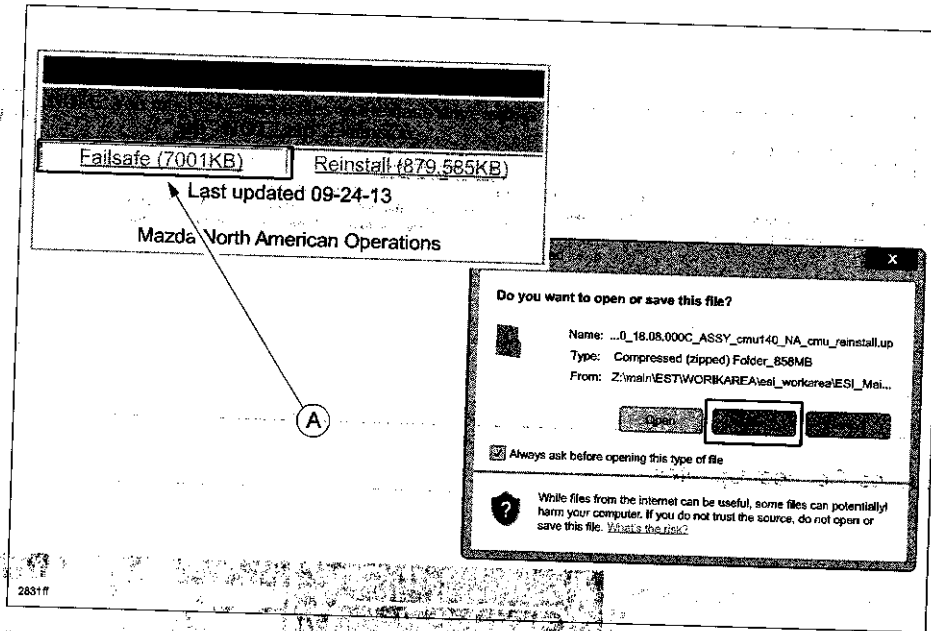
7. Select the FailSafe file (A) and "Save."

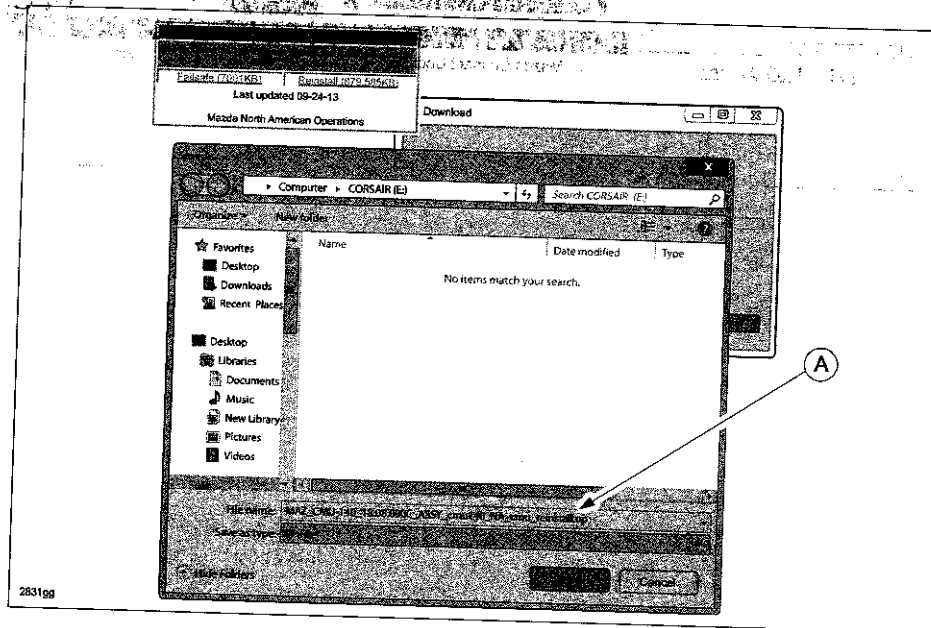
8. Change the file extension from ".zip" to ".up" (A)

NOTE: If you do not save the file with a ".up" file extension, you will have to delete the download and start again.

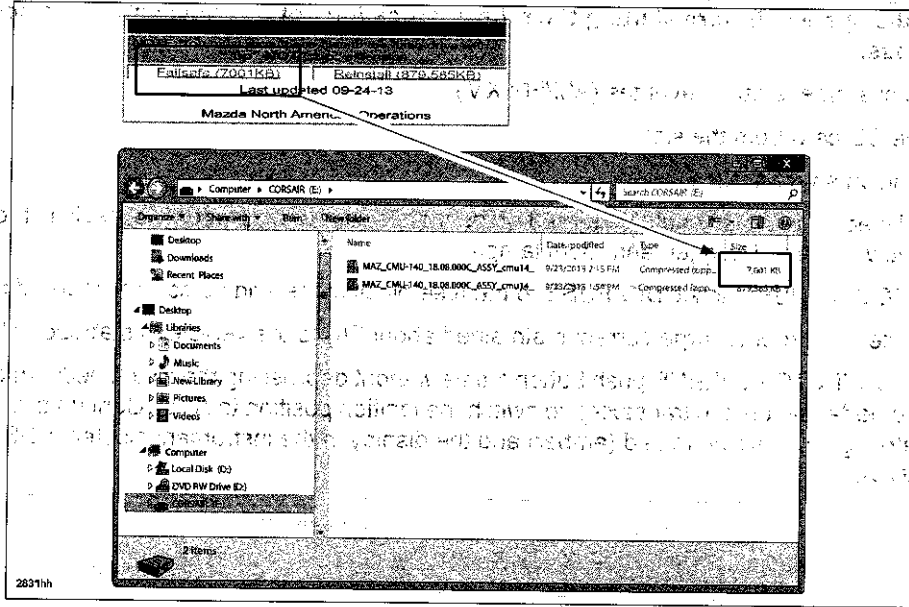
11. After completing the downloads, compare the size of the files to the ones on the download page.
- If the size is the same, proceed to the reflash procedure.
 - If the size is not the same, delete the files on the memory stick and start over.

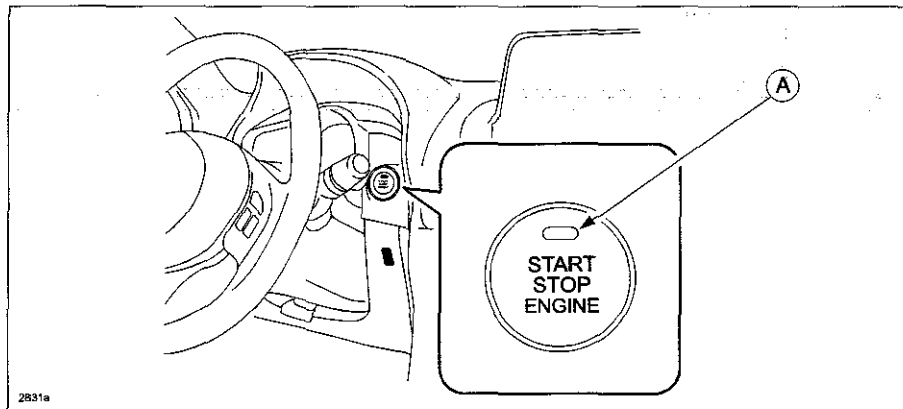
4. Install the ROOM FUSE and AUDIO FUSE to the fuse block in the engine compartment (if not installed).
5. Connect battery charger (charge current maintained about 7A) to the vehicle to stabilize voltage fluctuation.
6. Press the START/STOP ENGINE push button 1 time without depressing the clutch pedal (manual transaxle) or the brake pedal (automatic transaxle), to switch the ignition position to ACC. Confirm that the push button start indicator light (A) is illuminated (amber) and the display in the instrument cluster is OFF (ignition position is in ACC).

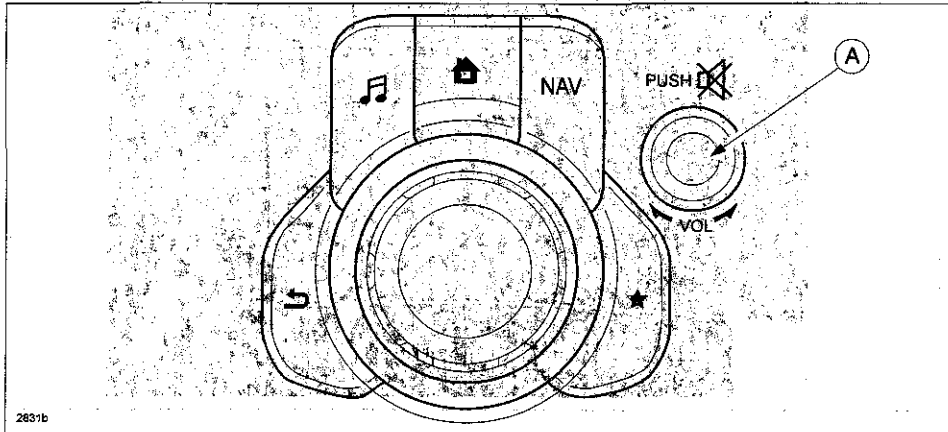
7. Verify that there is a sound coming from the speakers. If sound cannot be heard, turn the volume dial (A) to turn the volume up, or make sure that MUTE is not on.

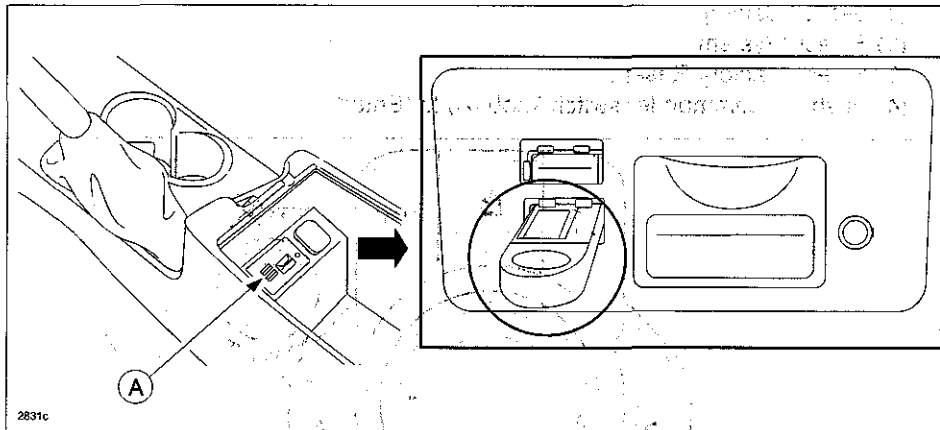
8. Connect the prepared USB memory stick to the either one of the two USB port (A).

NOTE: There should only be the prepared USB memory stick inserted in one of the USB ports. Nothing should be inserted in the other USB port during the re-flashing process.

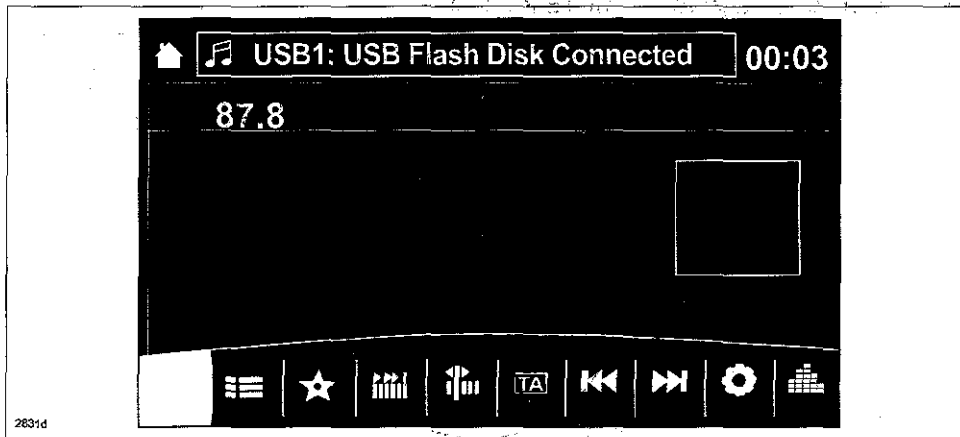
9. When the USB memory stick is recognized, the following message will appear briefly on the screen.

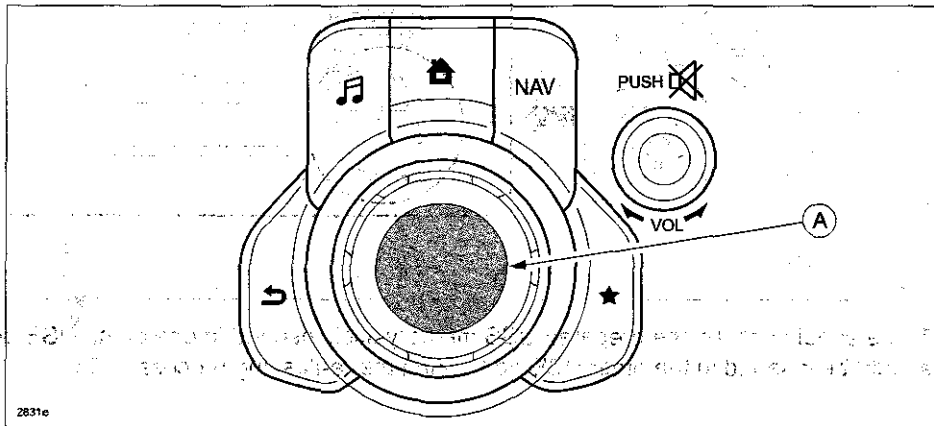
- It takes approx. 5 seconds before the USB memory stick is recognized.
- If the USB memory stick is not recognized, perform the following:
 - (1) Select "Setting".
 - (2) Select "System".
 - (3) Select "Factory Reset".
 - (4) Push the commander switch knob (A) to "Enter".

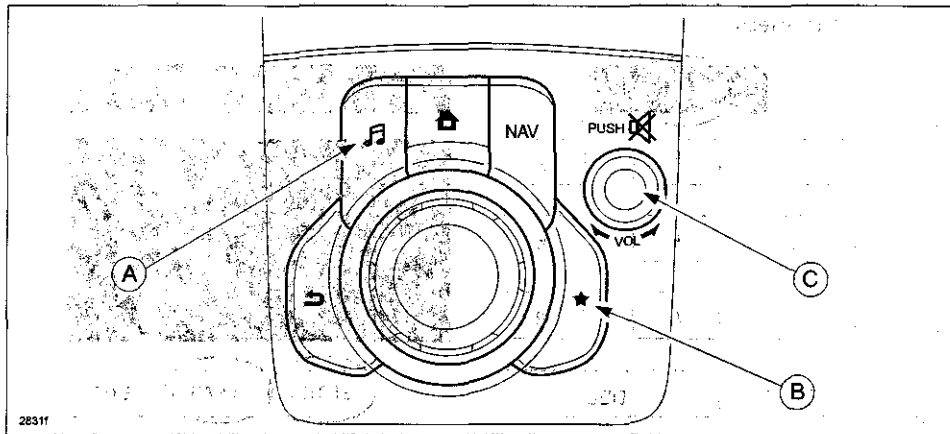
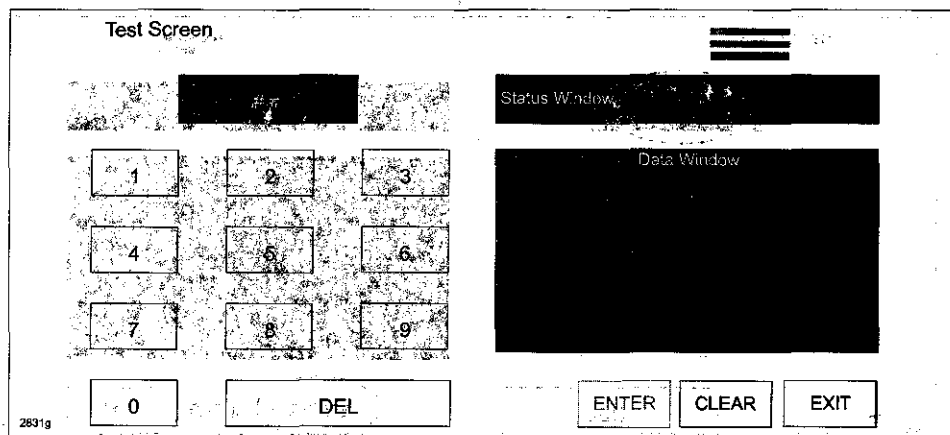
10. Press the three buttons (Music (A) + Favorites (B) + Volume Mute(C)) on the commander switch at the same time for 2-5 seconds and the Diagnostic Test Screen will appear.

19. Press the three buttons (Music (A) + Favorites (B) + Volume Mute(C)) on the commander switch at the same time for 2-5 seconds to open the Diagnostics Test screen again.

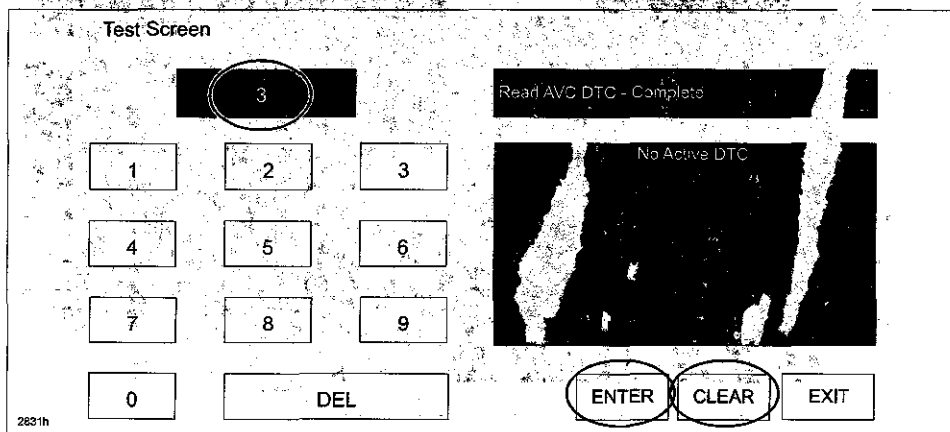
11. On the test screen, input '3' and then select "ENTER" to verify whether any DTCs (in the CMU) are active. Select "CLEAR" to go to next step.

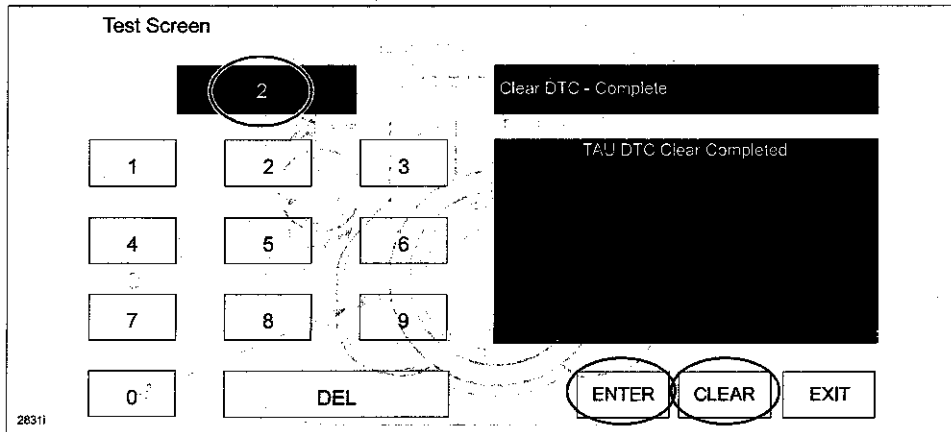
12. If any DTCs are present, input '2' on the test screen and then select "ENTER". This will internally clear all the earlier set DTCs (in the CMU). Select "CLEAR" to go to next step.

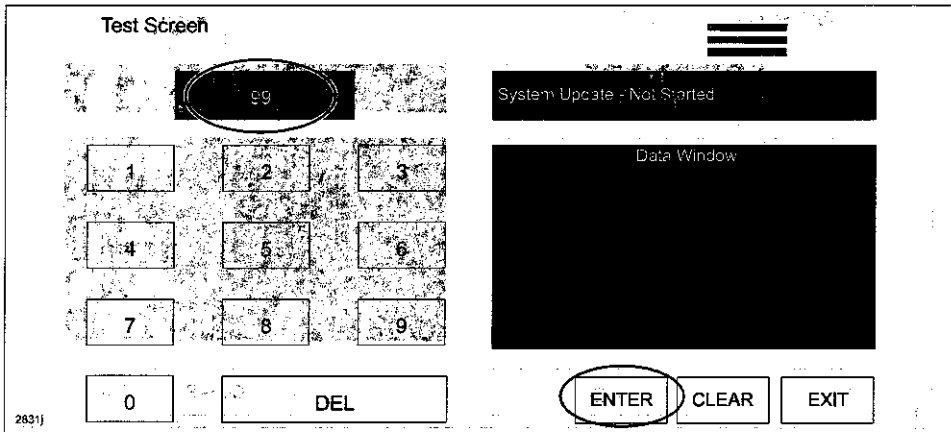
13. Use the touchscreen or the commander switch to input '99' and then select "ENTER" on the Test screen.

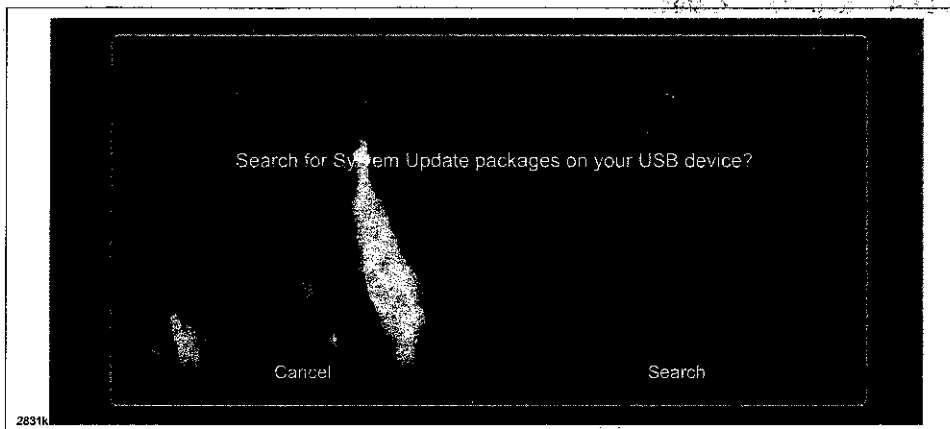
14. Select "Search" on the screen below.

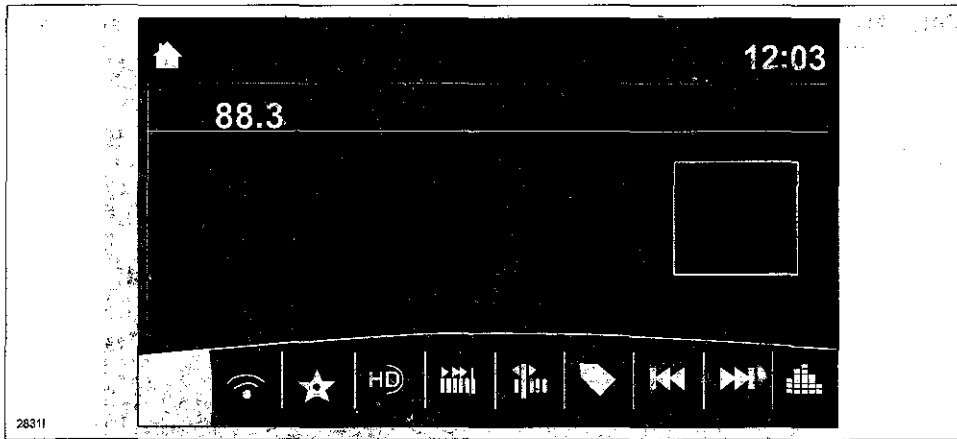
NOTE: If the following screen is displayed, perform the following.

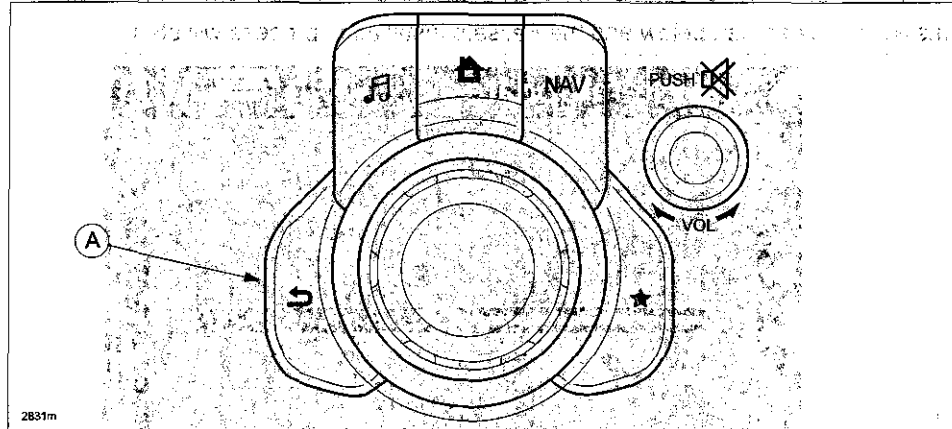
(1) Press the "Return" button (A) on the commander switch.

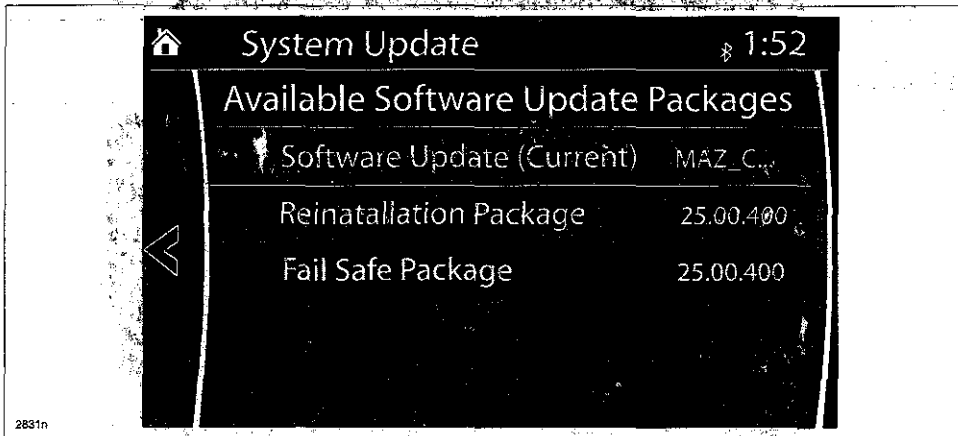
(2) Verify that the screen changes back to the screen below.

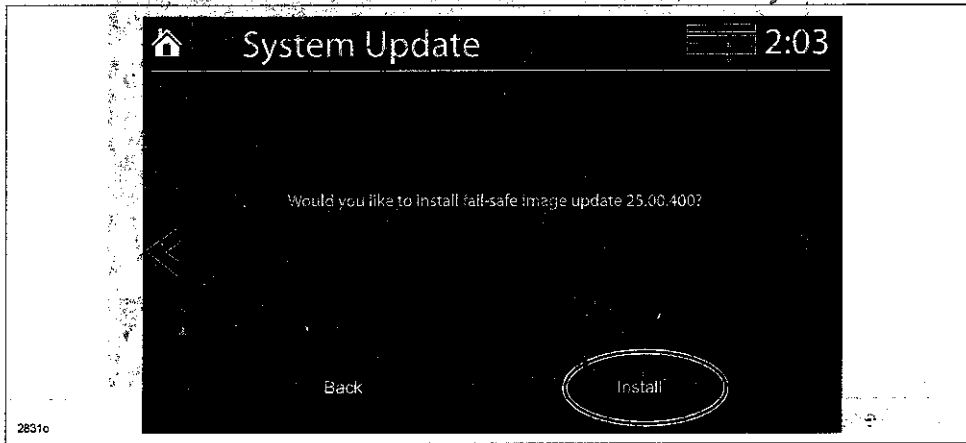
15. Select "Fail Safe Package" first using the touch screen:

CAUTION: Always do the "Fail Safe Package" first, followed by "Reinstallation Package".

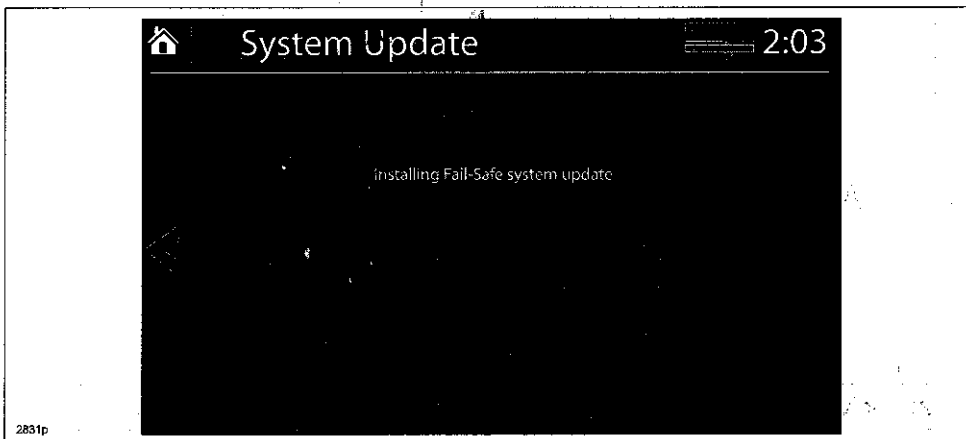
16. Select "Install" on the screen below and the Failsafe installation process will start.

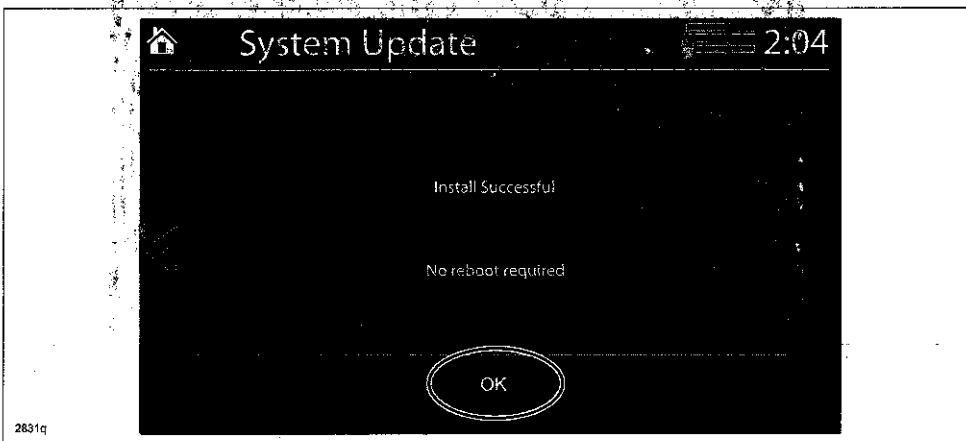
17. After the Failsafe installation process is completed, select "OK".

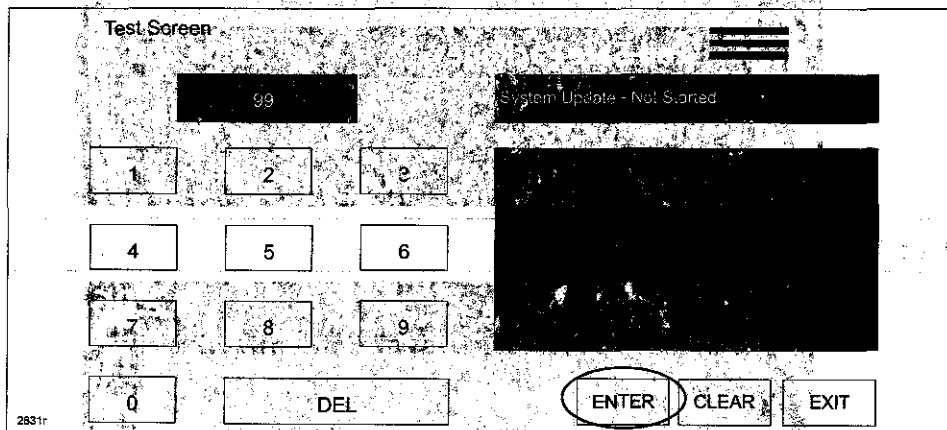
20. Use the touchscreen of the commander switch to input '99' and then select "ENTER" on the Test screen.

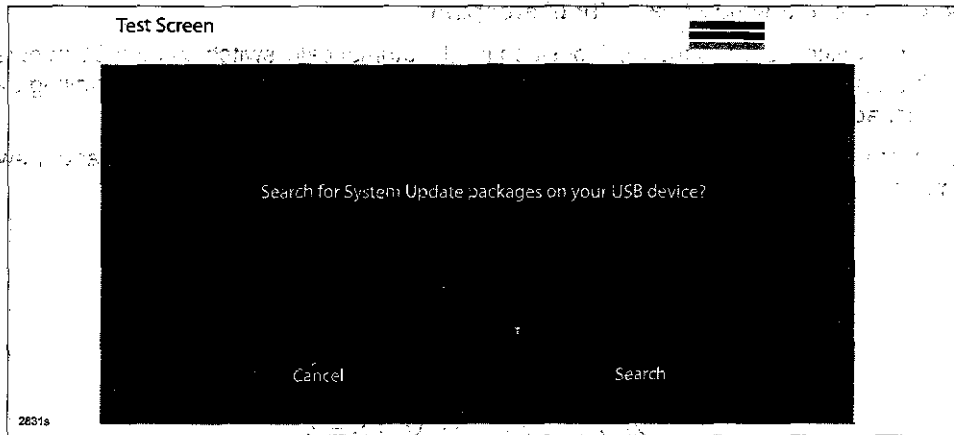
21. Select "Search" on the screen below.

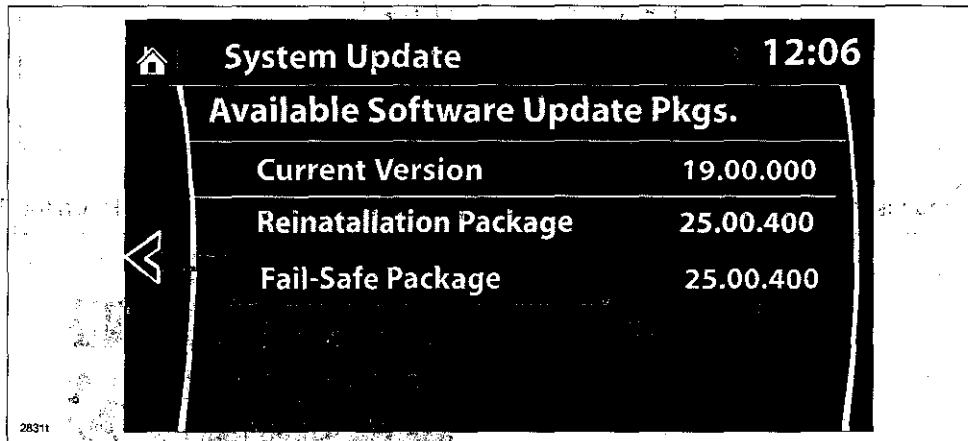
22. Select "Reinstallation Package" on the screen below.

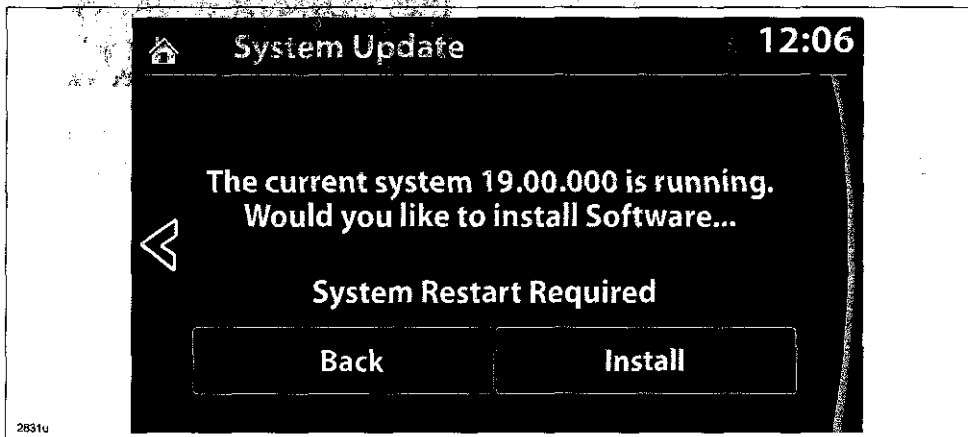
23. Select "Install" on the screen below.

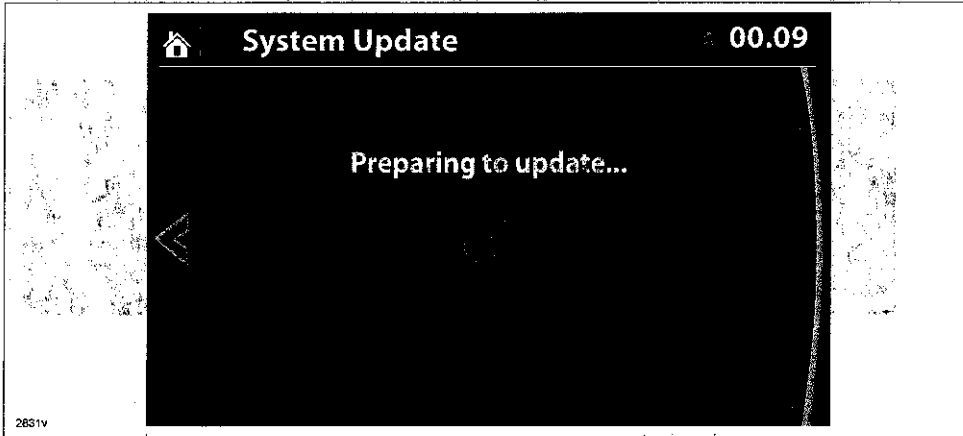
24. The screen below will be displayed.

NOTE: A blank screen is displayed momentarily. It will take approx. 2 minutes before the reflashing process moves to the next screen.

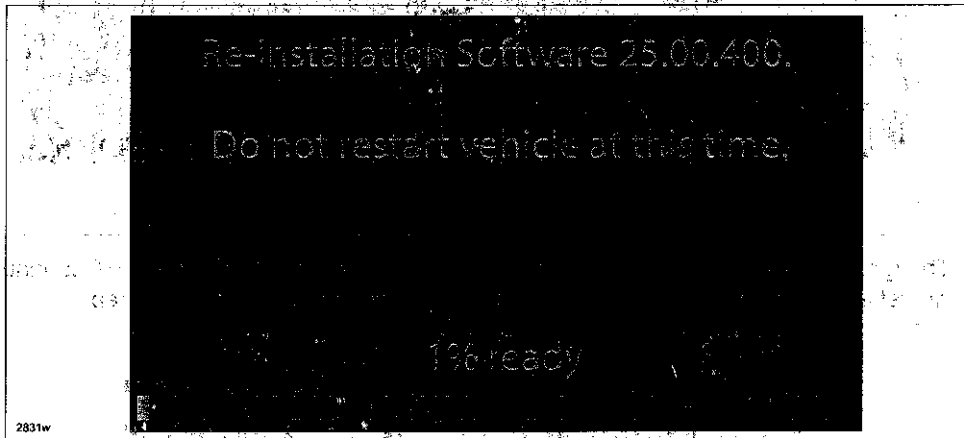
25. Reinstallation will start from 0% and as the reflashing process takes place, the progress bar will gradually increase to 100%.

NOTE: It may be difficult to read the display at times as it becomes dark, but "Do not restart vehicle at this time" is displayed.

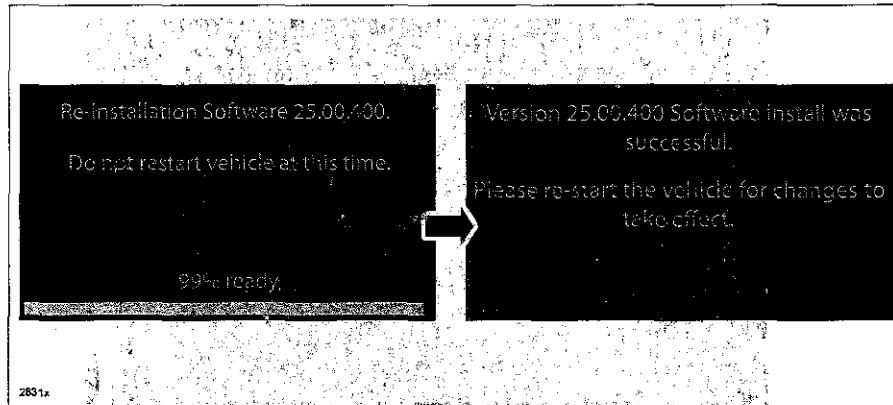
NOTE: It will take some time for the reflashing process to get from 98.% to 100%.

26. After the update is completed with the above right screen, confirm that the push button start indicator light is illuminated (amber) and the display in the instrument cluster is OFF (ignition is "ACC"). If the ignition is "OFF" and the push button start indicator light is not illuminated (amber), turn the ignition to "ACC" and one of the following two screens will be displayed.

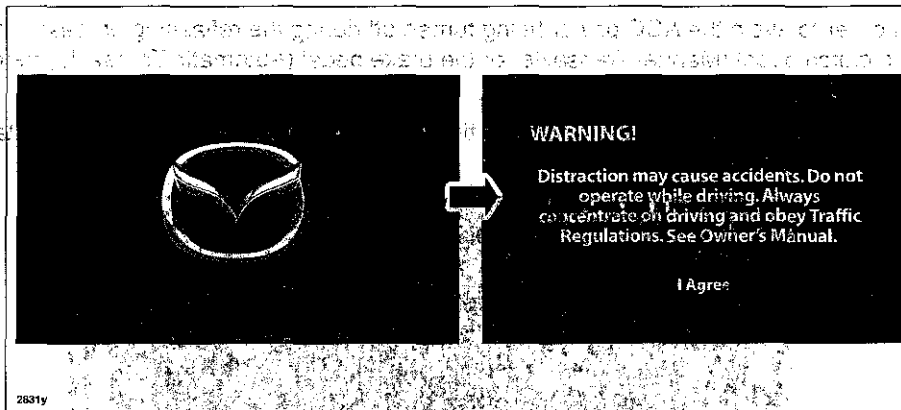
Type A: Reprogramming has already been completed. Go to next step.

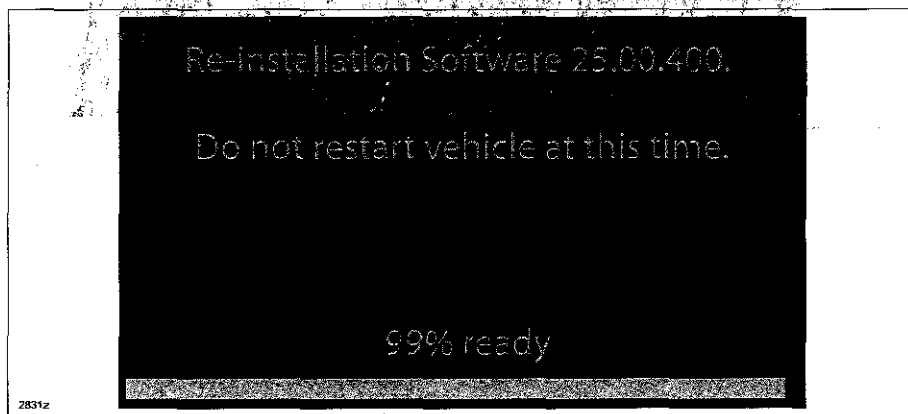
Type B: The ignition was turned "OFF" during the reflashing process. This screen will continue to be displayed until reflashing is completed. After the reflashing is completed, go to next step.
