**HYUNDAI**NEW THINKING.  
NEW POSSIBILITIES.**Technical Service Bulletin**

GROUP <b>CAMPAIGN</b>	NUMBER 13-01-040
DATE OCTOBER 2013	MODEL GENESIS SEDAN (BH)

**SUBJECT: GENESIS SEDAN (BH) 4.6L ECM UPDATE – (SERVICE CAMPAIGN TQ6)**

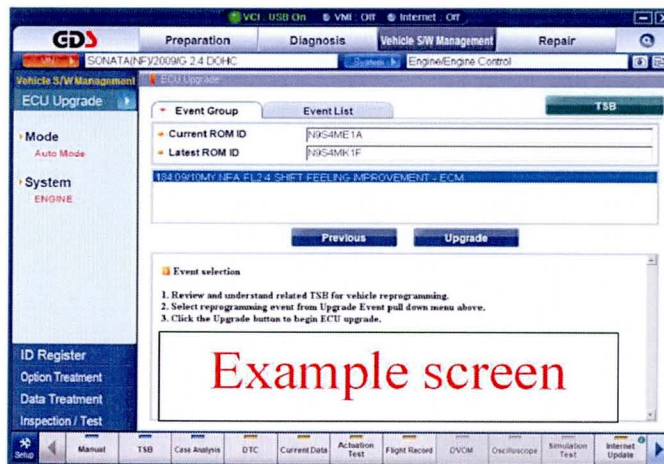
5. Select update event as listed on the **GDS Event list of page-1**. Select **Upgrade**.

6. If the screen indicates “**Voltage is OK**” (voltage > 12volts), select **OK**. If not, select **CANCEL** and charge the vehicle battery by running the engine for 10 minutes.
7. Updating will occur until 100% is reached on the bar graph. At the prompt, turn the ignition key OFF for 10 seconds, then turn it ON and select **OK**.
8. The GDS will confirm that ECM reprogramming is successfully finished. Select **OK**.
9. If the ECM update was not successful, go to **GDS MANUAL MODE ECM UPDATE**
