HYUNDAI NEW THINKING. NEW POSSIBILITIES. Technical Service Bulletin	GROUP FUEL SYSTEM	MODEL GENESIS SEDAN (BH)
	DATE OCTOBER 2013	NUMBER 13-FL-009
SUBJECT ECM UPDATE – MIL ON DTC P0456

This bulletin provides information for an ECM diagnostic code logic update on some Genesis Sedan 4.6L vehicles that may experience the following DTC:

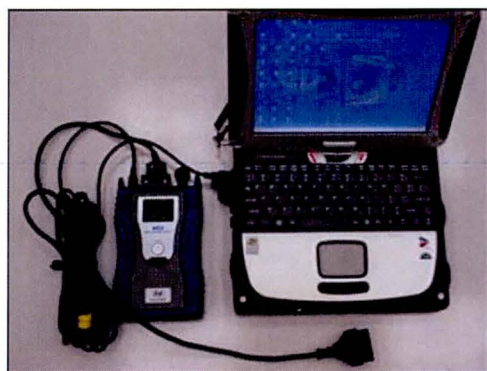
- Connect the USB cable between the GDS and the VCI.
- Connect the 16-pin DLC connector from the VCI into the DLC located under the driver's side dash.

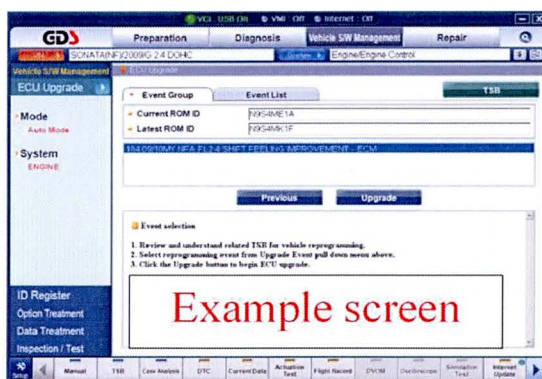
5. Select update event as listed on the **GDS Event list of page-1**. Select **Upgrade**.
