**HYUNDAI**NEW THINKING.
NEW POSSIBILITIES.**Technical Service Bulletin**

13-01-007

SANTA FE (AN)**SUBJECT: CLUSTER SOFTWARE UPDATE (SERVICE CAMPAIGN TN6)****This TSB supersedes TSB 12-01-049 to include Retail Vehicles.***** IMPORTANT******* Dealer Stock and Retail Vehicles *****

HYUNDAI
Global Diagnostic System**ECU Update****Description:** This bulletin provides the service procedure to update the instrument cluster software.**Applicable Vehicles:** 2013 MY SANTA FE (AN) vehicles produced from SOP to December 4, 2012.**GDS Information:**

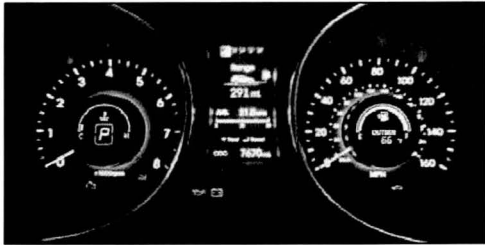
Model	Type	Cluster P/N	ROM ID	
			Previous	New
SANTA FE w/ Super Vision Cluster

94011-4Z000 94011-4Z010 94011-4Z020	-	B0 AD
SANTA FE w/ Conventional Cluster

Verify the ECM ROM ID before updating the vehicle's software. Refer to the table below.

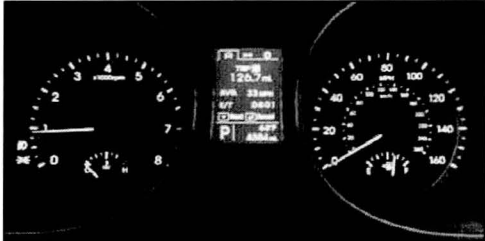
94001-4Z000 94001-4Z010 94001-4Z020	-	78 A2

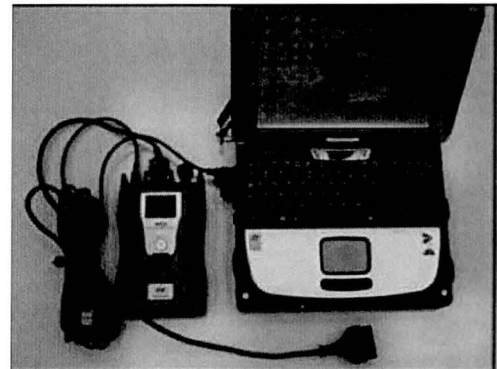
- Connect the USB cable between the GDS and the VCI.
- Connect the 16-pin DLC connector from the VCI into the DLC located under the driver's side dash.

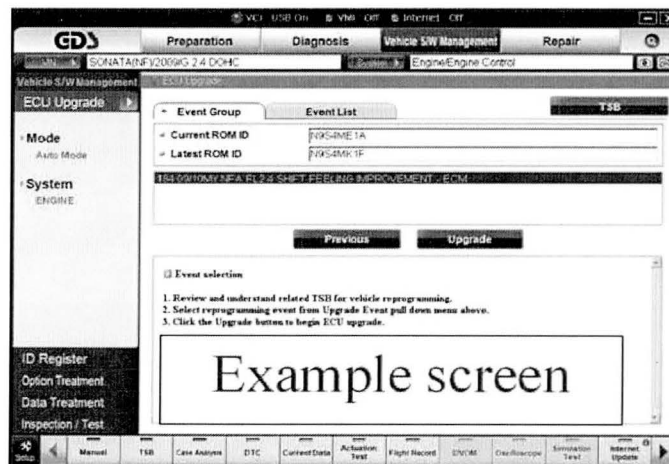
5. Select update event as listed on the **GDS Event list of page-1**. Select **Upgrade**.

6. If the screen indicates "**Voltage is OK**" (voltage > 12volts), select **OK**. If not, select **CANCEL** and charge the vehicle battery by running the engine for 10 minutes.
7. Updating will continue until 100% is reached on the bar graph. At the prompt, turn the ignition OFF for 10 seconds, then turn it ON and select **OK**.
