Techstream ECU Flash Reprogramming Procedure

Service Category Engine/Hybrid System

Section Engine Control

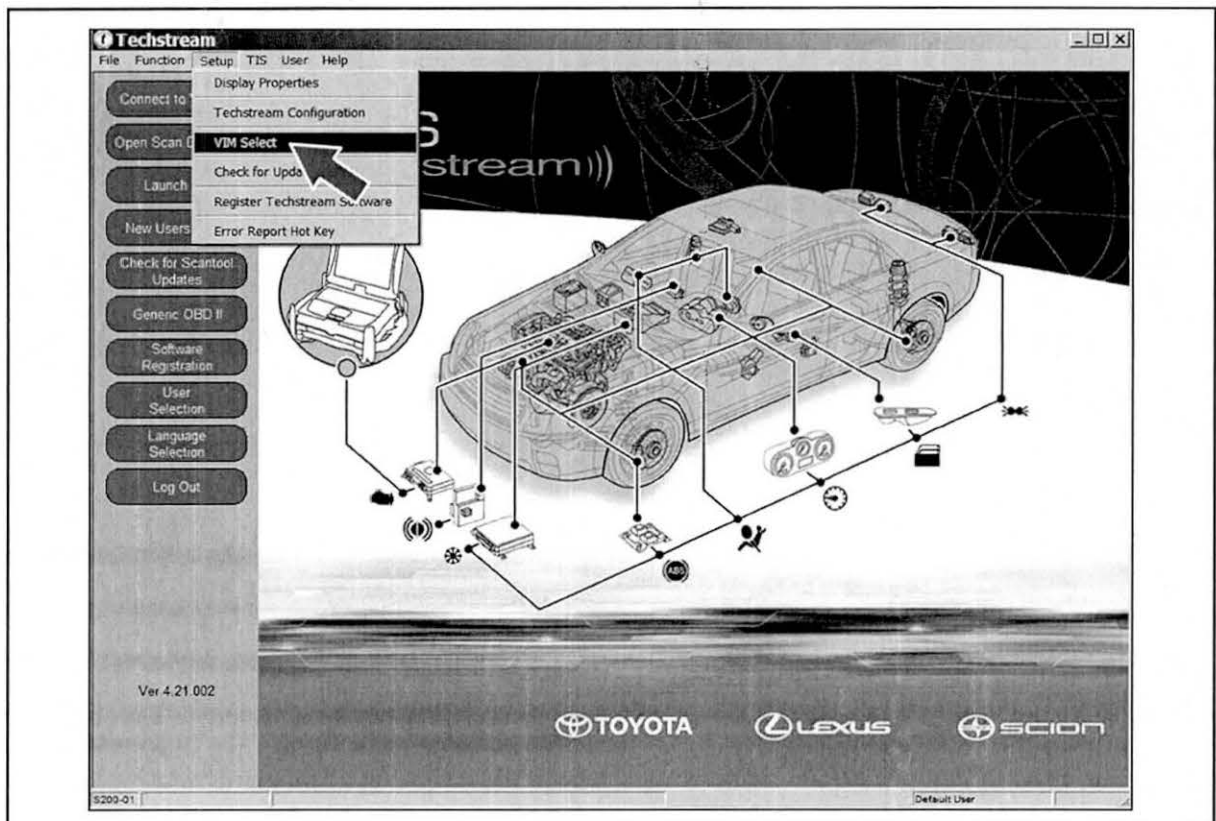
Figure 1.

1. Select "Setup" from the Techstream Main Menu screen.
2. Select "VIM Select" from the Setup drop down menu.

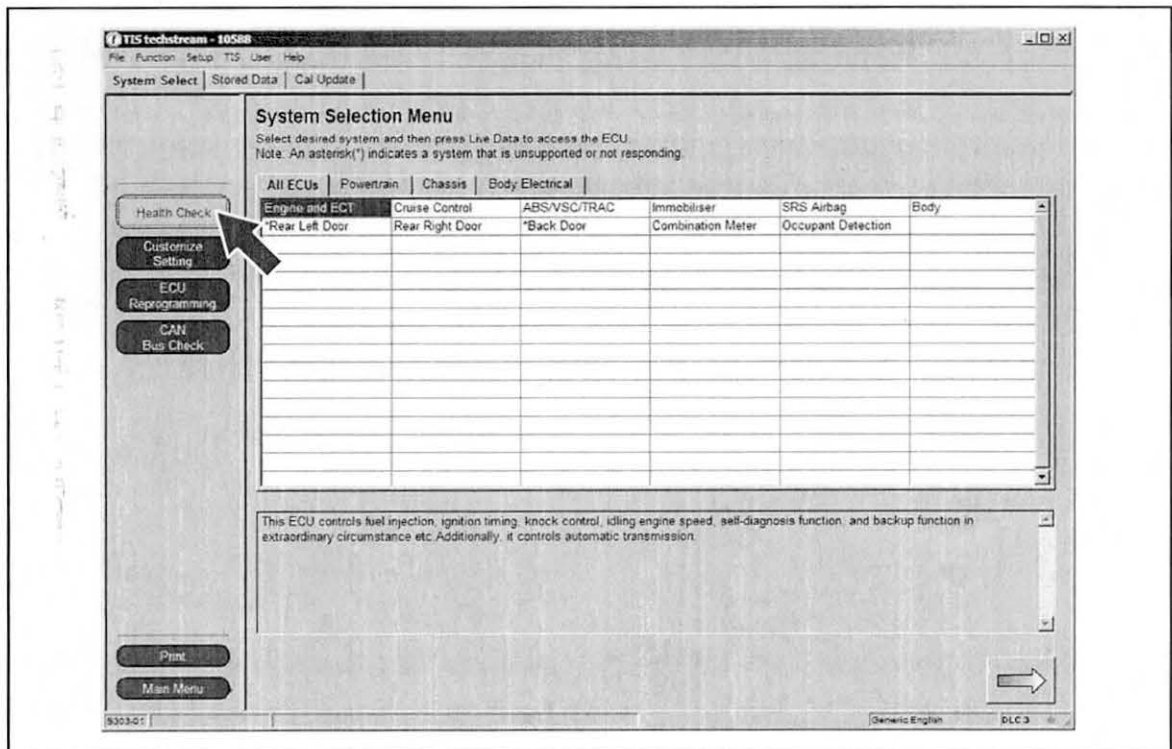
Figure 2.

1. Verify the vehicle's applicability for recalibration and locate desired calibration file.
 - A. Connect Techstream and establish a vehicle connection.
 - B. Click the "Health Check" button on the "System Select" tab.

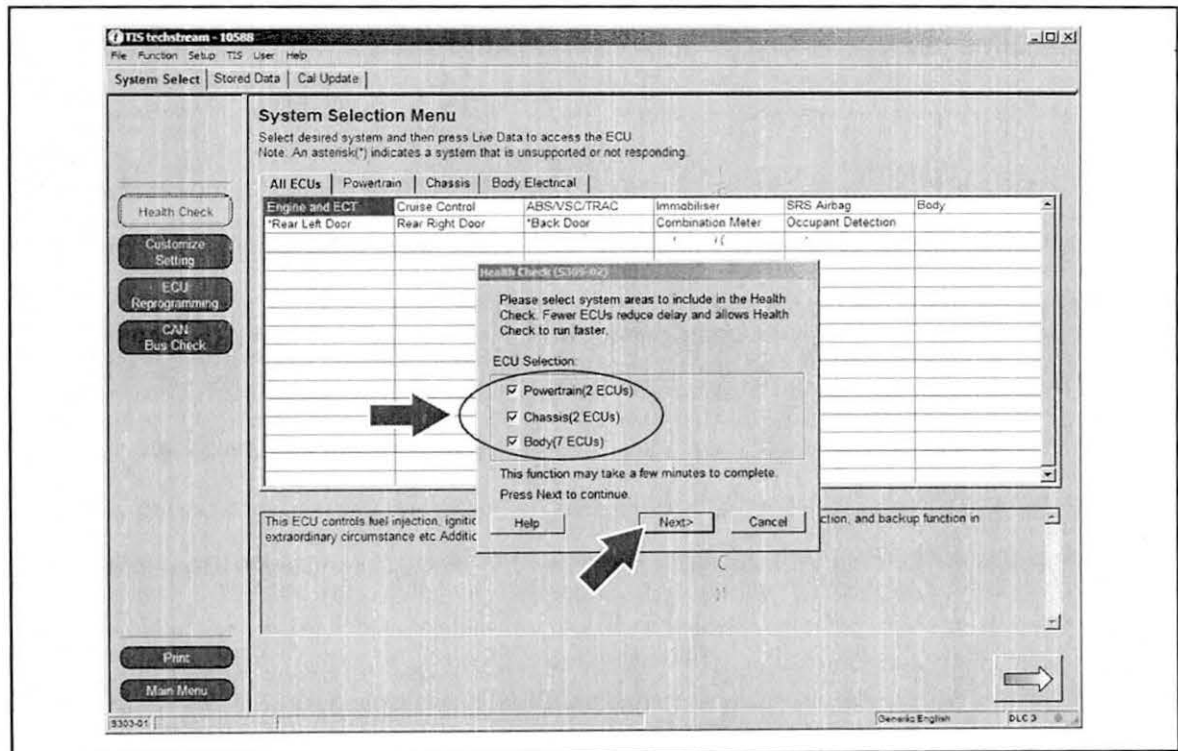
Figure 3.

C. Choose desired ECU group(s) in the "Health Check" dialog box.

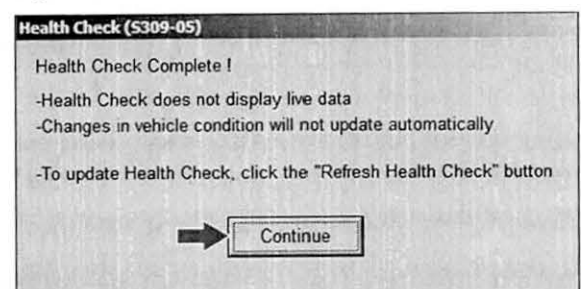
Figure 4.

E. Click "Continue" to view Health Check results.

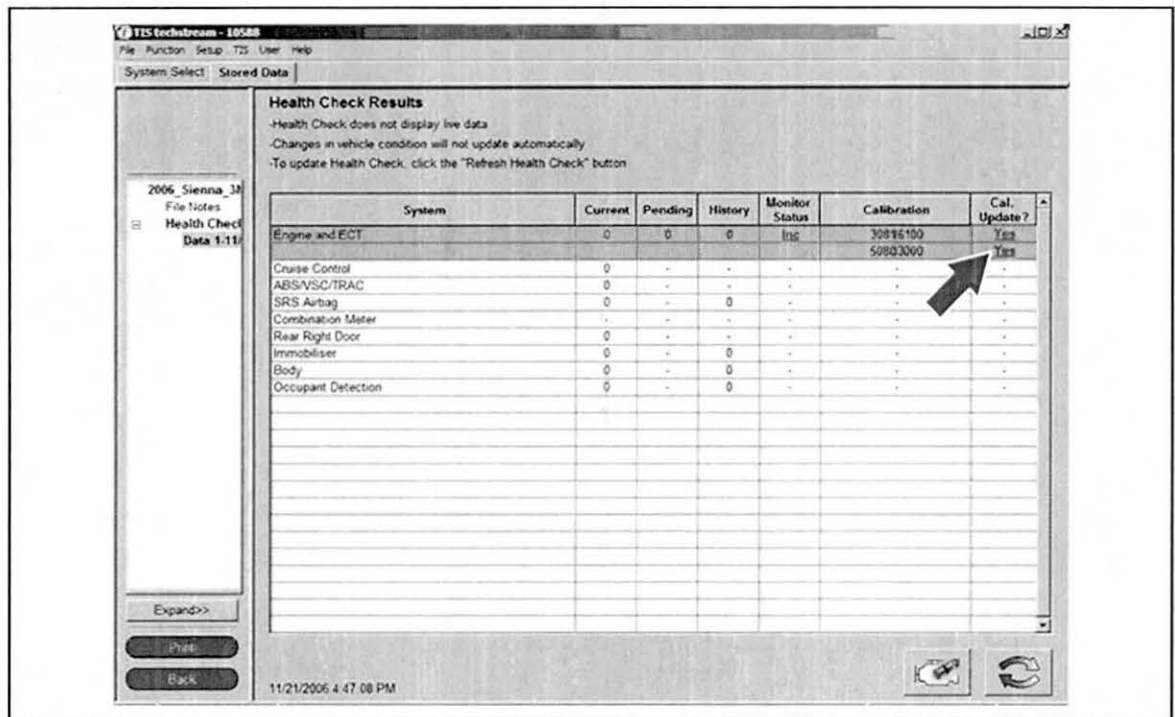
Figure 5.

- F. Available calibration updates are indicated by a Yes link in the “Cal. Update?” column. Click the Yes link to access the appropriate Service Bulletin on TIS.

- Note any DTCs stored in systems that will be flash reprogrammed.
- Clicking the Yes link will automatically launch TIS and perform a calibration search.

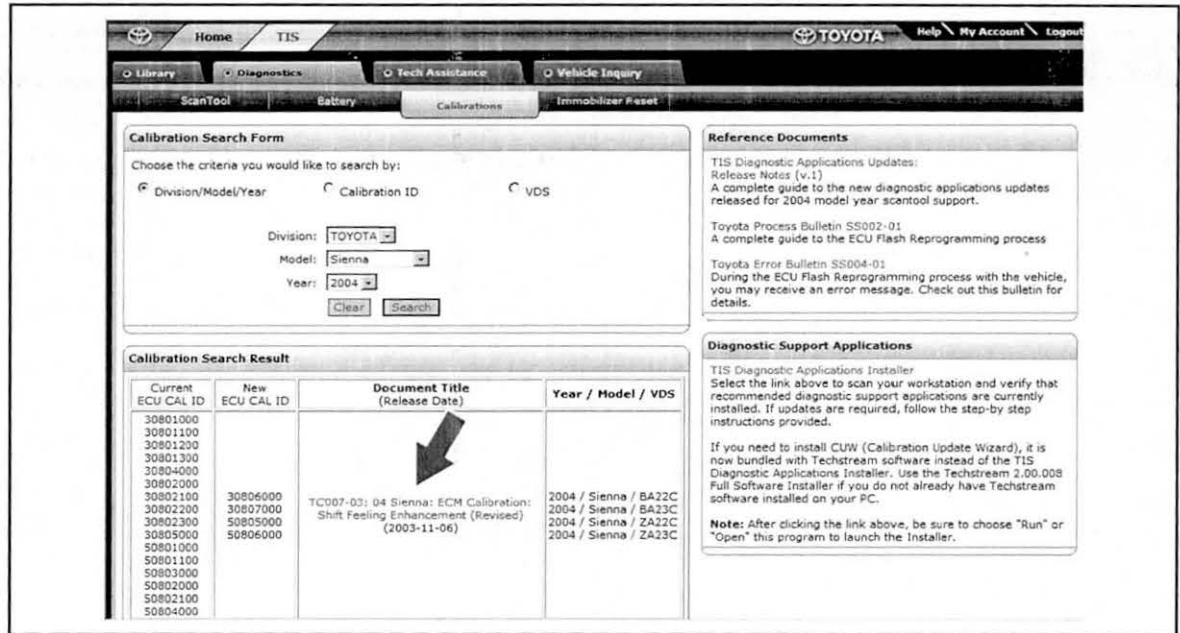
Figure 6.

H. To review the Service Bulletin and access the calibration file, click the Service Bulletin link in the "Document Title" column of the "Calibration Search Result" portlet.

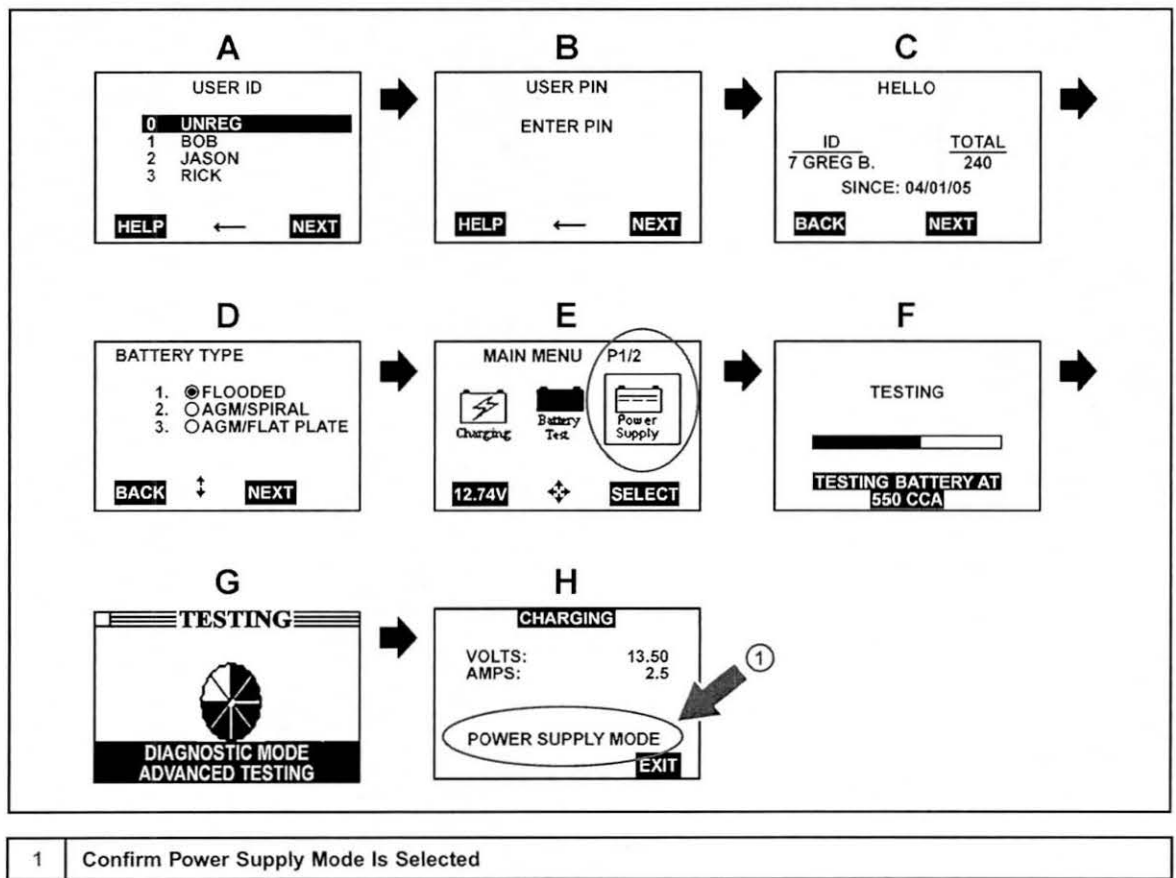
Figure 7.

2. Connect the GR8 Battery Diagnostic Station.
 - A. Connect the GR8 Battery Diagnostic Station to the vehicle and turn it ON.
 - B. Select Power Supply Mode by following the screen flow below.

- ECU damage may occur if the correct battery charger and mode setting are NOT used.
- Power Supply Mode is used to maintain battery voltage at 13.5 volts while flash reprogramming the vehicle.
- For details on how to use the GR8 Battery Diagnostic Station, refer to the GR8 Instruction Manual located on TIS, *Diagnostics – Tools & Equipment – Battery Diagnostics*.

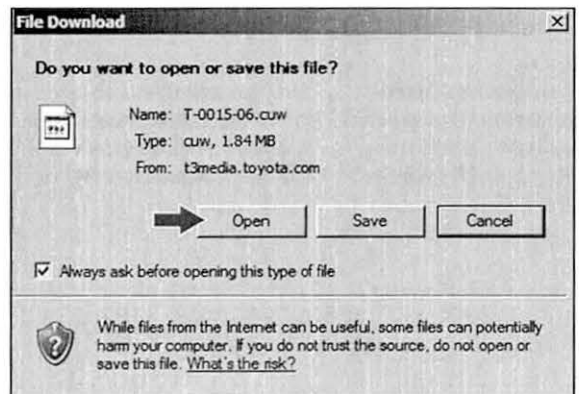
Figure 9.

- B. Click "Open" to load calibration file information.

Techstream pulls calibration files as needed to ensure the latest calibration file is used. Do NOT save calibrations locally on the hard drive or other media.

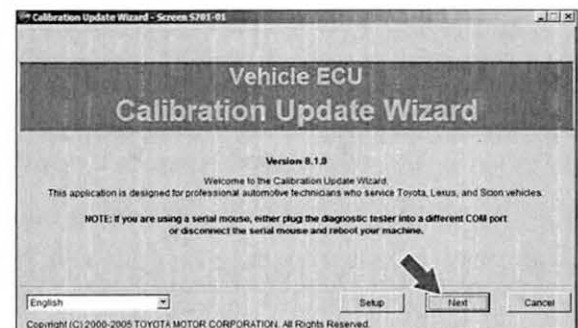
Figure 10.

- C. Click "Next" to start the calibration update process.

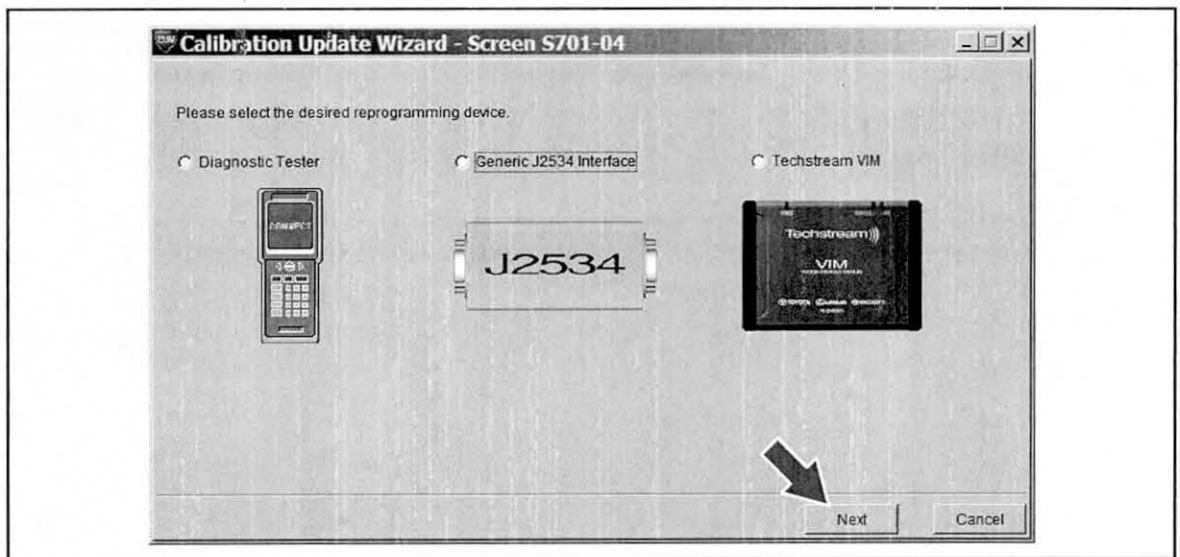
Figure 11.

D. Select the correct reprogramming device.

- If using Techstream 2.0, select “Generic J2534 Interface”.
- If using Techstream Lite, select “Generic J2534 Interface”.
- If using Techstream, select “Techstream VIM”.

Then click “Next”.

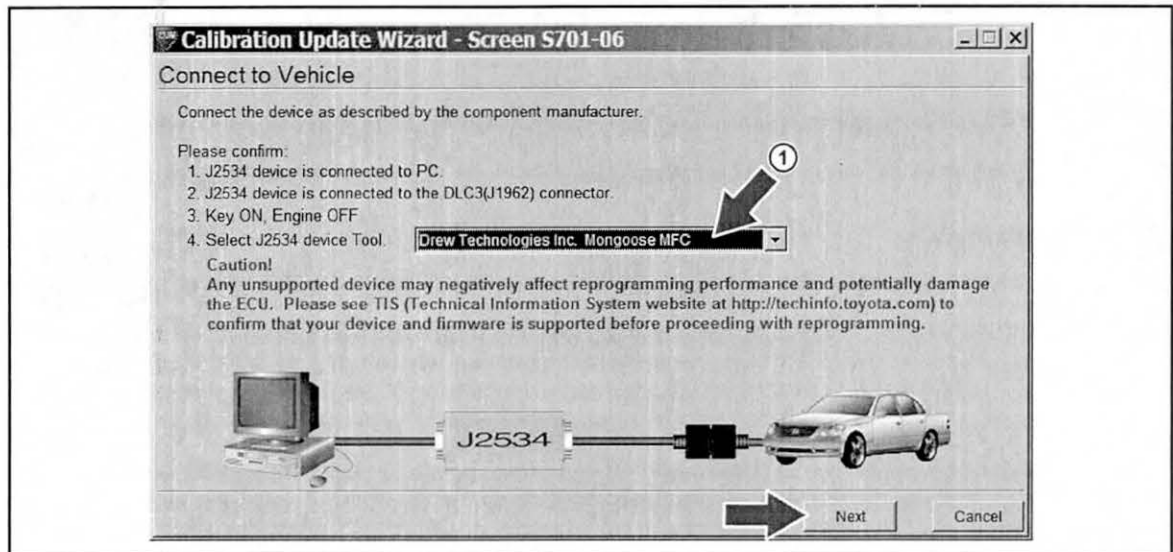
- PC is connected to VIM.
- VIM is connected to DLC3 connector.
- Ignition is ON and engine is OFF or "READY" OFF (hybrid vehicles).

Figure 12. Using Techstream 2.0 or Techstream Lite

1	Select Correct Device Tool ("Mongoose MFC" or "MongoosePro MFC")
---	--

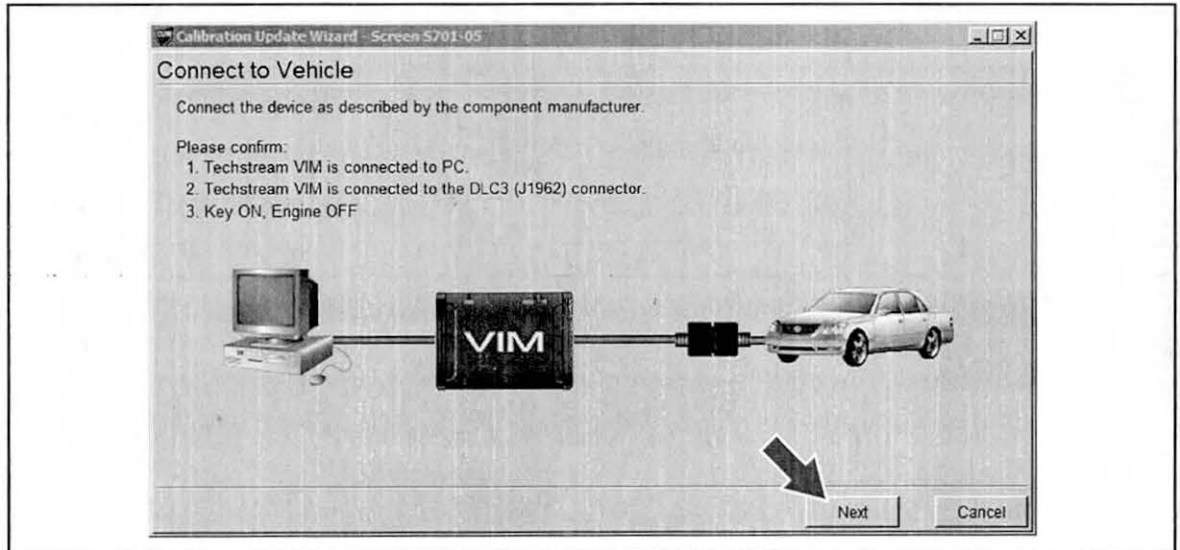
Figure 13. Using TIS Techstream

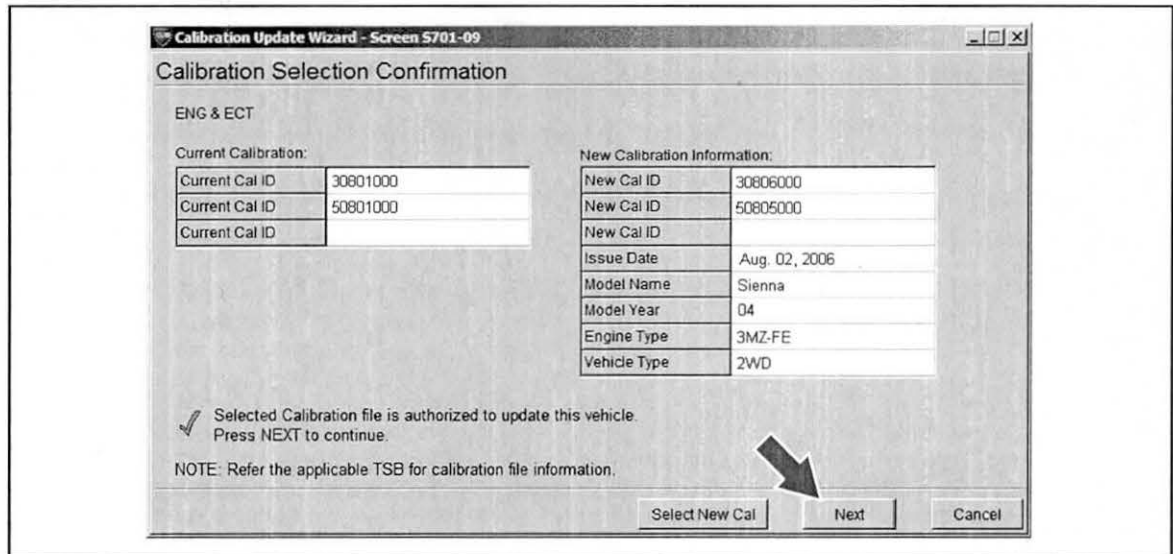
Figure 14.

- The total number of calibration IDs in the calibration file corresponds to the number of reprogrammable processors in the ECU.
- Each calibration file may contain up to three separate calibrations.
- Figure 14 shows an example of the update procedure for a two-processor ECU.

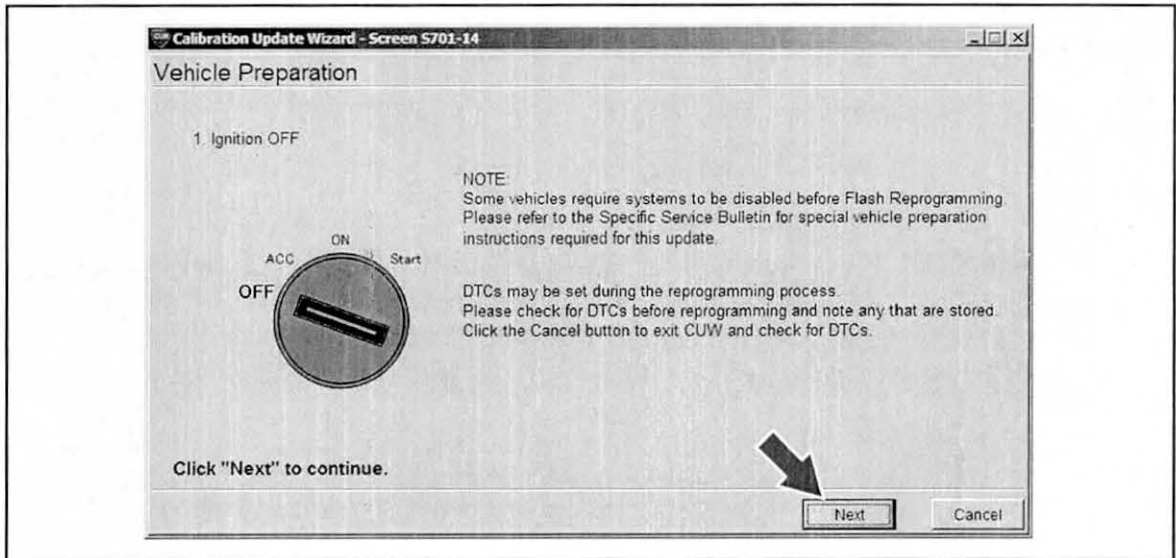
Figure 15.

G. Turn ignition OFF. Then click "Next".

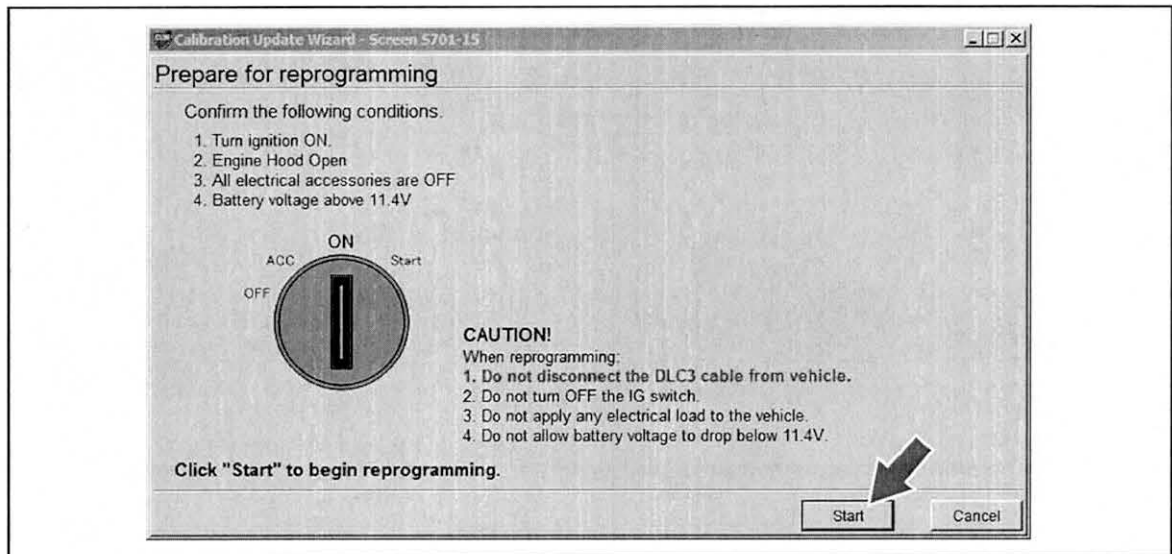
Figure 16.

Verify the vehicle is connected to a battery charger before continuing — If battery voltage falls below 11.4 volts, ECU damage may occur.

Then click "Start".

If key cycle is NOT done properly, reprogramming will stop at 10% and Cal 1 will fail to load.

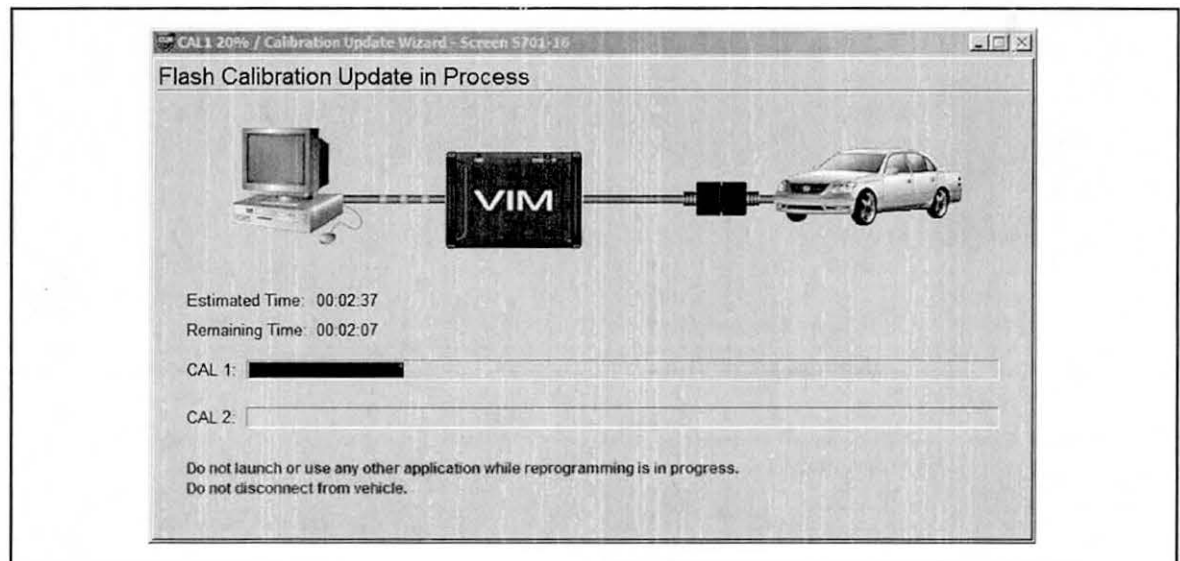
Figure 17.

- ECU flash reprogramming may take anywhere from 3 – 30 minutes per calibration file.
- Reprogramming time will vary depending on model and ECU communication protocol. Vehicles using CAN communication protocol will reprogram much faster (2 – 7 minutes).

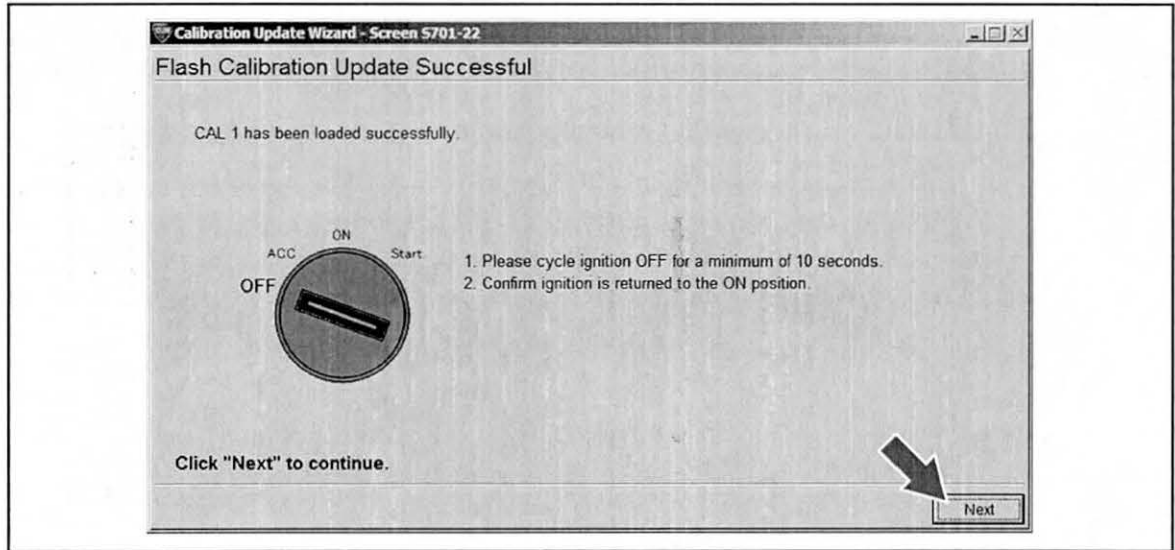
Figure 18.

- J. When Cal 1 has completed the update process, turn ignition OFF for a minimum of 10 seconds. Then click "Next".

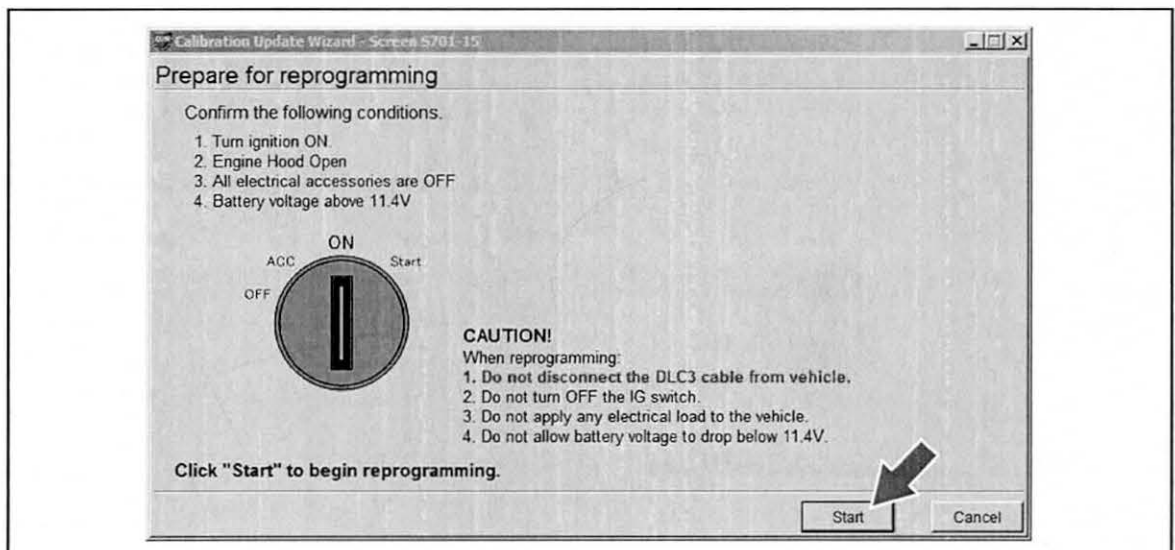
Figure 19.

- K. Turn ignition to the ON position. Then click "Start".

If key cycle is NOT done properly, reprogramming will stop at 10% and Cal 2 will fail to load.

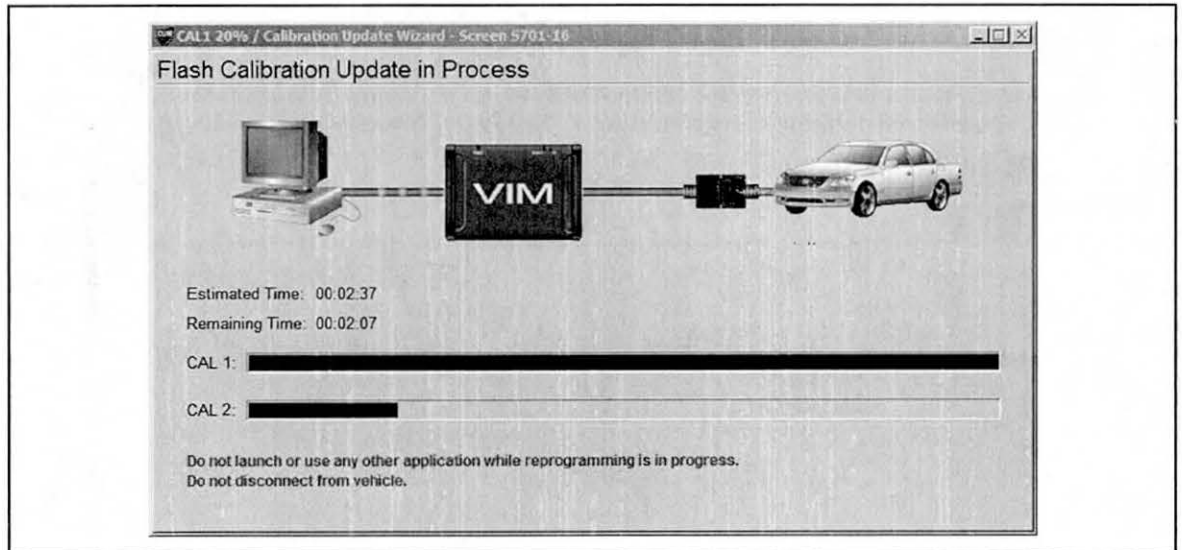
Figure 20.

- L. Do NOT disturb the vehicle during flash reprogramming.

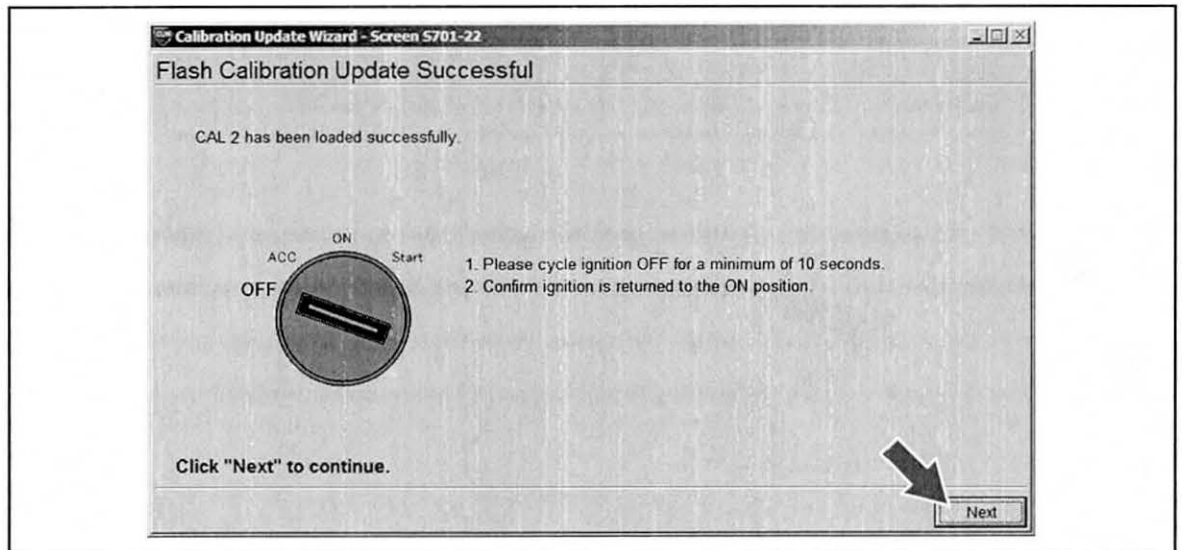
Figure 21.

- M. Turn ignition OFF for a minimum of 10 seconds. Then click "Next".

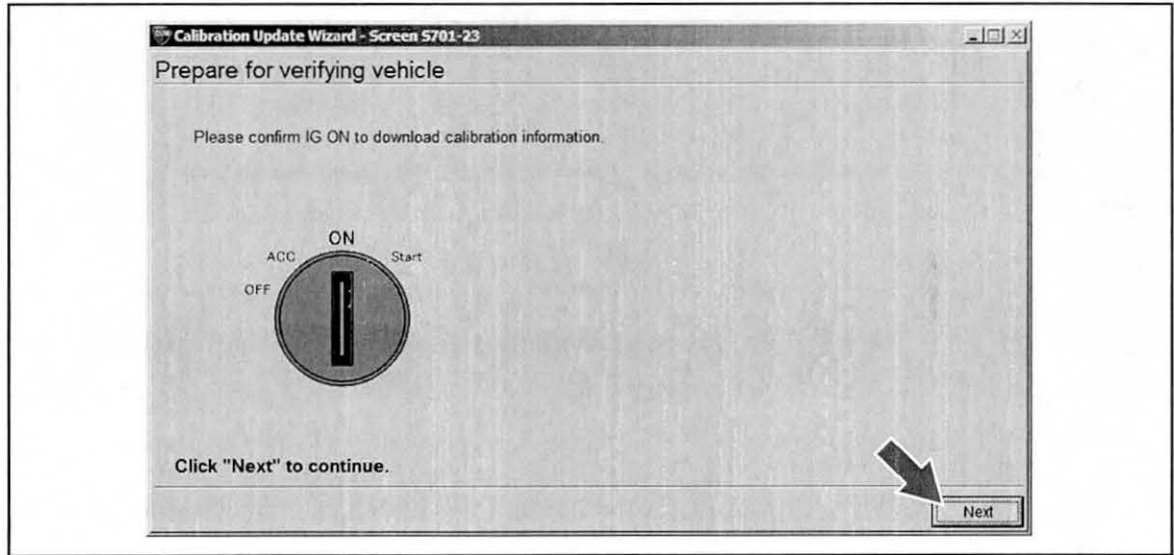
Figure 22.

N. Turn ignition to the ON position. Then click "Next".

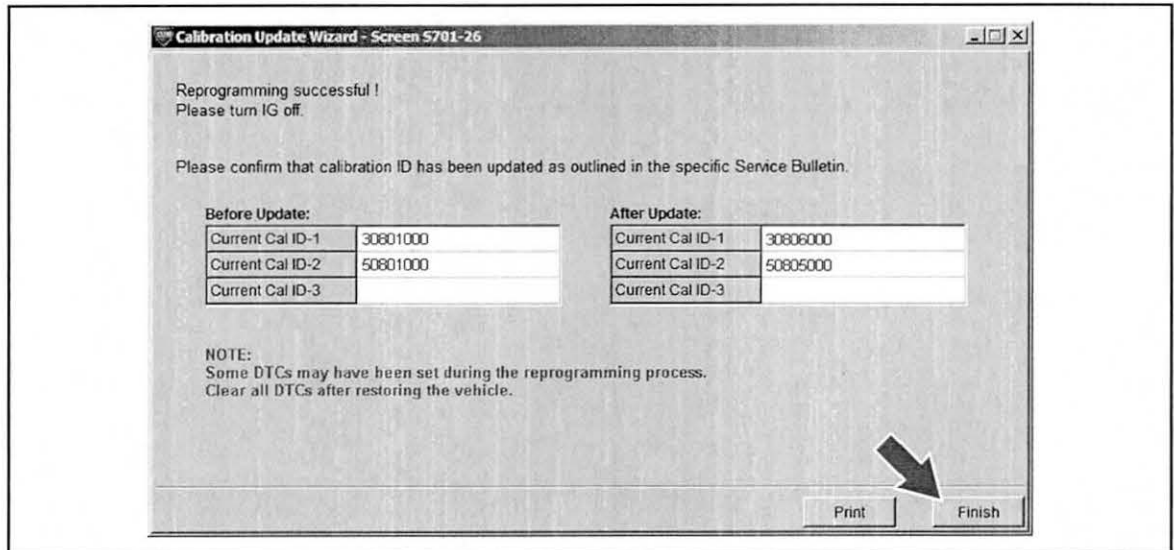
Figure 23.

O. Confirm all calibrations were updated as specified in the Service Bulletin. Then click "Finish".
