Bluetooth and Phone Menu Icons Unavailable

Service Category Audio/Visual/Telematics

Section Cellular Communication

Navigation Application Software Update Procedure

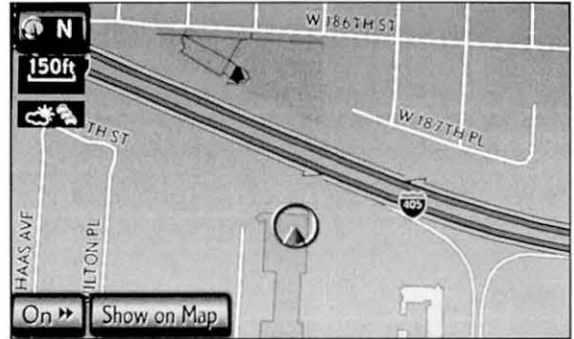
Figure 1.

1. Turn ignition to ACC. Map will be displayed.

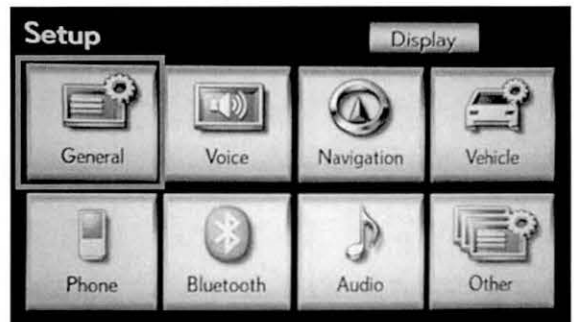
Figure 2.

2. Press "MENU" (only for haptic unit).

3. Press "Setup".

4. Press "General".

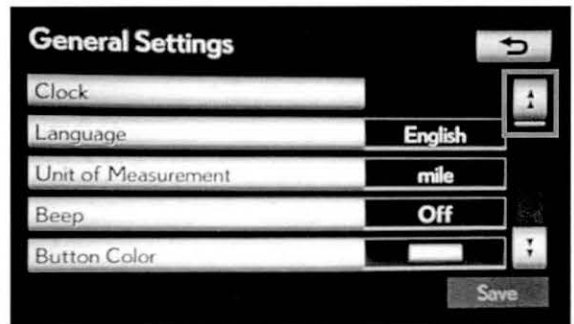
Figure 3.

5. Press the up arrow key one time.

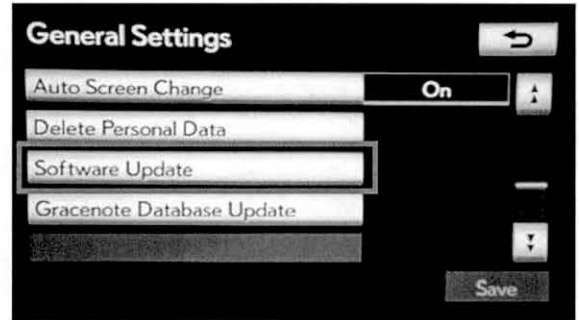
Figure 4.

6. Press "Software Update".

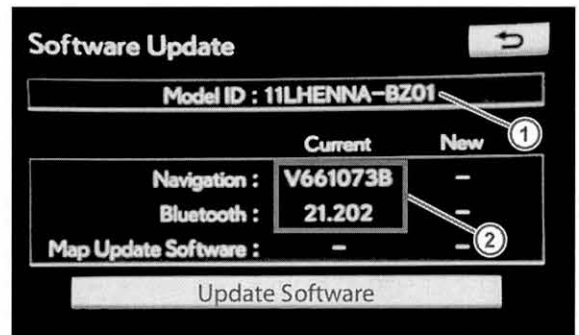
Figure 5.

7. Connect USB memory stick for the update.

1	ID Varies According to Vehicle
2	Current Version Is Displayed

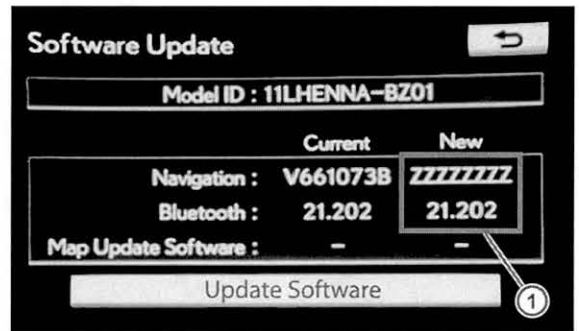
Figure 6.

8. Press "Update Software".

1	Version to Be Updated Is Displayed
---	------------------------------------

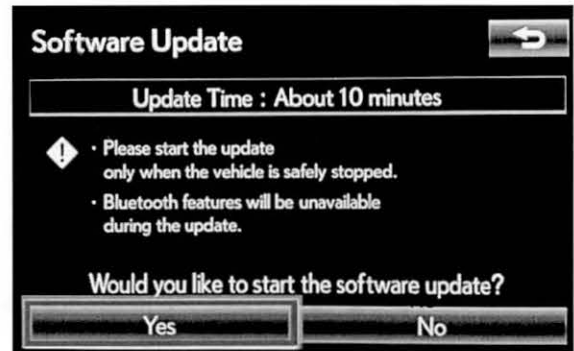
Figure 7.

9. Press "Yes".

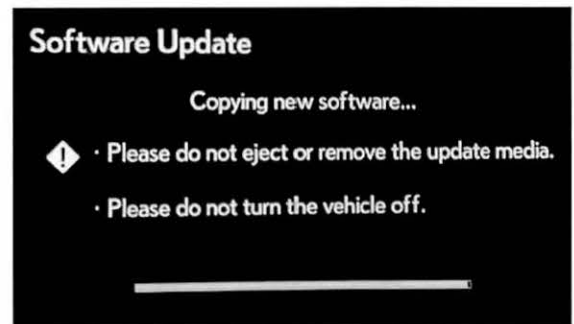
Figure 8.

10. Software Update screen will show "Copying new software...". Do NOT turn off the vehicle.

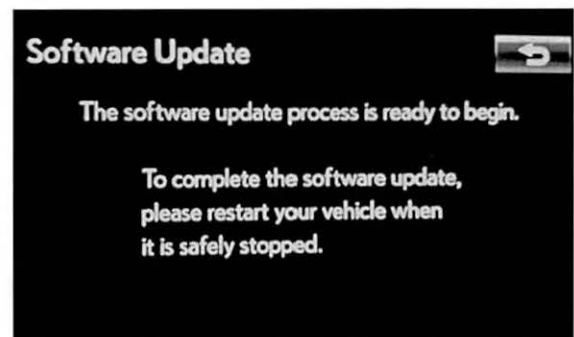
Figure 9.

11. Software Update screen will then show "The software update process is ready to begin". Follow on-screen instructions by turning the ignition OFF then back to ACC.

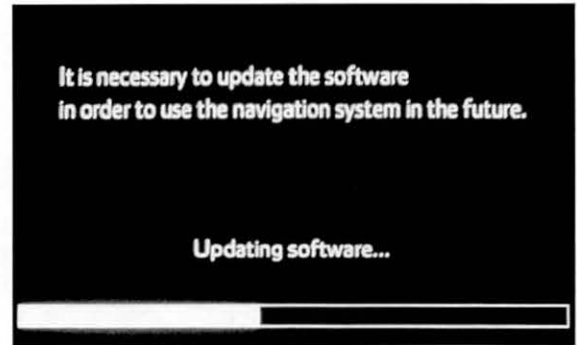
12. Updating should begin. "Updating software..." will appear on-screen. Figure 10.

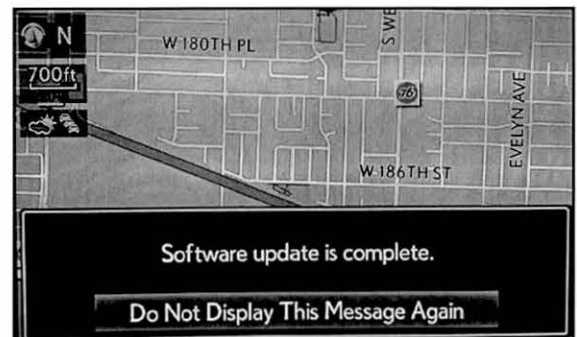
13. The map will display once the update is complete. Press "Do Not Display This Message Again". Figure 11.
