Navigation System Firmware Improvement (Generation 5)

Service Category Audio/Visual/Telematics

Section Navigation/Multi Info Display

Market USA

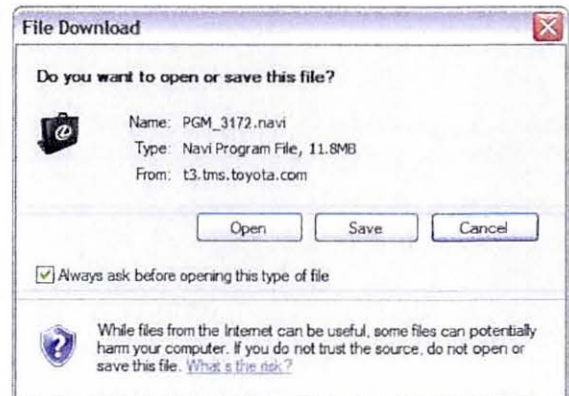
Figure 1.

The file is large and may take up to 10 minutes to download.

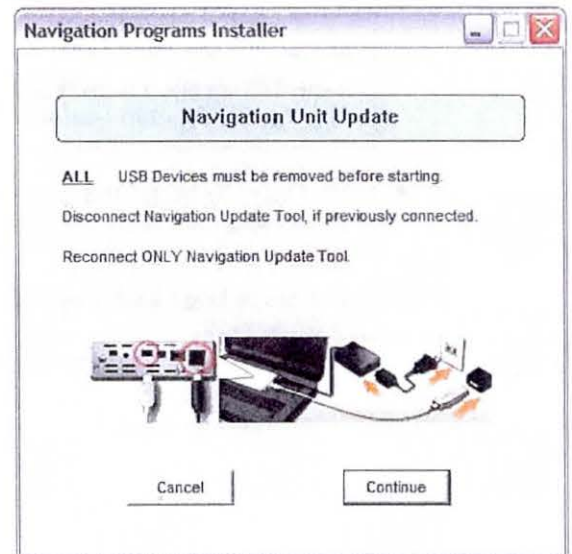
Figure 2.

6. Connect the Navigation Update Tool to the PC using the USB cable.
 - A. Make sure the USB cable is secured in **both** the PC and the Navigation Update Tool USB ports.
 - B. Confirm that the Navigation Update Tool is powered correctly.
 - C. Turn the power ON.
 - D. Click *Continue*.
7. Verify that both the transfer mode display light (green) and power supply display light (blue) are lit, then click *Continue*.

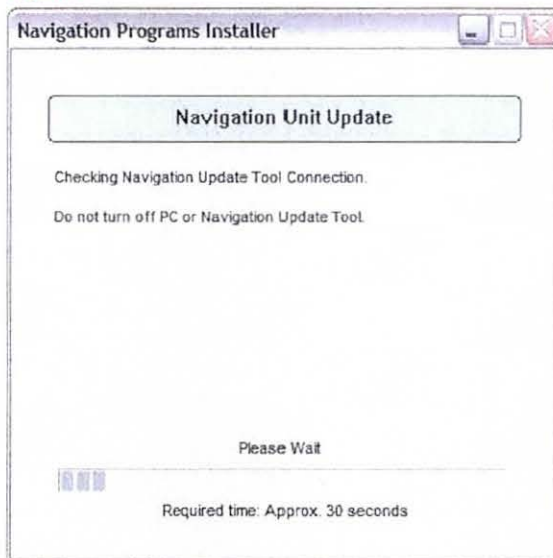
Figure 3.

8. The software will perform a connection check with the Navigation Update Tool. In the event an error is shown, please recheck the USB connection.

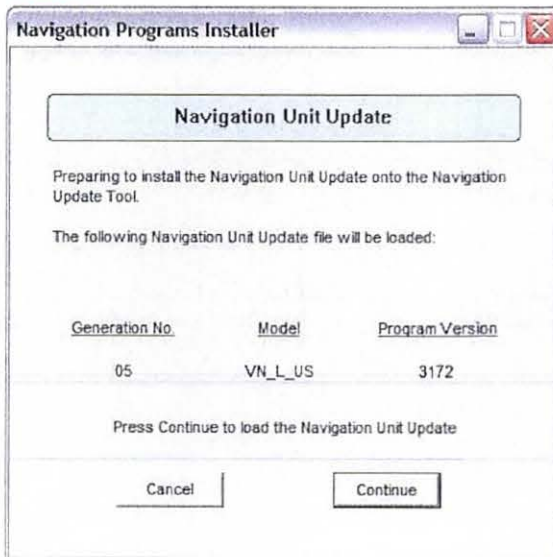
Figure 4.

9. Navigation Firmware is ready to be loaded onto the Navigation Update Tool, click *Continue*.

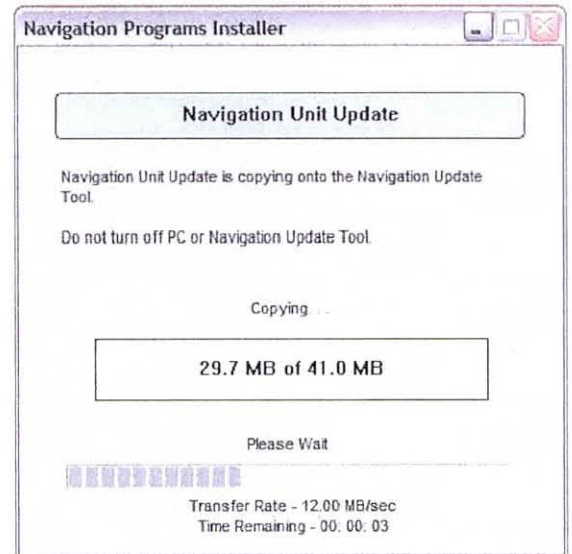
Figure 5.

10. Navigation Firmware will now load onto the Navigation Update Tool.

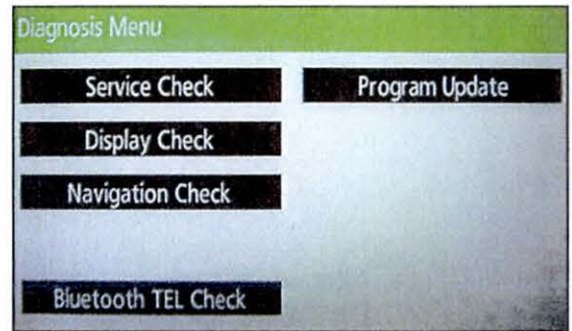
Figure 7.

1. Connect the Navigation Update Tool to the vehicle (tool MUST be disconnected from the PC).
2. Connect the GR8 Battery Diagnostic Station to the vehicle.
3. Press the "ENGINE START STOP" switch two times with the brake pedal released to cycle the ignition ON (Engine/Hybrid system OFF), and wait for the *Caution* screen to appear on the navigation display.
4. Press the *MAP* button, wait for the map to appear.
5. Hold down the *INFO* button and rotate the headlamp stalk switch ON and OFF 3 or more times until the navigation system enters the diagnostic mode.
6. Select *MENU* on the upper right side of the multi-display screen.
7. Select *Program Update*.

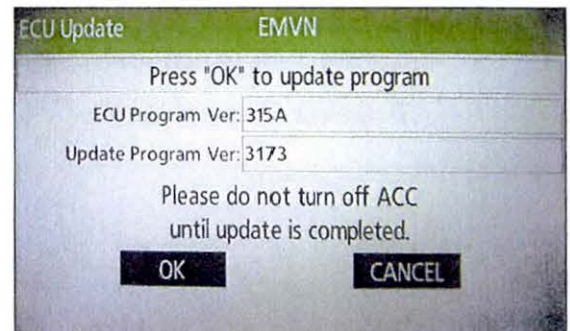
Figure 9.

10. When the *EMVN* screen is shown, select *OK*.

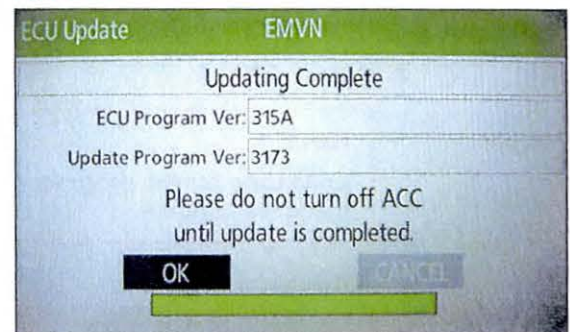
Figure 10.

11. After about 1 minute, if the update was successful the display will indicate "*Updating Complete*" at the top of the screen. Select *OK* to continue.

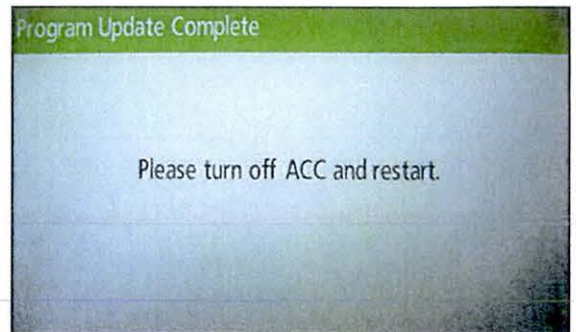
Figure 13.

- Cycle the Ignition OFF to finish the updating procedure.
