Service Bulletin

Bulletin No.: 10-03-09-001B

Subject: Shake/Vibration in Steering Wheel, Boom/Moan Noise at Highway Speeds on Smooth Roads (Replace Engine Mounts, Propshaft, Balance Wheel and Tire Assemblies or Correct Brake Rotor Runout)

Models: 2008-2009 Pontiac G8

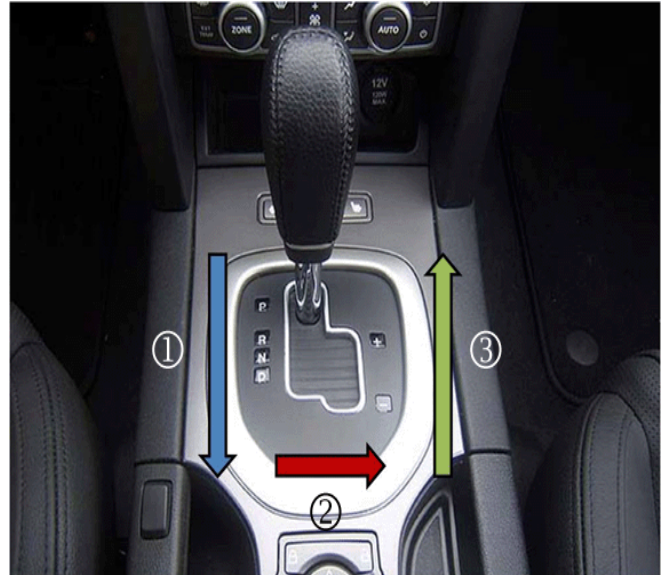
2366233

1. Shift the transmission to "D" (1).
2. Accelerate on a suitable road to a sustainable 88-112 km/h (55-70 mph).
3. Adjust your speed until the objectionable vibration is felt.
4. Move the shifter to the manual shift gate (2). This will engage the "sport shift" mode and automatically initiate a downshift to 5th gear if the vehicle is in top gear.

During a road test (with or without the customer), this concern may be isolated by disabling Active Fuel Management. If the customer is available, it may be of value to let the customer drive the vehicle. In order to disable this feature, you will engage 6th gear manually by performing the following steps:

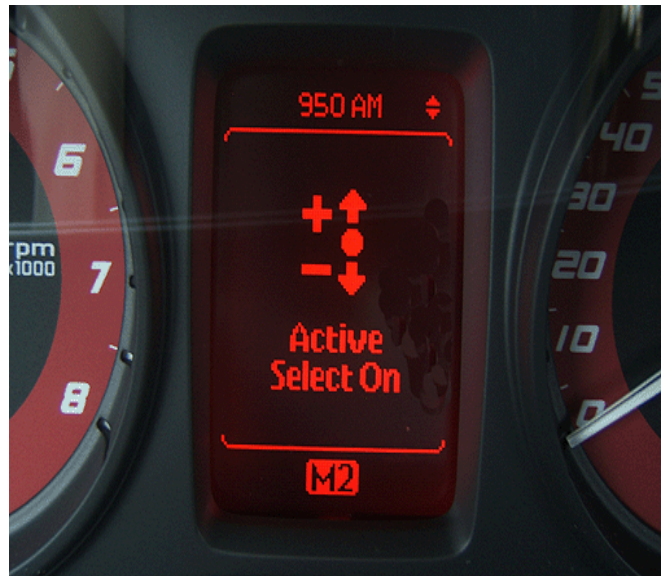
2366236

5. Move the shift lever forward to engage manual transmission control (3). The vehicle DIC will display "Active Select On."

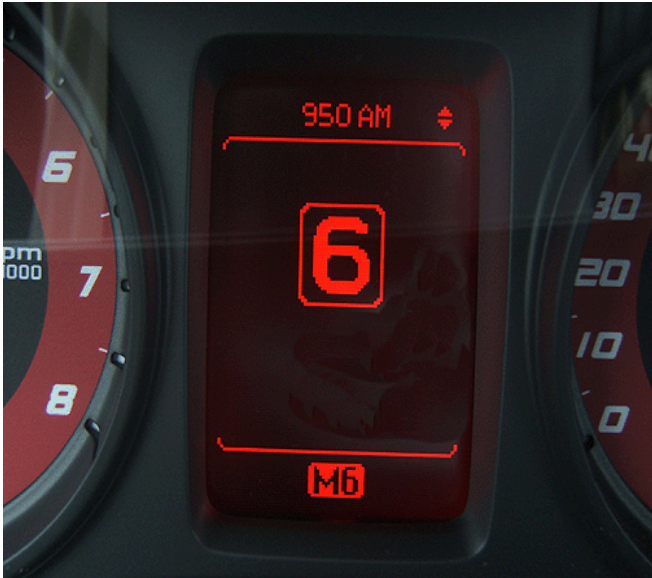
2366237

6. Push the lever forward to engage 6th gear. The vehicle DIC will display a "6."
7. The vehicle will now remain in 6th gear and AFM will be disabled. Try to reproduce the customer complaint varying your speed within the customer specified speed range. Try coasting, holding speed and slight acceleration as well. By shifting the transmission selector back to "automatic" and repeating the above steps you should be able to tell if AFM is contributing to the objectionable vibration.
