Radio Screen Brightness Difference Between Modes

Service
 Category Audio/Visual/Telematics

Section Navigation/Multi Info Display

YEAR(S)	MODEL(S)	ADDITIONAL INFORMATION
2013	RAV4

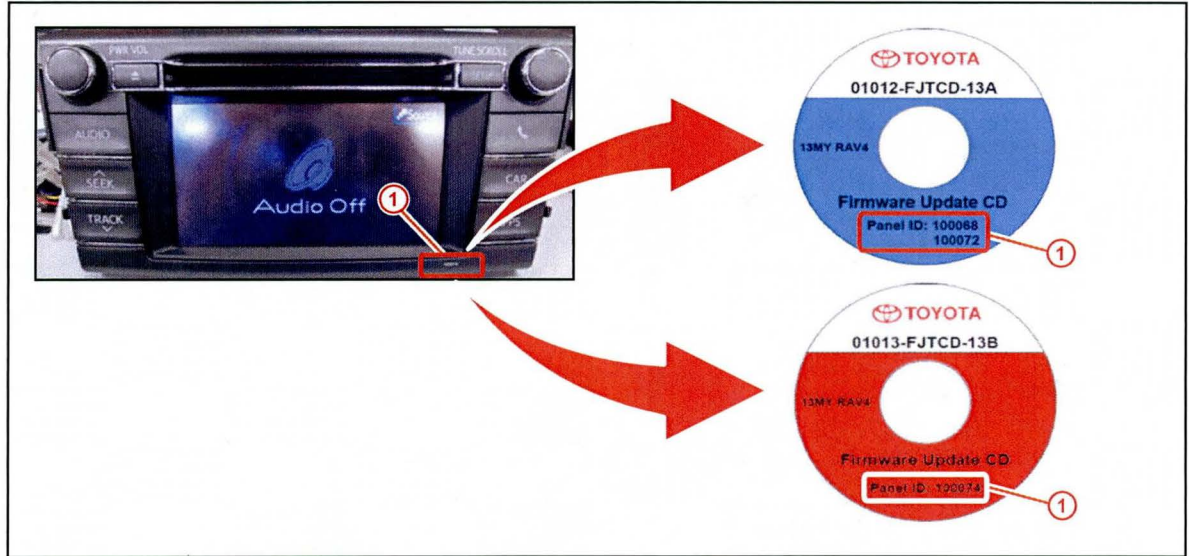
Figure 1.

1	Panel ID
---	----------

1. Confirm that the Firmware Update CD and the radio faceplate have the same Panel ID. (See Required Tools & Equipment for more detail.)
2. Start the engine, or install the GR8 Battery Diagnostic Station and connect it to the vehicle 12V battery terminals, and turn the ignition switch to ON.

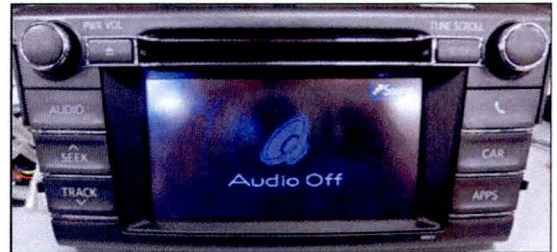
Figure 2.

3. Ensure that the audio function is turned OFF and that the screen reads "Audio Off."

The screen name and image may differ due to the language setting and/or the last mode used in Display Audio.

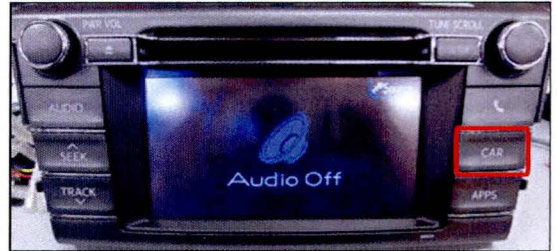
Figure 3.

4. Press and hold the CAR button.

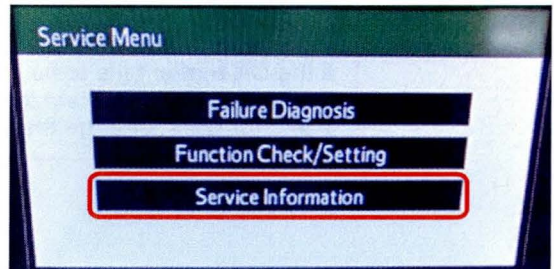
Figure 4.

5. While holding the CAR button, operate the ILL (light control) switch in the following sequence:
OFF – ON – OFF – ON – OFF – ON – OFF
6. When the *Service Menu* screen appears, select *Service Information*.

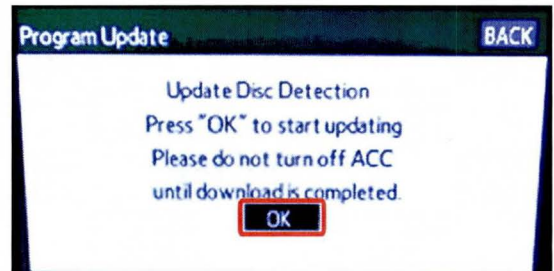
Figure 7.

9. Insert the disc.

10. Select *OK* once it becomes selectable.

If the *OK* button fails to become selectable after 5 minutes, eject and reinsert the disc. If it still does not work, change the disc to a new one.

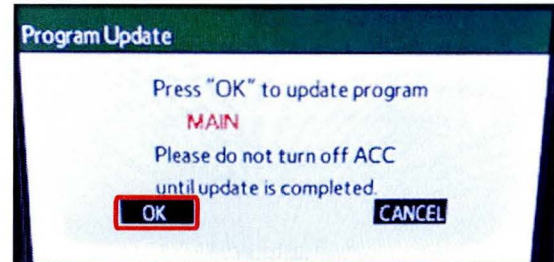
Figure 10.

13. Select *OK*.

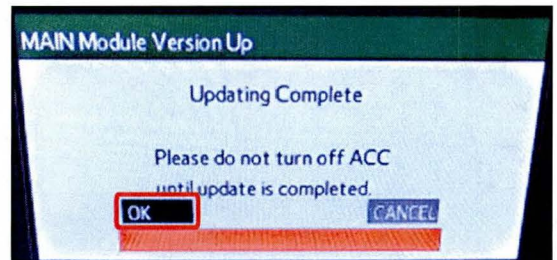
Figure 13.

17. Select *OK*.

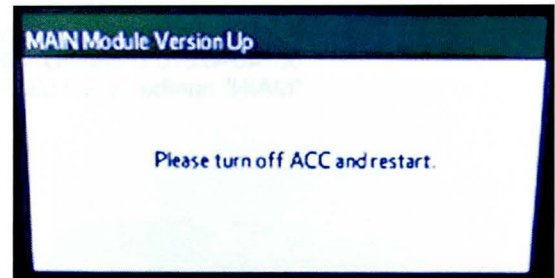
Figure 14.

- The message "Please turn off ACC and restart." will appear.

- Cycle the ignition switch and ACC OFF and then wait for at least 1 minute before cycling it back on.
