ECM and ACM Software Updates
OBD2013, MP7, MP8, MP10
CHU, CXU, GU, LEU, MRU, TD

PI0831, ECM and ACM Software Updates

(October 2013)

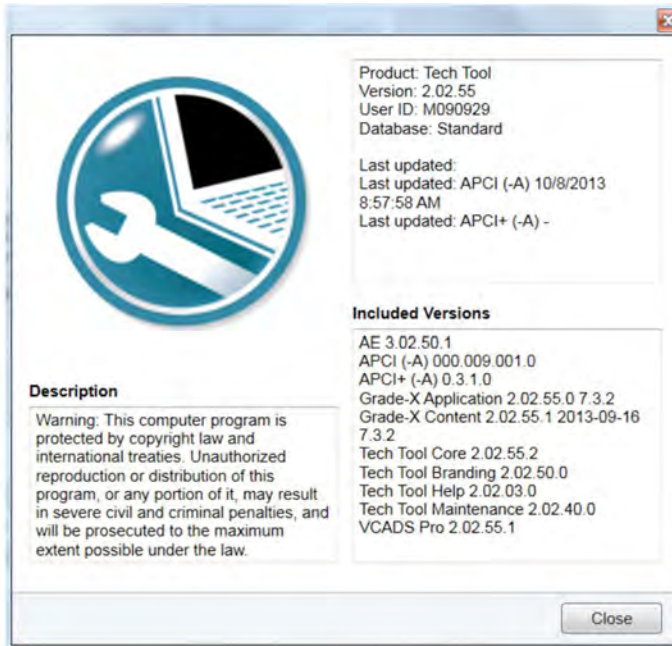
W2085456

Check Premium Tech Tool version by clicking on Help tab and then click on "About Tech Tool".
