ECM and ACM Software Updates
OBD2013, MP7, MP8, MP10
CHU, CXU, GU, LEU, MRU, TD

PI0826, ECM and ACM Software Updates

(October 2013)

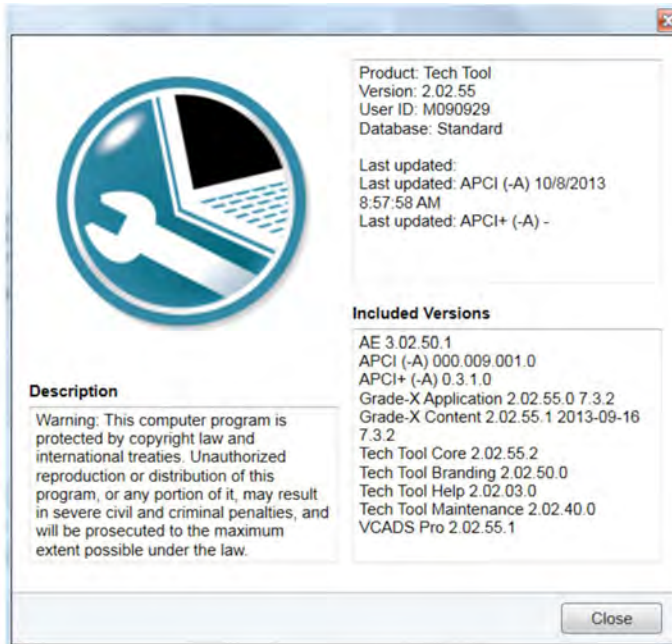
W2085456

Check Premium Tech Tool version by clicking on Help tab and then click on "About Tech Tool".

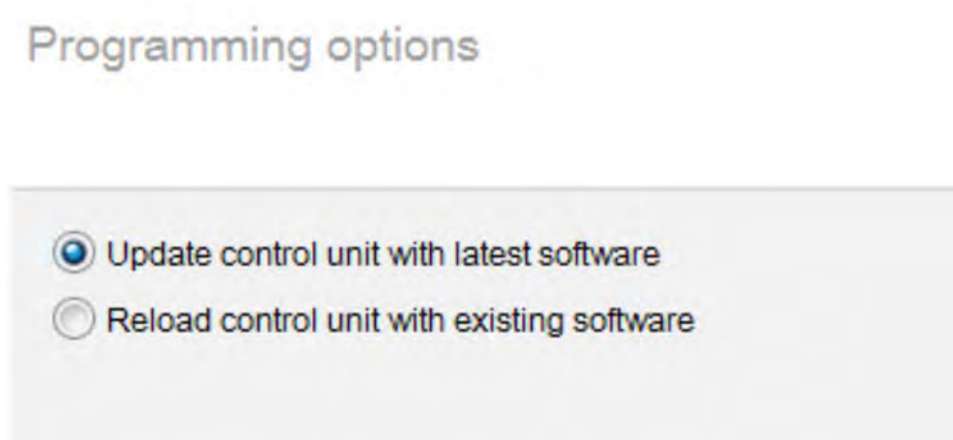
W2085461

- 9 Select Program to update the control unit with the latest software.

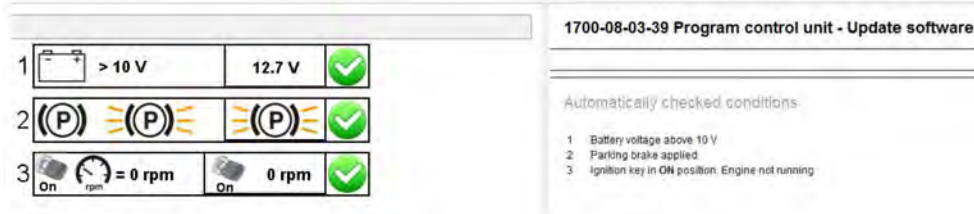
W2080113

10 Certain conditions must be met to continue with programming: battery voltage above 10v, parking brake applied, and ignition key in ON position with engine not running. When all conditions have been met, click Continue to proceed with programming.

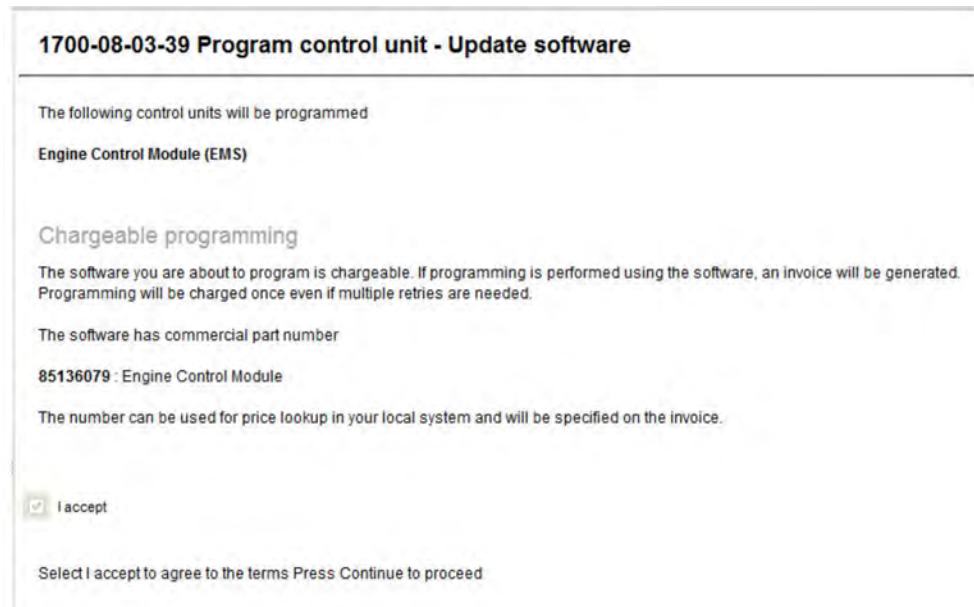
W2085462

11 Select "I accept" to agree to the terms and press Continue to proceed.
