GROUP Engine	MODEL 2012-2013MY Rio (UB) w/1.6L GDI
	NUMBER 131	DATE May 2013
<b>TECHNICAL SERVICE BULLETIN</b>		
<b>SUBJECT: ECM UPGRADE – KNOCK IMPROVEMENT</b>

## ECM UPGRADE – KNOCK IMPROVEMENT

UPGRADE EVENT NAME
203.UB 1.6 GDI KNOCK IMPROVEMENT (VER. 2)

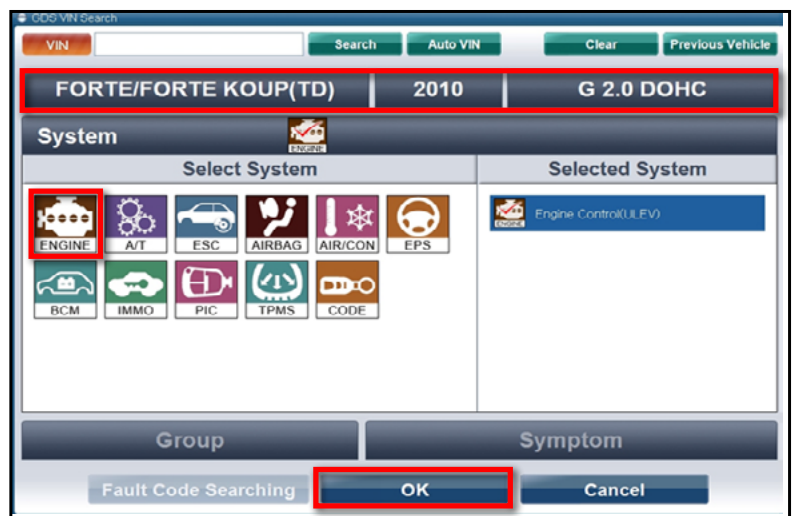
6. Select ENGINE system and click OK.

**NOTE: The display screen image to the right is for demonstration purposes only. Actual screen details will vary by model.**

7. Once back at the GDS Main Screen, select ECU Upgrade from the bottom right-hand corner. Next select Auto Mode, and then Engine. Perform the ECM upgrade in accordance with normal GDS tool ECM upgrade procedures.
