GROUP Fuel	MODEL 2010-2011MY Soul (AM) 1.6L
NUMBER 024	DATE March 2013

TECHNICAL SERVICE BULLETIN

SUBJECT: ECM UPGRADE – KNOCK IMPROVEMENT DTC P0328

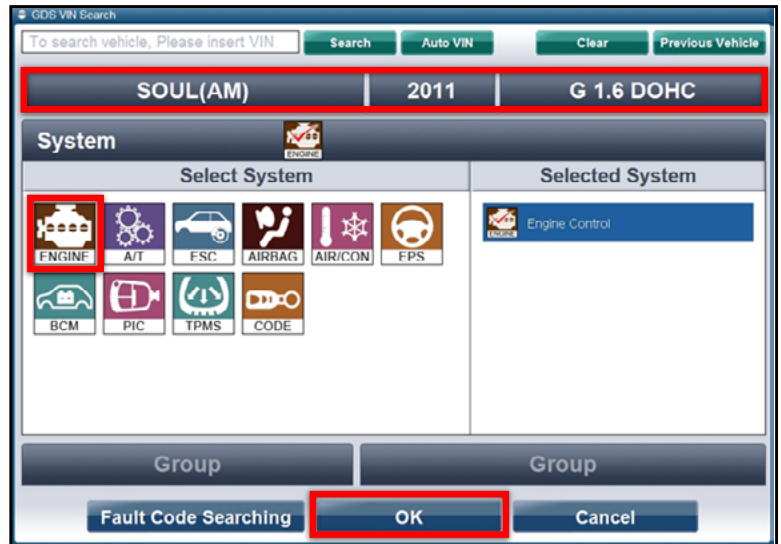
5. With the ignition key ON, turn ON the VCI and GDS tool. Access the GDS vehicle identification number (VIN) screen and configure the vehicle using the VIN Auto Detect function.
6. Select **ENGINE** system and click **OK**.

NOTE: Display screen to the right is for demonstrative purposes only and will vary depending on model.
