EMS & ACM SOFTWARE UPDATE  
9700 (B13R)

Software updates with enhancements are available for the engine control module (ECM) and aftertreatment control module (ACM) for the vehicles affected by the bulletin.

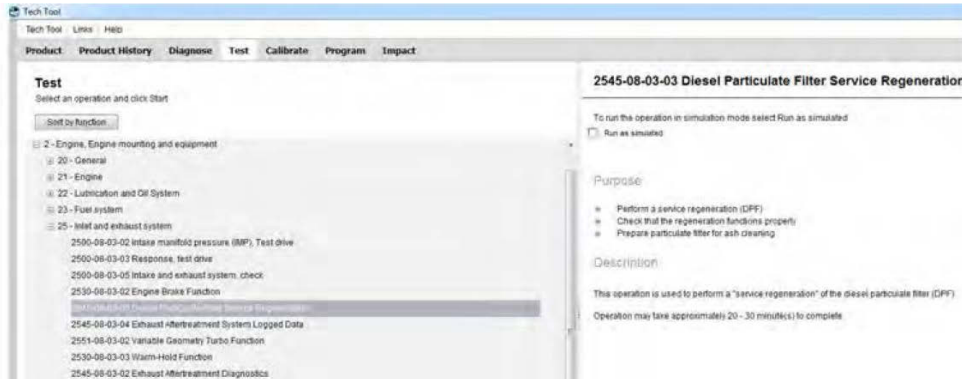
12. When ACM programming is complete, select Test from the Main Menu. Select 2545-08-03-03 Diesel Particulate Filter Service Regeneration and click on Start.
