REVISION A: THIS WARRANTY BULLETIN SUPERSEDES PREVIOUS VERSION.

EMS & ACM SOFTWARE UPDATE
9700 (B13R)

Software updates with enhancements are available for the EMS and aftertreatment control module (ACM) for the vehicles affected by the bulletin.

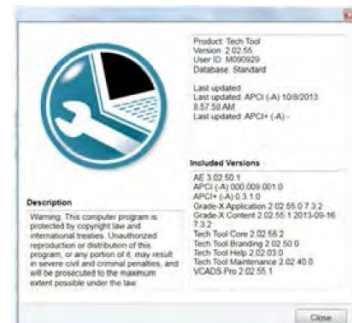
Check Premium Tech Tool version by clicking on Help tab and then click on "About TechTool".

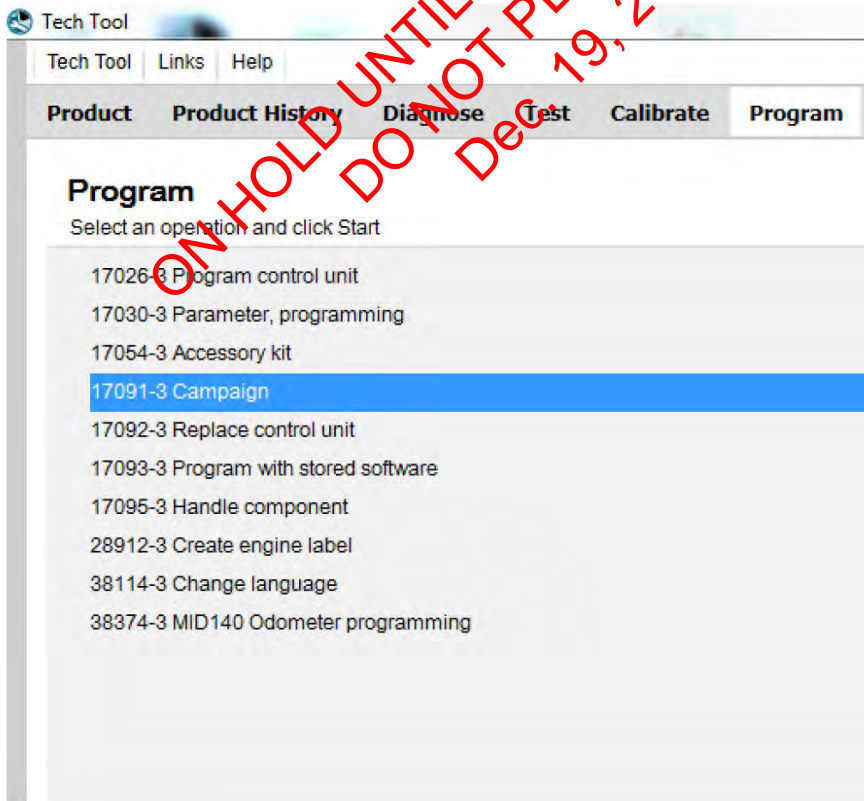
1. Secure the vehicle for service by parking it on a flat level surface, applying the parking brake, chocking the rear wheels, and placing the transmission in neutral.
2. Connect Premium Tech Tool (PTT) to the vehicle diagnostics connector using the 16 pin OBD cable 88890304 and Communication Interface 88890300. Connect the PC to a functional LAN or modem connection and a 120 Volt AC source.
3. Turn the ignition switch "ON".
4. Log in to PTT and Identify Vehicle is displayed.
5. Once the vehicle has been identified, enter the Work Order Number information, then click Start Work
6. From the Main Menu select Program and then Program Control Unit 1700-08-03-39. Then click Start.

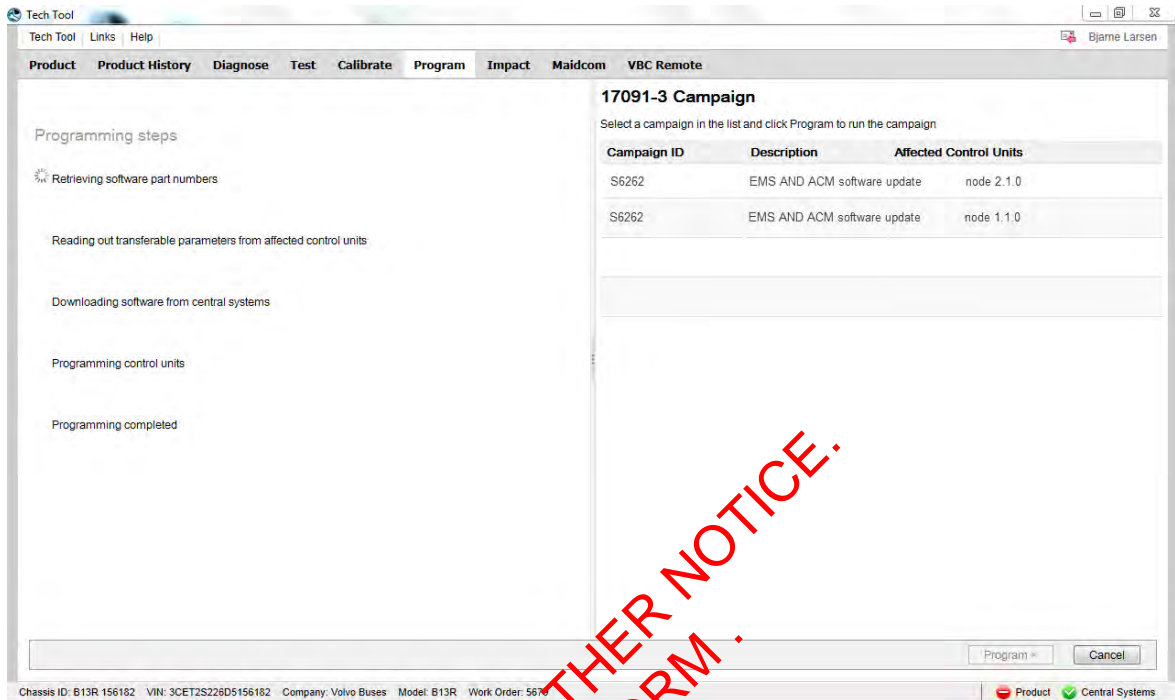
7. Select **Campaign** from the list. For this campaign, update the engine control module (EMS) and aftertreatment control module (ACM).

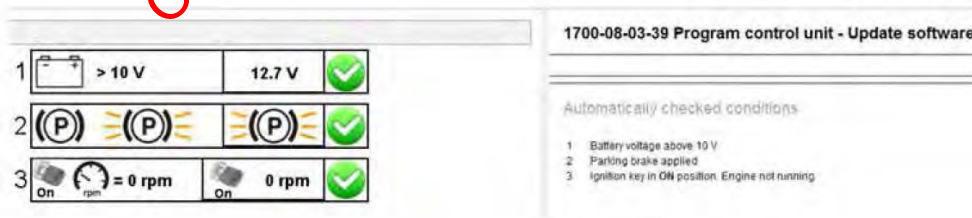
8. Select Campaign to update the control unit with the latest software.
9. Certain conditions must be met to continue with programming: battery voltage above 10v, parking brake applied, and ignition key in ON position with engine not running. When all conditions have been met, click Continue to proceed with programming.

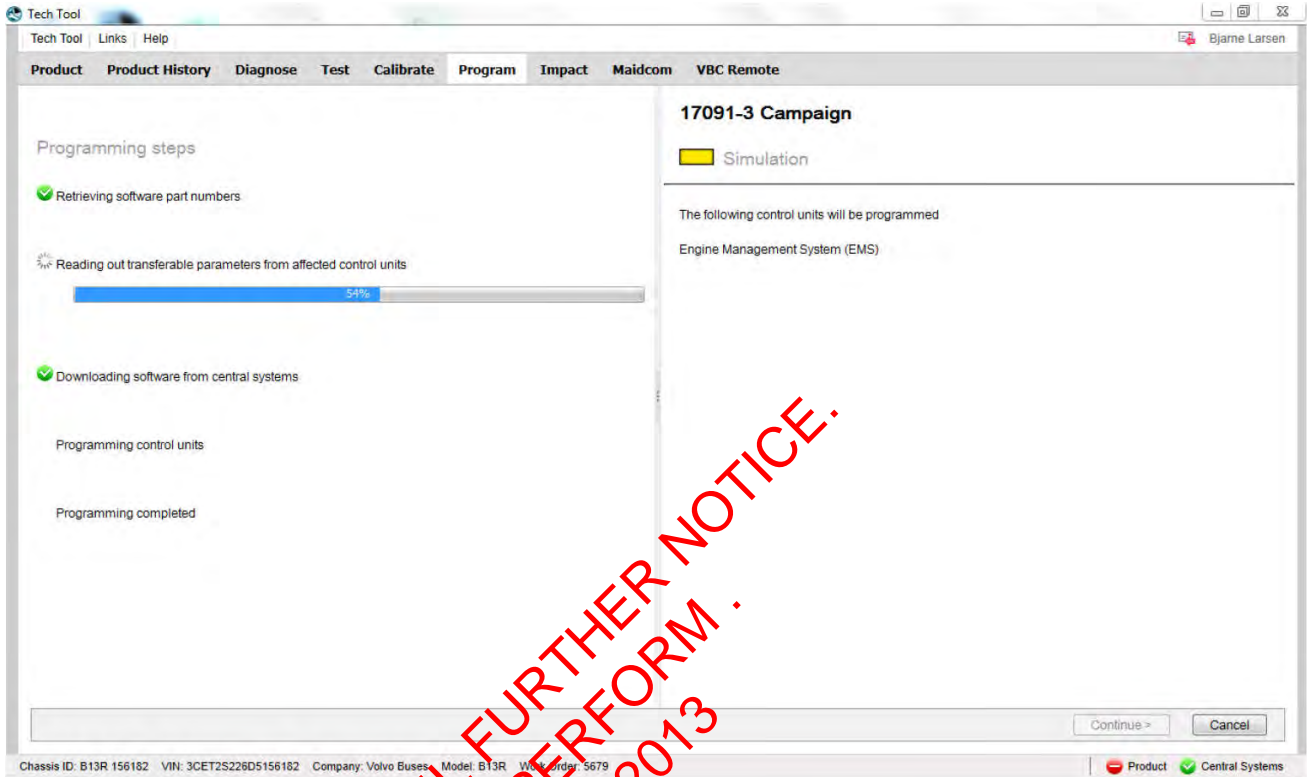
11. Program is now ongoing

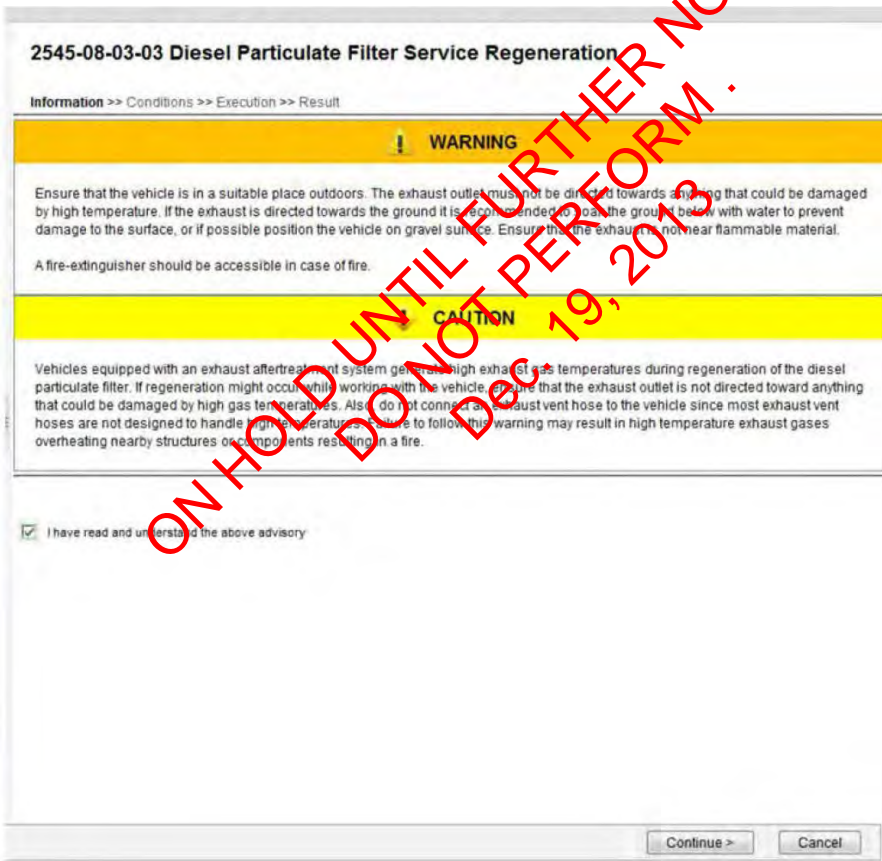
13. Review the advisories, check the box and click on Continue.

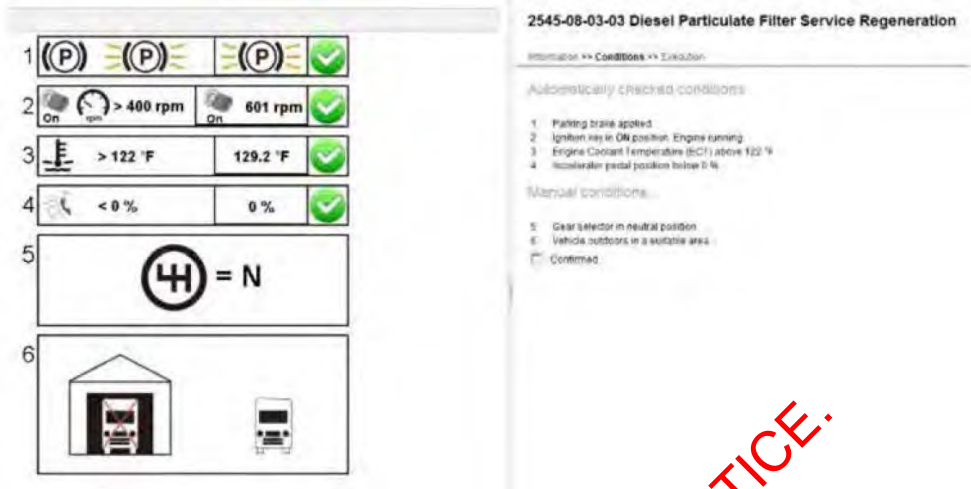
14. When all conditions are met, check the confirmed box and click on Continue.
