Subject: MIL ON WITH DTCs P0123 AND / OR P0222	Bulletin No: 01-008/13
	Last Issued: 07/02/2013

2011-2013 Mazda6

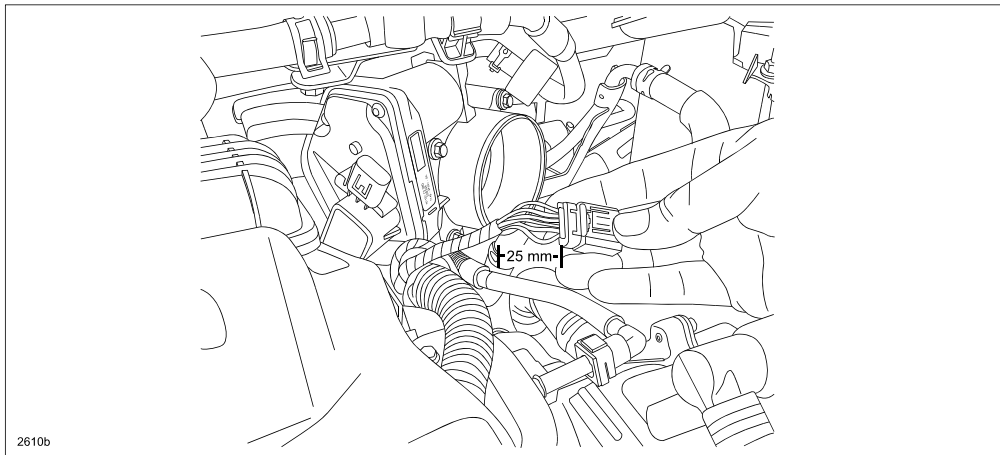
1. Record the customer's preset radio stations.
2. Disconnect the negative battery cable.
3. Disconnect connector from the MAF/IAT sensor.
4. Disconnect the MAF/IAT sensor harness retainer from the air cleaner cover.
5. Remove the air cleaner cover and resonance chamber as an assembly.
6. Disconnect connector 0140-222 from the throttle body.
7. Cut off approximately 25 mm (1 inch) of harness insulation (electrical tape) from connector 0140-222.

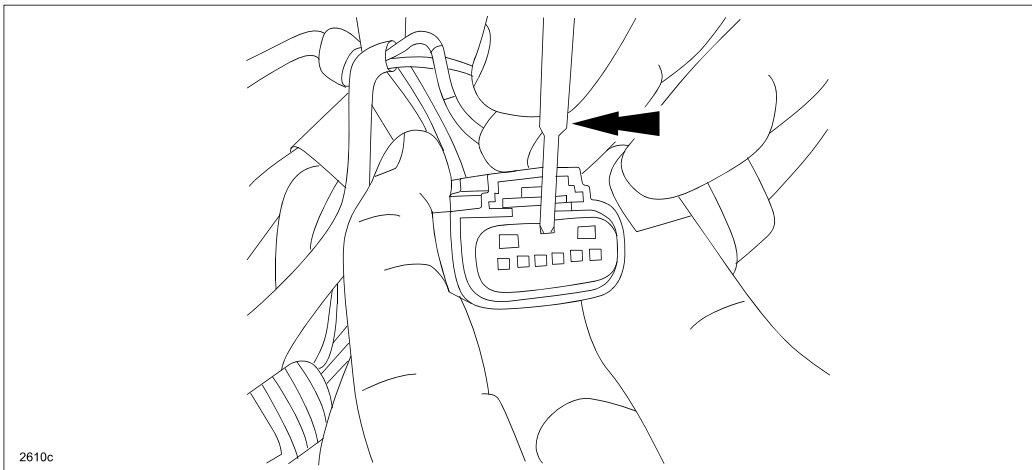
8. Remove the terminal lock from the connector.

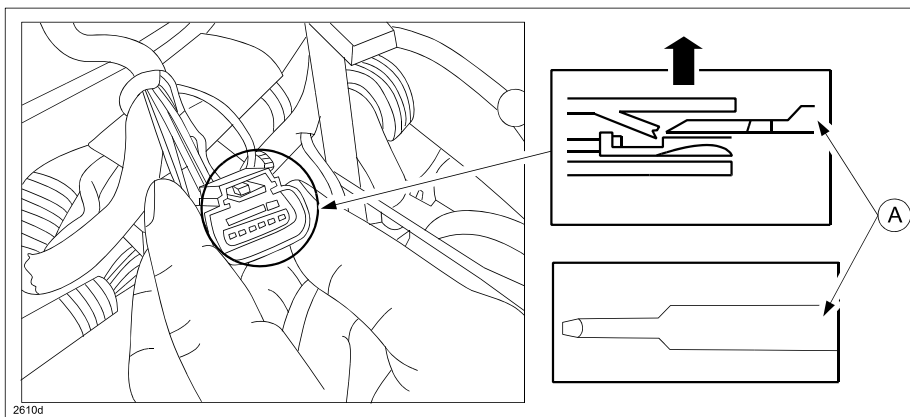
9. Remove all six (6) terminals from the original connector using an appropriate terminal tool (A) as shown below.

- This is necessary to install the new connector with the pre-installed diode.
- Angle of the tool goes upward to release the terminal lock.
- Discard the original connector.

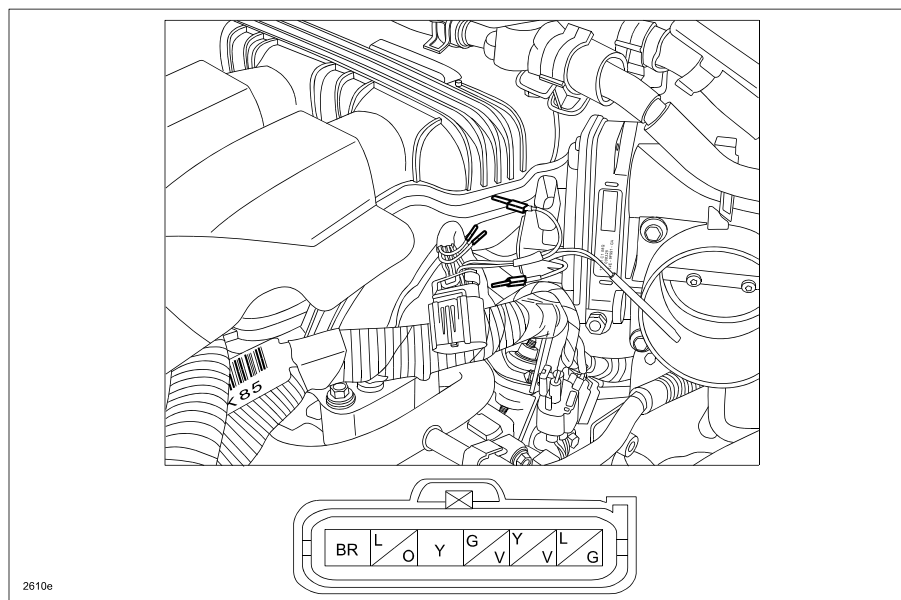
ETB Connector 0140-222 Wiring Locations:

Location	Wire Color		Location	Wire Color
#1	Brown (BR)		#4	Green/Violet (G/V)
#2	Blue/Orange (L/O) * **		#5	Yellow/Violet (Y/V)
#3	Yellow (Y) *		#6	Blue/Green (L/G)

* - Pre-installed wires

** - Pre-installed wire is not the same color as the vehicle harness

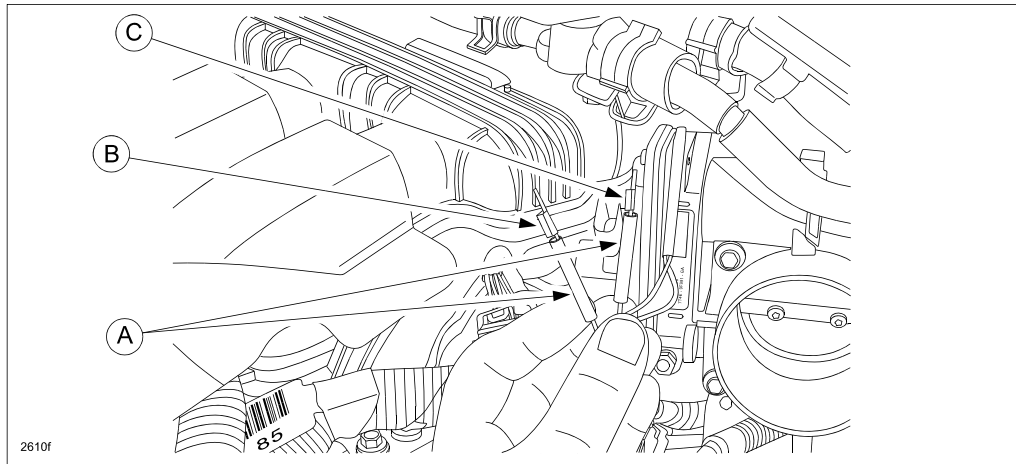
11. Re-install the red terminal lock onto the connector.
12. Place the heat shrink (A) over both Yellow (B) and Brown (C) male terminals (from new connector).

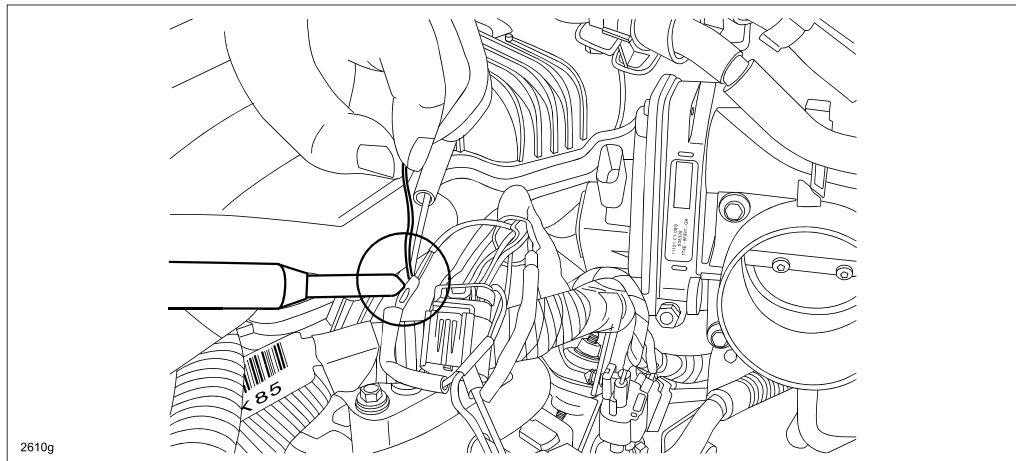
13. Connect the Yellow female terminal (from vehicle harness) and the Yellow male terminal (B) (from new connector).
14. Connect the Blue/Orange female terminal (from vehicle harness) and the Brown male terminal (C) (from new connector).
15. Solder the joints together.

- Before soldering, make sure the soldering iron is fully warmed up and its edge is cleaned with a sponge or rag soaked in water.
- Be careful not to melt the heat shrink tube while soldering.
- To prevent the heat shrink tube from shrinking due to heat generated during soldering, the heat shrink tube must be kept away from the heat generated at the soldering spot.

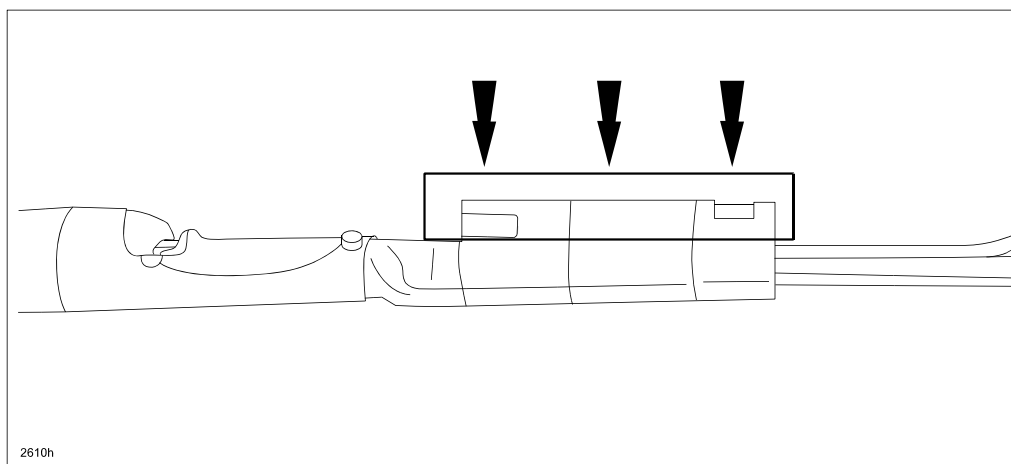
16. Using suitable pliers, squeeze both the Yellow and Brown male terminals at the protrusion to prevent sharp edges protruding through the heat shrink tubing.

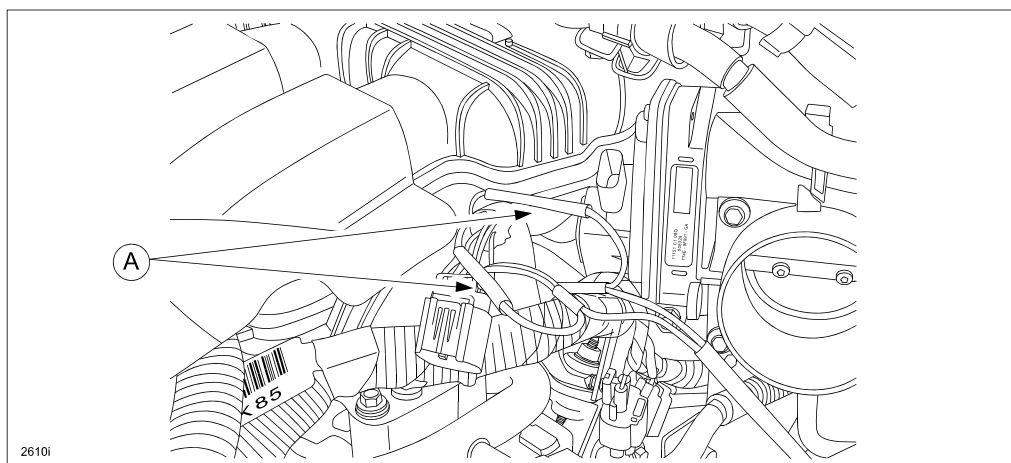
17. Place heat shrink (A) over both solder joints and shrink using a heat gun.

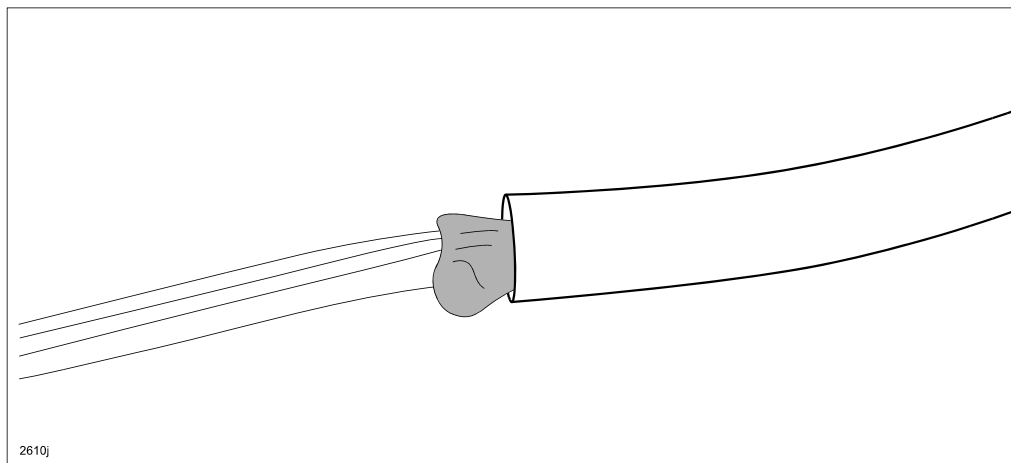
NOTE: Warm the wire up until plastic comes out from the edge, but do not touch the plastic right after shrinkage when it is soft.

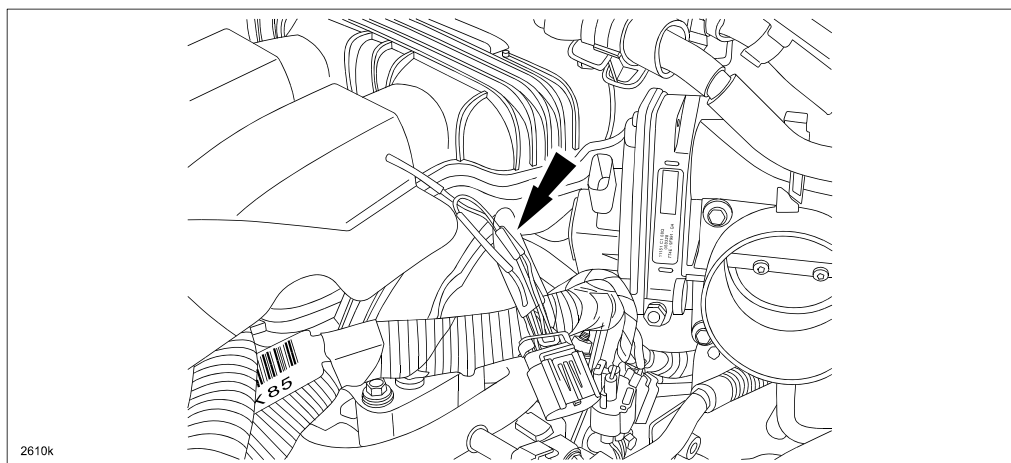
18. Fold the wires so they are flush with the harness.

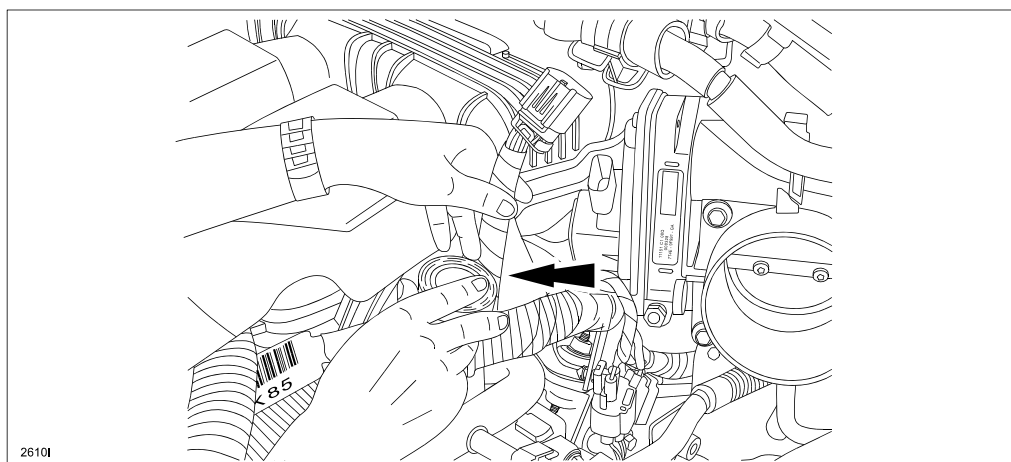
19. Re-tape the harness.

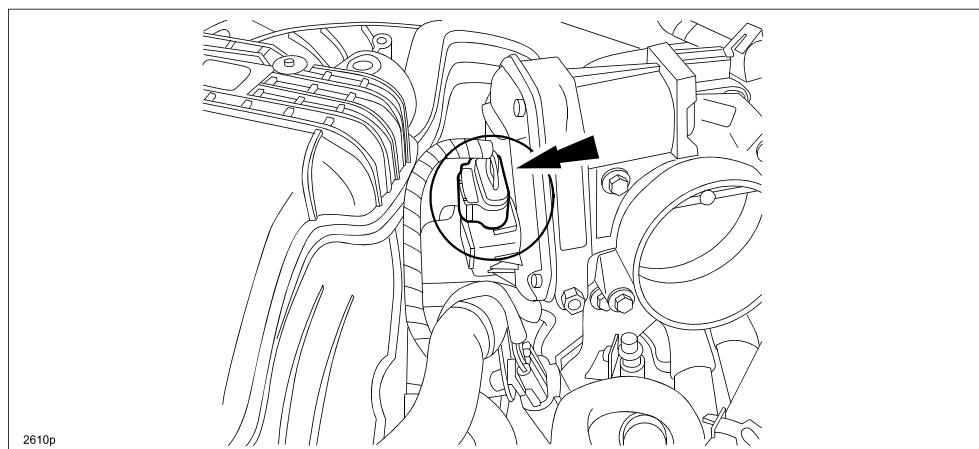
20. Reconnect the harness to the electronic throttle body.
