Subject: MAZDA SERVICE PROGRAM (MSP41) - MAZDA CONNECT INFOTAINMENT SYSTEM UPDATE	Bulletin No: 09-034/13
	Last Issued: 12/4/2013

An updated version of the software for the Connectivity Master Unit (CMU) has become available. Under this MSP41, the CMU of applicable Mazda3 vehicles will be reprogrammed to the updated version using a USB memory stick. This software update includes some fixes for the Infotainment System as described below as well as some additional minor fixes.

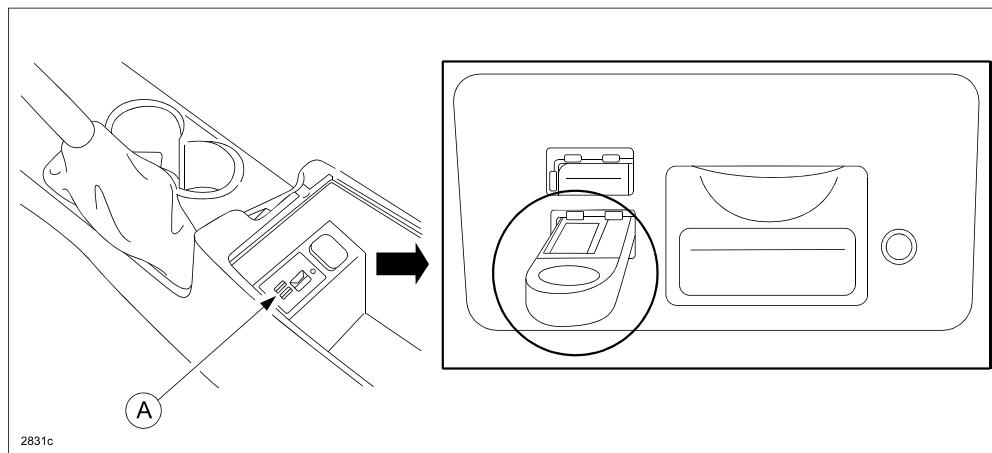
8. Connect the prepared USB memory stick to the either one of the two USB port (A).

NOTE: There should only be the prepared USB memory stick inserted in one of the USB ports. Nothing should be inserted in the other USB port during the re-flashing process.
